# Electrostatic discharge impacts on the main shaft bearings of wind turbines

**Abstract.** This paper studies the electrostatic discharge effect in wind turbines, a possible trigger source of main bearing current. A lab setup with a charge generator and downsized wind turbine was built to verify the impact of electrostatic discharge on the main bearing current. In the test, a fatal amplitude for the bearing current was found at only -93mV driven voltage on the shaft. Compared with the common mode voltage driven bearing current, the electrostatic discharge effect triggers the bearing breakdown at a lower shaft voltage but much higher bearing current amplitude. The results demonstrate that the electrostatic discharge effect is a pattern of bearing current in wind turbines and is much more dangerous to the bearing.

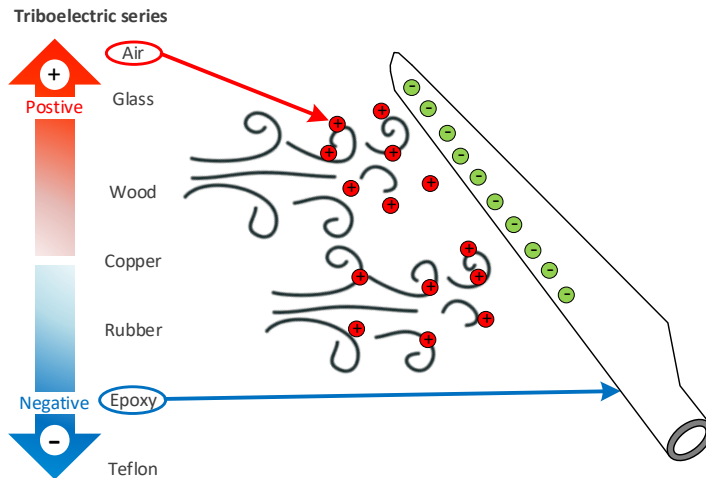
Figure 1: Wind blowing over a wind turbine blade.

45 Additionally, the blads can be electrically charged when wind come into contact with the blads and separated. This effect is known as triboelectric charging. As shown in Figure 1, different material's electron affinity is shown. Air is likely to given out electrons and polymers, such as epoxy and PTFE, have ability to attract electrons and become negatively charged.

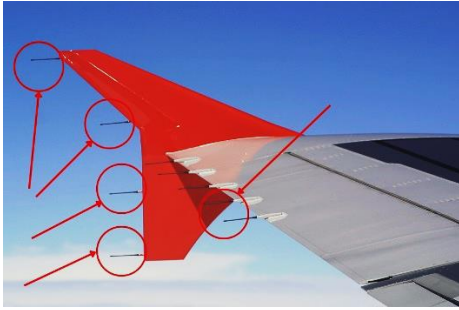
**Figure 2: Dischargers on aeroplane wings.**

50 One example of minimizing triboelectric effect in engineering application is the static dischargers on aeroplanes. An aeroplane's surface is often coated with polyurethane. As the plane moves in the air, its surface will accumulate charges and induce high electric field causing uncontrolled discharges and damage the aeroplane parts, especially modern electronics. To avoid such discharge risk, a number of needle-shaped dischargers are installed on the wings, as shown in Figure 2, these needles provide discharge points to dissipate accumulated charges back to the air via so called corona discharges.

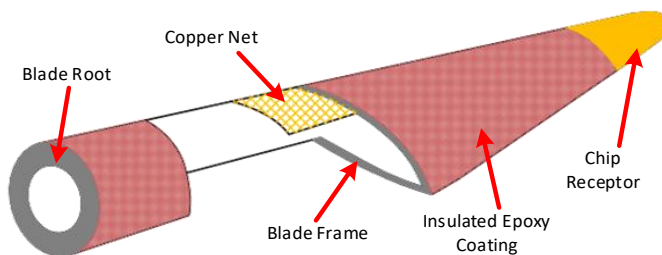
70 **Figure 3: Wind turbine blade structure diagram.**

60 The structure of a typical wind turbine is shown in Figure 3. The blade has a multilayer structure, consisting of the blade frame, filling material, lightning protection components and surface coating. The frame, which provides the basic mechanical structure is usually made of wood, glass fibre, or carbon fibre. The outermost surface of the frame is coated with a layer of epoxy resin based polymeric coating to prevent erosion. Inside the blade, the lightning protection system comprises receptors and a copper net. The receptors that attract lightning from clouds are installed at the tip and middle of the blade respectively (Méndez et al., 2018) and located on the outermost part of the coating. The copper net that provides a path to ground is embedded between the epoxy coating and the frame.

Regarding the blade structure, most components are dielectric materials, except for the lightning protection components. This provides a path for the surface-accumulated charges to be naturalized.

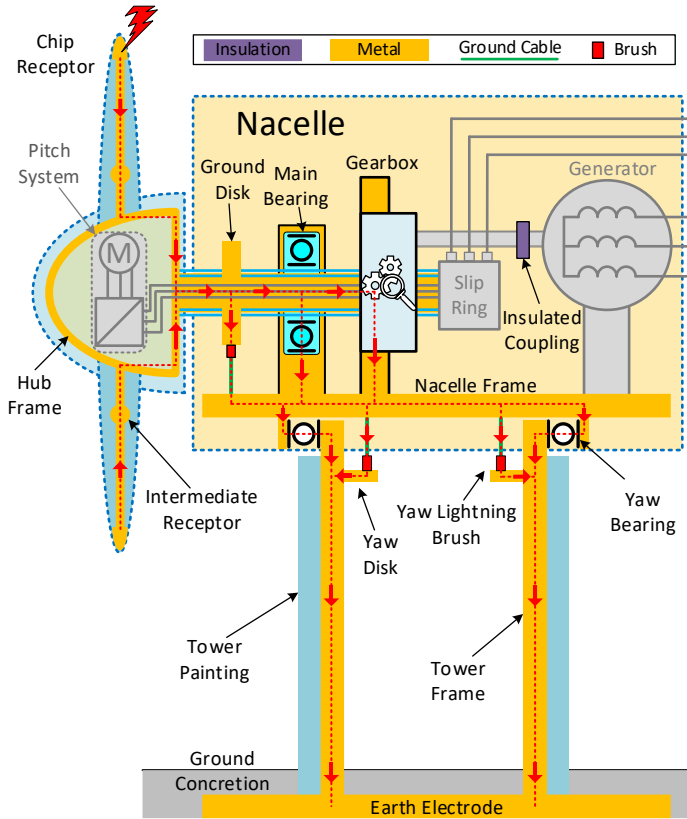
**Figure 4: A typical wind turbine lightning protection system.**

At the wind turbine level, the continuously accumulated charges on the blades find a way to discharge to the wind turbine's lightning protection system and conduct to the ground (Hernández et al., 2019) resulting a current flow. There are different types of wind turbines configurations, with the most widely installed ones being geared and gearless turbines. Figure 4 shows a typical wind turbine with gearbox transmission, main bearing, and gearbox installed directly on the main shaft. The generator is connected to the gearbox via an insulated coupling. In gearless wind turbines, the gearbox is eliminated, and the generator is installed directly with the main shaft.

In the lightning protection system, the blades are electrically connected to the hub frame and main shaft. The main shaft is fitted with a carbon brush which conducts charges on the main shaft to the nacelle frame and onward to the grounding system via the tower frame.

However, in reality, charges may take different paths from the main shaft to the nacelle frame. Though, the main shaft has a brush installed but there is also the main bearing and gearbox (geared turbine) or generator (gearless turbine). The main bearing and gearbox bearing or generator bearing provide a parallel current path for charges on the main shaft. The different paths are indicated by dashed red lines with arrows in Figure 4.

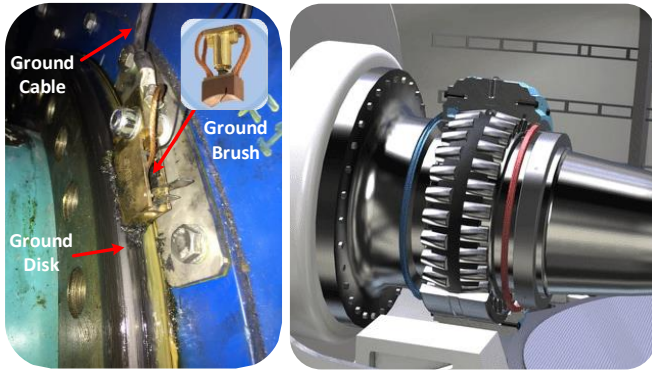
90 **Figure 5: Typical ground brush and wind turbine main bearing.**

Figure 5 shows a typical ground brush and a main shaft bearing. The ground brush is a cuboid block around 5cm long and 1 cm wide, usually made of carbon or metal with one of the cambered surfaces to match the surface of the ground disk. The main bearing is a double-row tapered roller bearing, comprising an inner race, outrace, rollers and lubrication grease. Its diameter ranges from a few dozen centimetres to meters. Thus, contact surfaces area of a main shaft bearing can be significantly

95 larger than the contact surface of a ground brush, resulting lower resistance path for charges to flow.

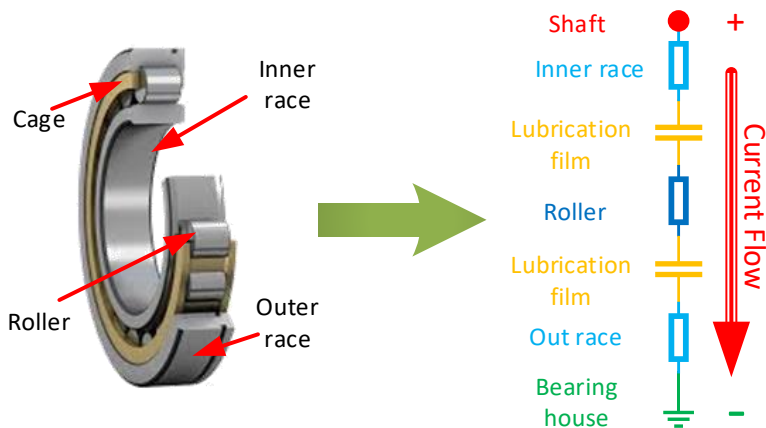
**Figure 6: Basic structure of a typical rolling bearing.**

Figure 6 shows a typical roller bearing structure. It consists of an inner ring, outer ring, rollers and roller cage, plus oil or grease packed between the races and rollers. In the turbine, the inner race's electrical contact is a mechanical connection to the main shaft, while the outrace is connected to ground via the bearing housing.

The inner race, outer race, rollers and cage are made of metal. The rollers are held by the cage and are thus electrically connected. From the electric circuit standpoint, the bearing can be modelled as a capacitor and a resistor in series. Compared with the impedance of the capacitor, the resistance value is extremely small and usually disregarded in the circuit model.

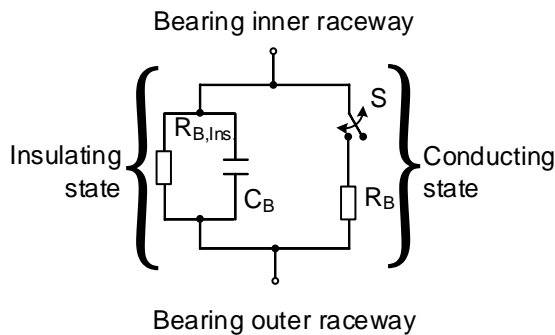
**Figure 7: Bearing electrical model under different states.**

105 The electrical properties of bearings have been studied by many researchers. In the rotation system, the bearing has different electrical states at different rotation speeds. At low rotation speeds, the main bearing supports the rotor, which weighs several tons. The lubrication grease between the roller and races is only partially filled and the bearing is operating in a conductive state. As the rotation speed of the rotor increases, a thin gap between the roller and races is formed and may filled with the lubrication grease, thus the bearing switches to its insulated state. A typical electrical model (Joshi, 2018) of the bearing is  
110 shown in Figure 7. In this model, a switch is used to model the state transition of the bearing.

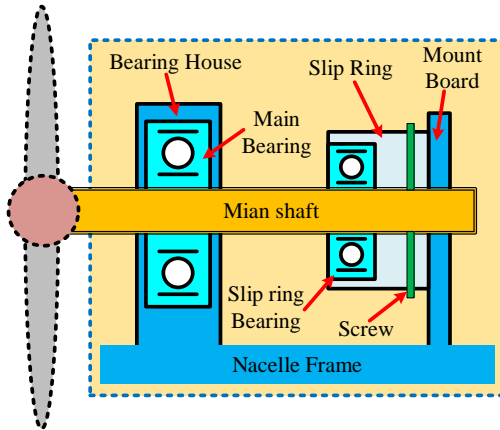
**Figure 10: Laboratory turbine suspension system.**

150 The suspension subsystem supports the turbine rotor and locks the rotor from axial movement. Its principal components are the main bearings, nacelle frame and slip ring. Its configuration is shown in Figure 10. The suspension consists of a two-point system whose rotor is suspended by two bearings. The main bearing inside the bearing housing is a typical cylindrical roller bearing (SKF NU204) that can only support a radial load, while the slip ring bearing inside the slip ring is a typical ball bearing that can support both radial and axial loads. The nacelle frame, bearing housing and mounting board are manufactured as a single unit.

155 A single unit. The slip ring is mounted on the mounting board, thus locking the slip ring in the axial direction. The main shaft goes through the main bearing and slip ring. At the rear end of the slip ring, the main shaft is locked together with the slip ring by screws. Thus, the rotor is locked in the axial direction by the slip ring and mounting board.

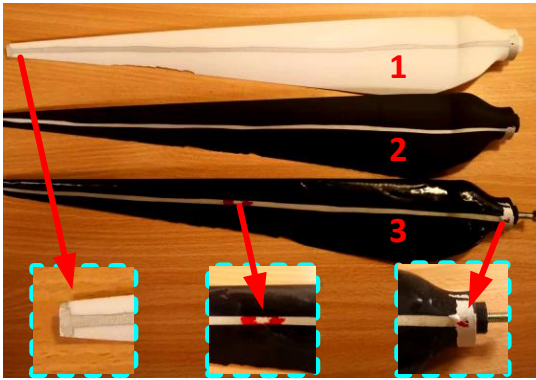
**Figure 11: Coated wind turbine blades.**

Figure 11 shows the coated blades. These are 3D printed in different colours of nylon. Electrically conductive silver lines are painted on both sides of the blades to provide the conductive path. Rectangular areas are painted onto the blade tips to simulate the chip receptors. A screw mounted at the root of each blade electrically connects to the silver painted lines via a copper wire. The whole surface of blade 3 in Figure 11 has been coated with a layer of epoxy resin, except for the tip and a pit in the middle as lightning receptors.

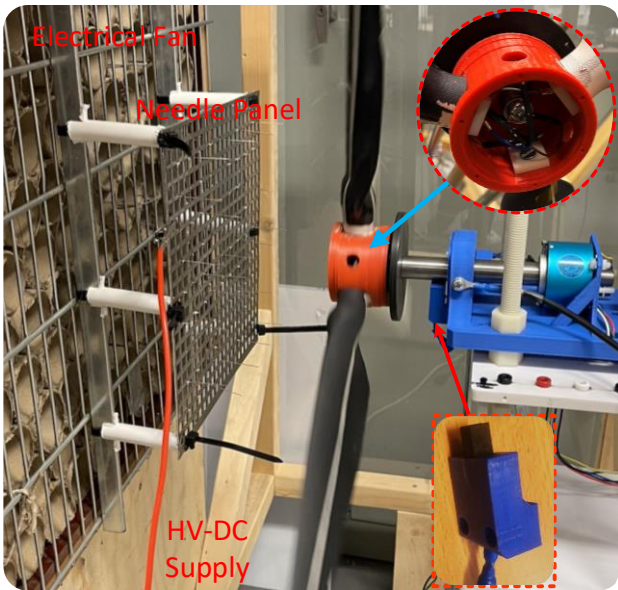
**170 Figure 12: ESD impact on the main shaft bearing, test setup.**

The main shaft is a hollow steel, with the hub mounted on the output side by a nut. Inside the hub, the screws into the blade's root are electrically connected to the shaft's rear end by three cables. These details also illustrated in the Figure 9. On the shaft's drive side (see sub-bottom figure in Figure 12), a carbon brush holder is mounted on the nacelle board and the carbon

brush is forced into contact with the surface of the main shaft by a spring. A conductive cable at the end of the brush connects  
175 the brush to the system's ground or test equipment.

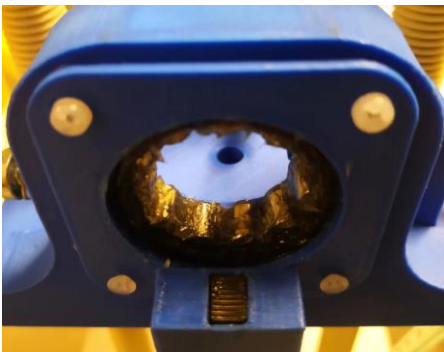
**Figure 13: Cylindrical roller bearing (in housing) packed with extra lubrication grease.**

180 According to the electrical model of the bearing introduced in Section 4, the bearing operates in the conductive state under  
low-speed rotation but switches to its insulated state as the speed increases. In a wind turbine, the main bearing normally  
operates in its insulated state. Under lab conditions, the selected bearing uses an oil based thin lubrication in the cylindrical  
roller, and thus often operates in its conductive state. To keep the lab turbine main bearing working state similar to the main  
shaft bearing in wind turbine, grease based thicker lubrication was injected into the space between the rollers and races. The  
185 bearing with extra non-conductive grease is shown in Figure 13

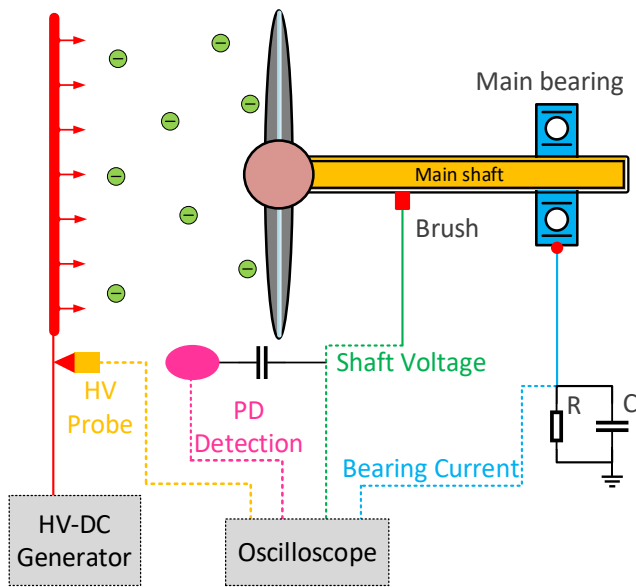
**Figure 14: Lab test connection.**

195 Comparing to the field wind turbine, the brush used in the lab setup is served as a voltage probe and connect to the ground via  
 the oscilloscope's 1 M $\Omega$  input impedance. To emulate a similar current path in the real wind turbine, the miniature bearing  
 with a dynamic impedance of 10 k $\Omega$  is selected by scaling. As based on our field measurements, due to lubrication and  
 contaminations, the brush's dynamic contact resistance is generally high, over 10 k $\Omega$ , whereas the bearings' impedances are  
 in the range of few ohms, thus current will mainly passing through the bearing instead of the brushes. In the lab setup, the  
 200 miniature bearing's outer ring is grounded via a current shunt. Connected in this way current will mainly pass through the  
 bearing. Figure 14 shows the test connection for the setup.

In the test setup, the used shunt capacitor is 100pF and the shunt resistor is 1kΩ. In the test connection shown in Figure 14, one side of the current shunt is connected to ground and the other feeds to the oscilloscope which measures the current passing through the main bearing as a voltage signal.

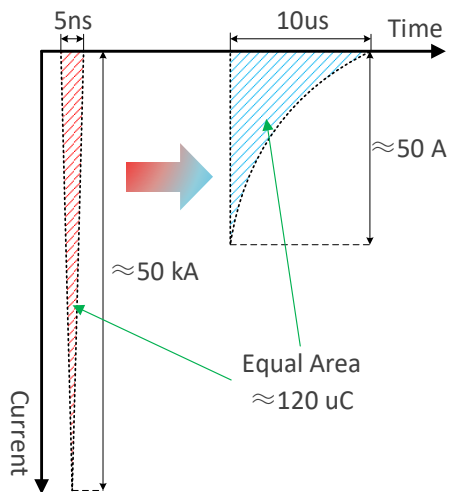
**Figure 15: bearing discharge current test method indication.**

210 The discharge has an extremely high amplitude current flowing for an extremely brief period. This is usually a matter of few nanoseconds with the current amplitude being in the kiloampere range. The amplitude and bandwidth of the discharge current are usually beyond the measurement range of an oscilloscope. To capture the current, the main bearing is grounded via a parallel resistor and capacitor (RC) circuit which measures the bearing discharge current. In this RC circuit, the capacitor slows the current flow, and the shunt resistor converts the current signal into a voltage signal. As shown in Figure 15, the RC circuit

215 slows the progress of the discharge current and reduces its amplitude. But the total amount of dissipating charges remains the same.

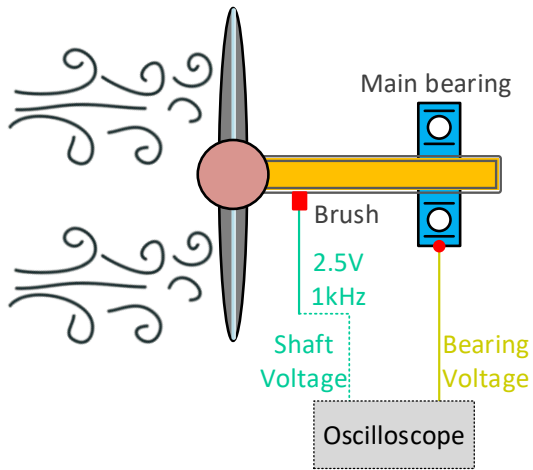
**Figure 16: Bearing state test connection.**

Due to the extra grease injected into the main bearing, the bearing can operate in its insulated state. The first test verifies the bearing's operating state. Figure 16 shows the test connection; a 2.5V square wave voltage signal with frequency of 1k Hz is

applied to the shaft via the carbon brush and the main bearing's outtrace is connected directly to the oscilloscope to monitoring  
230 its voltage.

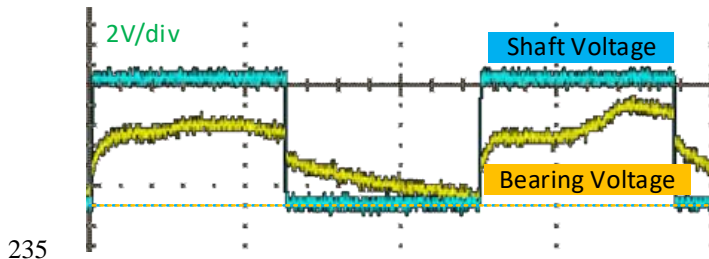
**Figure 17: Bearing voltage without grease.**

The turbine was rotated by the wind (5-6m/s) at around 80 rpm and no charge generation from the needle panel. The bearing, with and without grease, is shown in Figure 17 and Figure 18 respectively.

In the case of the bearing without grease, the bearing often operates in a conductive state, with the outer race voltage waveform  
240 nearly following the input voltage and showing very little voltage drop on the bearing impedance. In the case of the bearing

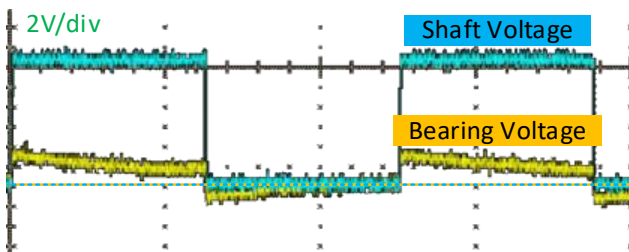
**Figure 18: Bearing voltage with grease.**

with grease, there was a significant potential difference between the inner and outer races, indicates an insulating state in bearing.

It is clear that injecting grease into the main bearing changes its operating condition from a conductive state to an insulated one. Furthermore, under the insulation state, there was no electrical breakdown in the bearing at 2.5V.

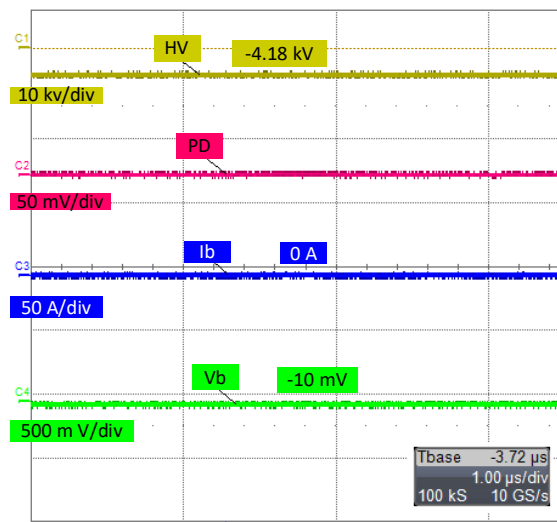
**Figure 19: Bearing voltage and current at -4.18 kV needle voltage.**

Using the test system connection in Figure 14, different DC voltage levels were applied to the needle panel. In the test, the charge accumulated / induced on the blade was conducted to the main shaft via the lightning protection system. The charges accumulated on the main shaft are impeded by the grease in the main bearing to the ground. The electrical properties of the main bearing mean that it acts as a dynamic capacitor, blocking DC but conducting AC. The charges from the air are unipolar particles, whose movement generates a negative DC current flow from the blade to the main shaft. These airborne charges are stored on the bearing's inner race and build up a DC electric potential on the main shaft. As shown in Figure 19, the needle panel supplied with a voltage of -4kV in channel 1 and in channel 4, a voltage of -10mV is induced on the shaft. Because the airborne charges form negative sources, the voltage on the main shaft is also negative. Based on the bearing's current curve in channel 3, there is no current flowing through the bearing.

290 Unlike the test A, the test B, a DC potential was built up at the shaft by means of charges accumulation via the blads. As shown in Figure 23 a, the accumulated charges built up a static electric field over the grease. But the amplitude of the electric field on the bearing grease is not strong enough to break down the bearing. Thus, the potential on the main shaft kept in a stable DC value, as shown in Figure 19.

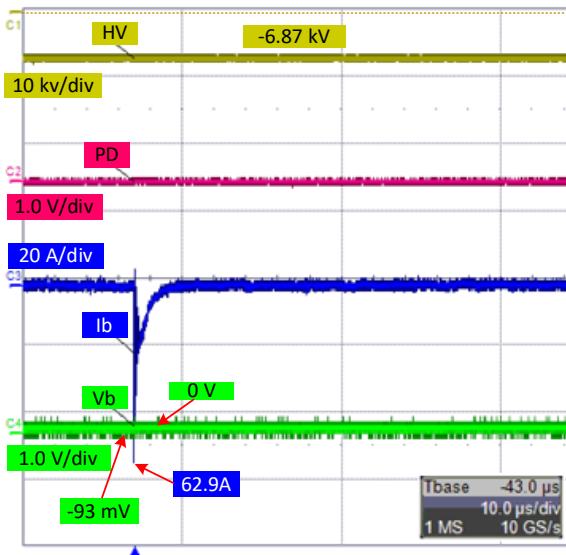
Figure 20: Bearing voltage and current at -6.87 kV needle voltage.

In Figure 20, with a -6.87kV DC voltage applied to the needle panel, the voltage build-up on the main shaft reached only -93 mV. From the bearing current curve, a breakdown clearly occurred on the bearing and its amplitude reached 62.9 A. During the breakdown process, the induced voltage on the shaft dipped to zero.

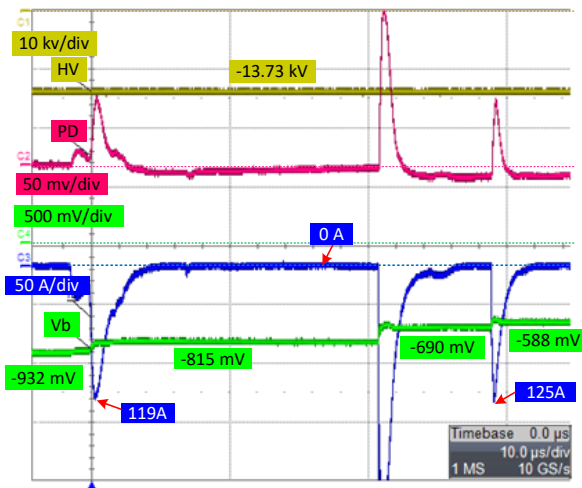
Figure 21: Bearing voltage and current at -13.73 kV needle voltage.

265 With the increasing needle voltage, the charge density in the tunnel further increases. When the needle voltage was increased to -14kV, the bearing broke down more frequently. The test results appear in Figure 21, in which the induced voltage reaches -932mV. Within the same timespan as Test B, breakdown occurred three times, with the bearing current amplitude reaching hundreds of amps. During each breakdown, the shaft voltage dipped by several hundred millivolts.

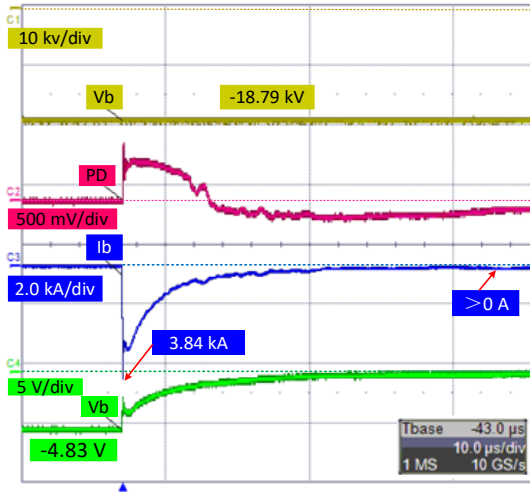
275 **Figure 22: Bearing voltage and current at -18.79kV needle voltage.**

270 Further increasing the charge density, the applied needle voltage was adjusted to -18.79 kV. As indicated in Figure 22, the induced shaft voltage reached -4.83V. The breakdown occurred in the bearing during rotation, with the current flowing through

the bearing peaking at 3.84kA. After the breakdown, the bearing's operating state reverted to a conductive state. There was a continuous current flow through the bearing, even after the voltage had dropped to nearly zero.

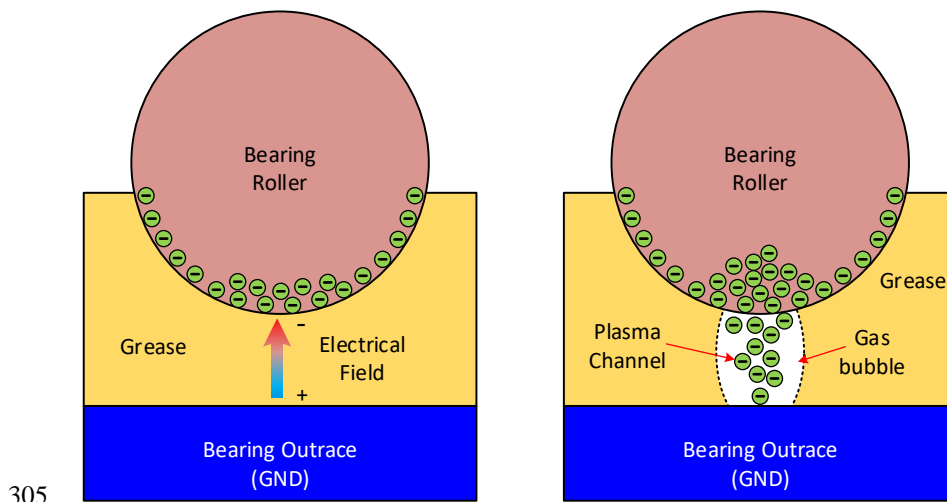
**Figure 23: Charge movement during breakdown.**

300 During the bearing breakdown, the electric arc is generated through the grease and causing a gas channel between roller and outer race. With increasing current flow, A plasma channel can be built (as shown in Figure 23 b) and the accumulated charges dissipated to the outer race, which is grounded via the mechanical connections. The shaft voltage dipped to zero and the electric field on the bearing grease was not enough to maintain the discharge channel. Thus, the discharge channel disappeared with the rotation and the breakdown process ended (Maradia and Wegener, 2015).
