# Non-destructive sub-surface inspection of multi-layer wind turbine blade coatings by mid-infrared Optical Coherence Tomography

**Abstract.** Non-destructive inspection (NDI) is useful in the industrial sector to ensure that manufacturing follows defined specifications, reducing the quantity of waste and thereby the cost of production. Optical Coherence Tomography (OCT), a well-known diagnostic technique in medical and biological research, is increasingly being used for industrial NDI. In the mid-infrared (MIR) wavelength range, OCT can be used to characterise parts and defects not possible by other industry-ready scanners, and enables better penetration than conventional near-infrared OCT.

In this article, we demonstrate NDI of wind turbine blade (WTB) coatings using an MIR OCT scanner employing light around 4  $\mu\text{m}$  from a supercontinuum laser source. We inspected the top two layers of the coating (topcoat and primer) in two different samples. The first is to determine the maximum penetration depth, and the second one is to imitate defect identification. [We also developed a basic algorithm to extract the thickness layer of the topcoat and primer.](#) The results of o

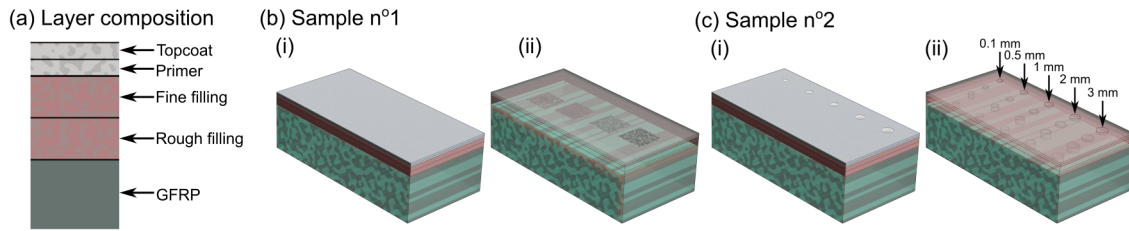
**Figure 1.** (a) Schematic of the layer composition of the samples visualised in (b,c). (b) Sample with aluminium foil patches placed at the interfaces between layers. (c) Sample with punch defects in different layers. For (b-c), (i) and (ii) show opaque and transparent 3D illustrations of the samples.

Two sets of samples were tested, denoted n°1 and n°2, one set with aluminium foil inside, and the other one containing intentional defects. Figure 1(a) shows a schematic of the layer composition above the glass fibre ~~reenforced~~reinforced polymer (GFRP) the material used for the inside of the WTB, and Fig. 1(b-c) presents 3D illustrations of both samples. During the process of fabrication, the layers are subsequently applied and dried in a controlled environment. Each layer is sanded before the application of the next one. For sample n°1, between each layer a small square of aluminium foil was inserted. It was used to benchmark the penetration depth of the MIR OCT scanner and the refractive index of the layers.

For sample n°2, at each layer, before the drying process, some defects were created to imitate some manufacturing defects (cf. Fig 1(c) and Fig. 2).

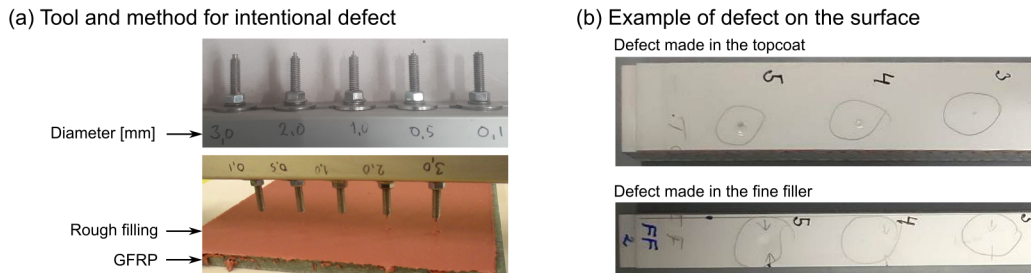
**Figure 2.** (a) The tool and method used to create the defects in each layer during the sample manufacturing. (b) Two example pictures of the surface of the sample with intentional defects in the topcoat and in the fine filler.

For each layer, 5 holes with different diameters were made by punching the paint in staggered rows with metallic needles with different diameters: 0.1 mm, 0.5 mm, 1 mm, 2 mm, and 3 mm. The punched holes subsequently undergo two processes before the layer is entirely dry:

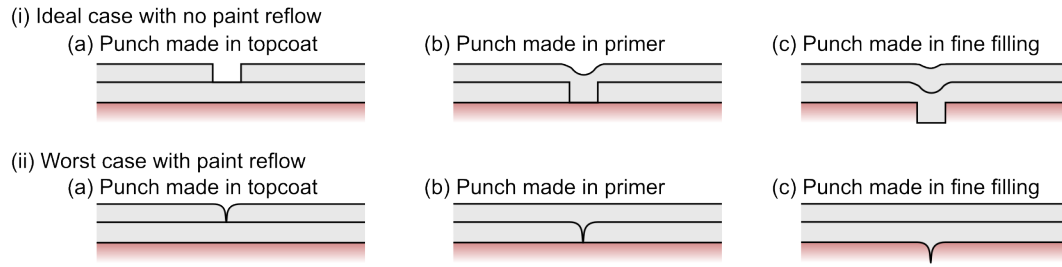
**Figure 3.** Illustration of the impact of introducing punch defects at different layers in the production with (i) an ideal case without any reflow, and (ii) the worst case of reflow of wet paint, (a) in the topcoat, (b) in the primer, and (c) in the fine filling.

- (i) In an ideal case, the hole made after the punch doesn't change and keeps the size of the needle. Then the hole is filled with a subsequent paint layer, if it is not made in the top layer.
- (ii) In most cases, there is a more or less important reflow of wet paint after punching. This reflow could entirely fill the hole.

The resultant defects after processes (i) and (ii) are illustrated in Fig. 3(i) and Fig. 3(ii) for the three punched layers corresponding to (a), (b), and (c), respectively. The deeper the layer the punch is made, the less severe the disturbance in the surface of the coating is expected to be. In contrast, punches in the topcoat are not remedied by subsequent coating layer deposition and are most likely to persist. For this reason, punches in the topcoat will only be remedied by process (ii).

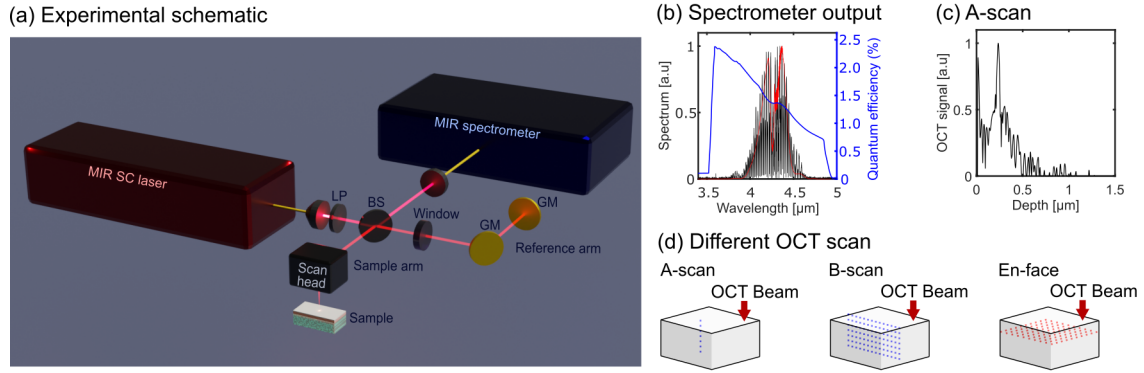
**Figure 4.** (a) 3D representation of the MIR OCT system, SC: supercontinuum, LP: 3.2  $\mu\text{m}$  long pass filter, BS: beam splitter, GM: gold mirror. (b) Reference spectrum in red, measured interference spectrum in black, upconversion efficiency in blue, and (c) the corresponding calculated A-scan. (d) Schematic of the different OCT scans used in this article.

The MIR OCT scanner is presented in Fig. 4(a). The light source is an in-house fabricated MIR supercontinuum (SC) source covering a spectrum from 1 to 4.6  $\mu\text{m}$  (Woyessa et al. (2021)) coupled to a Michelson interferometer. Due to the range of the spectrometer and to minimise the amount of unnecessary power, there is a long-pass filter at the input of the interferometer, which removes light at wavelengths shorter than 3.2  $\mu\text{m}$  (cf. Fig. 4). At the output of one arm of the interferometer, the scan-

the cross-sectional image, a flattening post-processing procedure was applied for correcting this effect. The different types of OCT scans presented in this article are illustrated in Fig. 4(d).

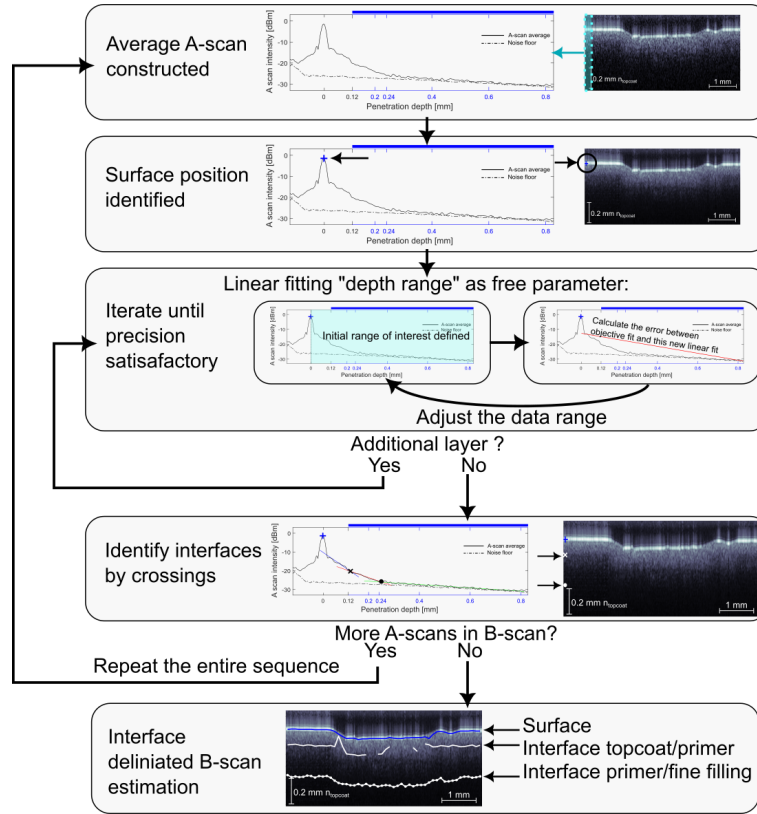
**Figure 5.** Graphical representation of our algorithm.

After the calculation of this *objective fit*, from an area (hopefully) without defects, we can then run the automatic interface  
 130 recognition program in the interested area. It is possible to run the program with no averaging B-scan, but to enhance the  
 automatic recognition of each interface, we averaged 10 neighbouring B-scans around the interested B-scan and then applied  
 the algorithm on it. The algorithm follows the protocol outlined in the Fig. 5

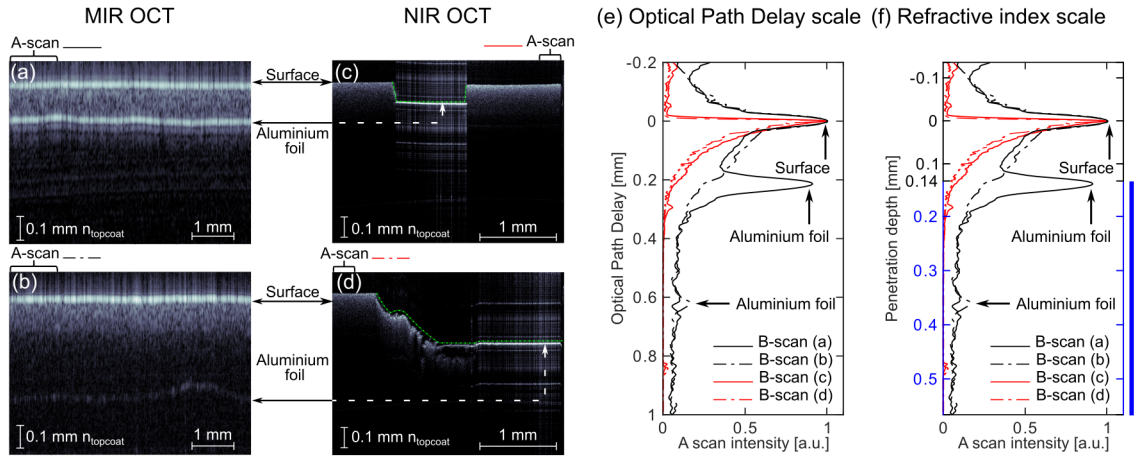
**Figure 6.** (a-b) Comparison of penetration depth between B-scans in MIR OCT ( $4\ \mu\text{m}$  centre wavelength) and (c-d) in NIR OCT ( $1.3\ \mu\text{m}$  centre wavelength). The dashed green line in (c-d) shows the part where the coating was intentionally removed for the NIR OCT measurement to find the presence of aluminium foil. For each B-scan, the physical distance in depth was calculated with  $n_{\text{topcoat}} \simeq 1.49$ . (e-f) Comparison of the A-scan average of each B-scan is depicted in (a-d). (e) Present the results with the Optical Path Delay (*OPD*) scale (false scale) and (f) scale with  $n_{\text{topcoat}} \simeq 1.49$  (from 0 to  $0.14\ \mu\text{m}$ ) and then scale with  $n_{\text{primer}} \simeq 1.84$  (blue scale from  $0.14\ \mu\text{m}$ ) (real scale).

In the following figures, including Fig. 6(a-d), for a better understanding, we make the compromise to calculate the depth scale presented in the B-scans with the refractive index from the topcoat  $n_{\text{topcoat}} \simeq 1.49$ .

Figures 6(e) and (f) present the A-scan average of each B-scan depicted in Fig. 6(a-d) with the  $OPD$  scale in (e), and with the scale calculated with  $n_{\text{topcoat}} \simeq 1.49$  (from 0 to  $0.14\mu\text{m}$ ) and then calculated with  $n_{\text{primer}} \simeq 1.84$  (blue part from ~~from~~  $0.14\mu\text{m}$ ) in (f). The black curves present the A-scan averages of the MIR OCT B-scan, solid line (a) and dashed line (b), while the two red curves present the A-scan averages of the NIR OCT B-scan, solid line (c) and dashed line (d). The average was made over 100 A-scans, which represent  $1.146\text{mm}$  for MIR OCT and  $0.29\text{mm}$  for NIR OCT. MIR OCT allows us to characterise the sample through the primer and slightly into the fine filling until around  $360\mu\text{m}$ . For the NIR OCT evaluation, the signal is completely attenuated after a physical depth of  $100\mu\text{m}$  due to strong scattering. In the NIR, the signal is dominated by multiple scattering, so the real OCT signal penetration depth is most likely significantly shorter Israelsen et al. (2019).

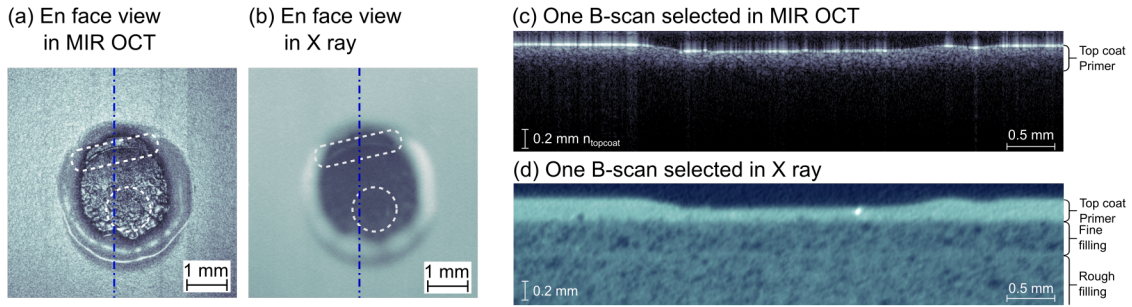
**Figure 7.** Comparison between MIR OCT and X-ray CT measurements made of the defect made in the topcoat part with a diameter of 3 mm. (a-b) *En face* view of the surface of the sample. (c-d) Selected B-scan in approximately the same place. The blue dashed lines in (a-b) show where the B-scans were extracted.

Figures 7-8 show comparisons between X-ray CT and OCT measurements from the sample n°2 made inside the topcoat with a 3mm diameter needle. The X-ray CT machine was a Zeiss Xradia 520 Versa, with a resolution of 1-50  $\mu\text{m}$  in samples of size 1-50 mm. The *En face* view from OCT and X-ray CT is presented in Fig. 7(a,b), respectively, from which it was possible to identify the same areas on the sample, highlighted by the white dashed boxes. The resolution of X-ray CT is lower than OCT due to the large scanning area, chosen to avoid too long scanning time. Indeed, the total time for the characterisation of an area that contains 3 defects,  $\sim 10 \times 1 \times 1.5$  cm, was around 6hours. For the OCT, the scanning time was 40 min for each defects defect area  $\sim 5.73 \times 5.73$  mm<sup>2</sup>. With the resolution of MIR OCT, it is possible to detect the surface bump.

To further compare the two technologies, we selected one B-scan from MIR OCT and one B-scan from X-ray CT (cf. Fig. 7(c,d)) approximately at the same location, shown by the dashed blue line in Fig. 7(a,b). On both, on the right, the brackets show the different layers position. The penetration depth is better in X-ray CT, however, the issue here is the resolution. This resolution is correlated to the sample size and so the scanning area, and the larger the sample, the lower the resolution of the X-ray CT with a fixed time Mishnaevsky et al. (2021). The resolution of OCT in depth depends only on the laser source, and the transverse resolution depends on the scanning head, and for our case, the imaging lens used. The smallest granular visuals in Fig. 7(a) and (c) come from the presence of speckles within the measurements.

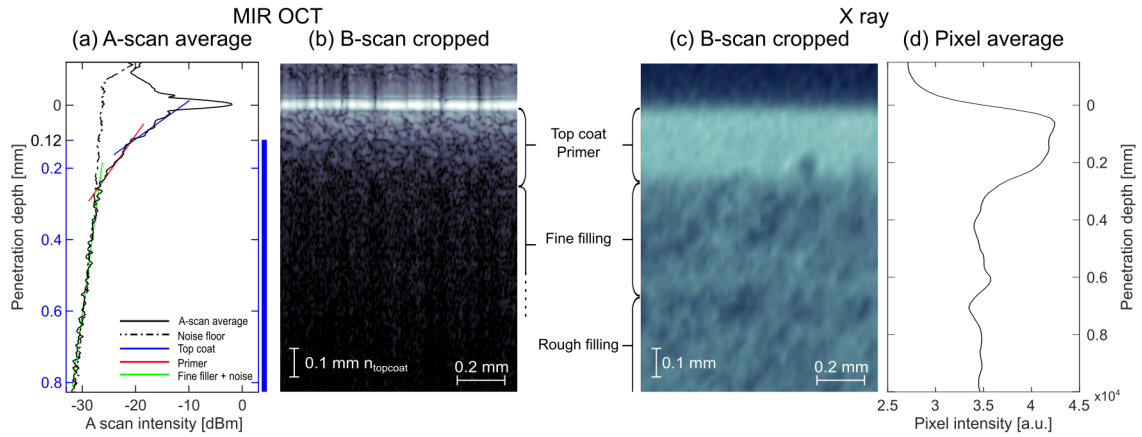
**Figure 8.** Comparison between (b) MIR OCT B-scan and (c) X-ray CT B-scan. (a) is the A-scan average of (b) and (d) is the pixel average of (c). For (a) the penetration depth is calculated with the  $n_{topcoat}$  (from 0 to 0.12  $\mu\text{m}$ ) and then  $n_{primer}$  (blue scale from 0.12  $\mu\text{m}$ )). The solid ~~lines~~ blue, red, and green ~~lines~~ are the ~~fit-fits~~ of topcoat, primer, and fine-filling ~~combine-combined~~ with the noise floor. blue fit =  $(-75.09 \pm -9.81) \times OPD/n_{topcoat} + (6.10 \pm 2.9)$ ; red fit =  $(-47.53 \pm -6.53) \times OPD/n_{primer} + (-7.25 \pm -0.89)$ ; green fit =  $(-4.31 \pm -0.10) \times OPD + (-23.12 \pm -0.15)$

To achieve a better comparison between MIR OCT and X-ray CT, we selected the first millimetre horizontally of Fig. 7(c,d) and show this in Fig. 8(b,c). An average A-scan is associated with the B-scan from MIR OCT (cf. Fig. 8(a)), and a pixel average is associated with the B-scan from X-ray CT (cf. Fig. 8(d)). For Fig. 8(a), the spatial average was made over  $\simeq 0.991$ mm (173 A-scanA-scans), and for Fig. 8(d), over  $\simeq 0.998$ mm (66 A-scanA-scans). In both cases, it is possible to distinguish the topcoat and the primer part, represented by the first two slopes in (a) and the first two plateaus in (d). The third slope in the MIR OCT A-scan plot is the beginning of the fine filling layer, continuing until the noise floor (black dashed curve) in Fig. 8) at around

0.36 mm. Beyond this point, the losses are too pronounced to detect the bottom part of the fine filling. Blue, red, and green solid lines in Fig. 8(a) are, respectively, the fit of the topcoat, primer, and combination of fine filler plus noise.

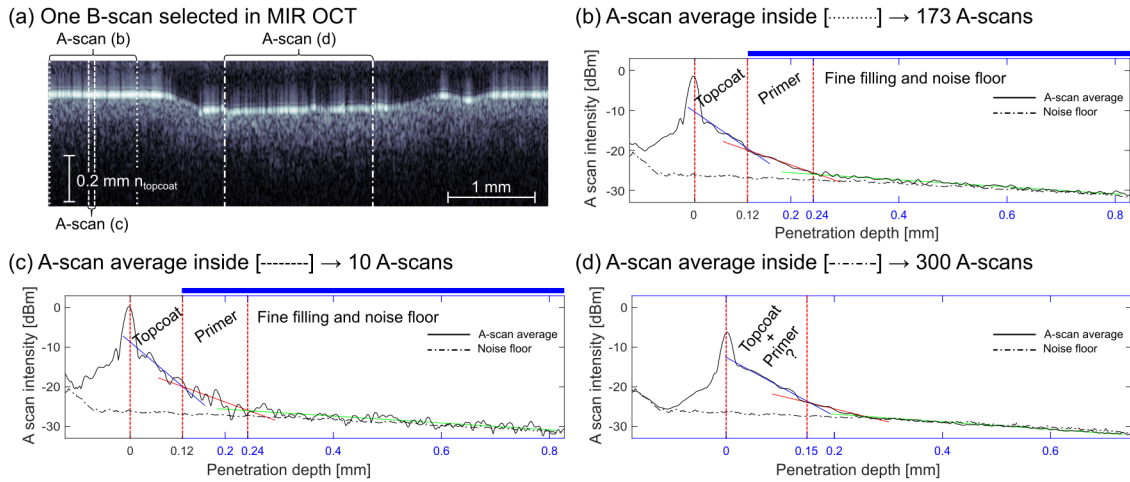
**Figure 9.** (a) The B-scan selected is the same as in Fig. 7, the dashed boxes show where the A-scan was extracted to calculate the average in (b-d). For (b-c) the penetration depth is calculated with the  $n_{\text{topcoat}}$  (from 0 to 0.12  $\mu\text{m}$ ) and then  $n_{\text{primer}}$  (blue scale from 0.12  $\mu\text{m}$ ), and for (c) the penetration depth is calculated with  $n_{\text{primer}}$ .

205 We conducted a study of coating thickness, topcoat, and primer on sample n°2 (cf. Fig. 9) by tracking the bottom interface of the topcoat and the primer layer. Figure 9(a) shows on the B-scan where ~~are~~ the different average A-scan regions are, while Fig 9(b-d) present the corresponding A-scan averages (black solid curves). The average parameters are for (b) 173 neighbouring ~~A-sean-A-scans~~ ( $\sim 0.9913 \text{ mm}$ ), (c) 10 neighbouring A-scan ( $\sim 0.0573 \text{ mm}$ ), and (d) 300 neighbouring ~~A-sean-A-scans~~

( $\sim 1.719$  mm). The beginning of the fine filling part can be detected up to a depth of approximately 0.36 mm, where the noise floor intersects with the A-scan averaging.

The average A-scans depicted in Fig. 9(b) and (c) present the limitation of averaging. As shown in Fig. 9(c), the fluctuations caused by speckles are significant enough to affect the curves curve fitting if too few A-scans are use-used in the averaging. For Fig. 9(d), the averaging was performed inside the intentional defect part. In this region we expect a certain amount of topcoat was removed after the intentional defect was made with the needle. In an ideal world, all the topcoat should be removed in this region, but the fitting slop does not correspond to the primer fit in Fig. 9(b). It is possible that there was a non-uniform topcoat residue above the primer on the 300 A-scans. As we expect to have only primer in an ideal case, the scale for penetration depth was calculated only with  $n_{\text{primer}}$ .

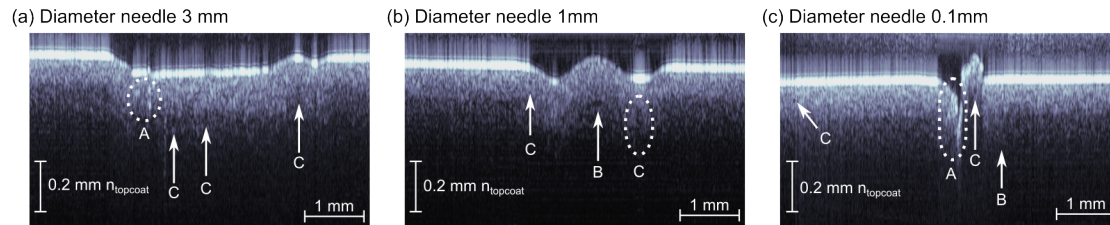
**Figure 12.** Summary of additional defects detected. To enhance visibility, (a-c) represent an average of 5 B-scans. Defect categories found are for (a): A and C, (b): B, and C and (c): A, B and C

Figure 12, presents three typical defects that were detected in sample n°2. In Fig. 12(a), there is the presence of bright particles inside the dashed circle (defect A) and the presence of air bubbles trapped inside the coating (defect C - see white arrows).

Figure 12(b) shows the presence of an air bubble (defect C - left arrow), a crack (defect B - right arrow) just under the area where the intentional defect was made marked by the white arrows, and a hole (defect C - dashed circle). Due to the viscosity of the paint, the bottom part of the layer of the primer or the topcoat may have been moved. Fig. 12(c) shows the presence of inclusion (defect A - dashed circle), air bubbles trapped inside the coating (defect C - left and middle white arrows), and the suspicion of a crack (defect B - right white arrow).
