Feasibility of up-tower repair concepts for pultruded carbon spar cap planks in wind turbine blades

Abstract. While modern wind turbine blades utilize pultruded carbon-fiber-reinforced polymer (CFRP) planks for structural integrity in spar caps, these materials can sustain damage from operational stresses, leading to potential failures if unaddressed. Traditional down-tower repairs result in significant costs related to dismantling and transporting, especially for offshore installations, emphasizing the need for efficient up-tower repair methods. This research utilizes a finite-element model of an 81.6 m rotor blade designed for a 7 MW offshore turbine, subjected to aeroelastic simulations to evaluate load conditions during maintenance. The analysis focuses on a step-wise increased repair zone, assessing susceptibility to buckling, cyclic strains, and permissible wind speeds. Results indicate that while substantial repairs can endanger structural stability, turbulence-induced strain amplitudes are manageable. Recommendations include installing temporary pretensioning and buckling support structures to enhance safety during repairs. Various innovative support concepts are proposed

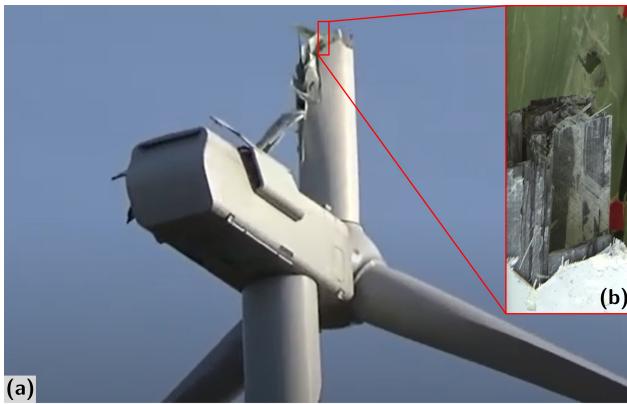
Figure 1. Blade loss incident after 2 years of operation (Pierrot, 2022) showing typical damage resulting from a lightning strike event (Ylikoski, 2020).

Modern wind turbine blades utilize carbon-fiber-reinforced polymer (CFRP) planks in their load-carrying structures, i.e., the spar caps. These CFRP planks are pre-manufactured in a pultrusion process and stacked into the blade structure. The pultrusion process ensures high-quality fiber alignment and fiber volume fraction, and low numbers of manufacturing defects. It can further ensure that all these properties are produced with high reproducibility, leading to outstanding mechanical properties. CFRP planks can be damaged during operation due to stress concentration resulting from insufficient bonding between planks, voids, defects, or dielectric breakdowns (Harrell, 2020), or flashovers caused by a lightning strike (Girolamo, 2020). If such damage is not repaired, it can lead to blade loss (Fig. 1).

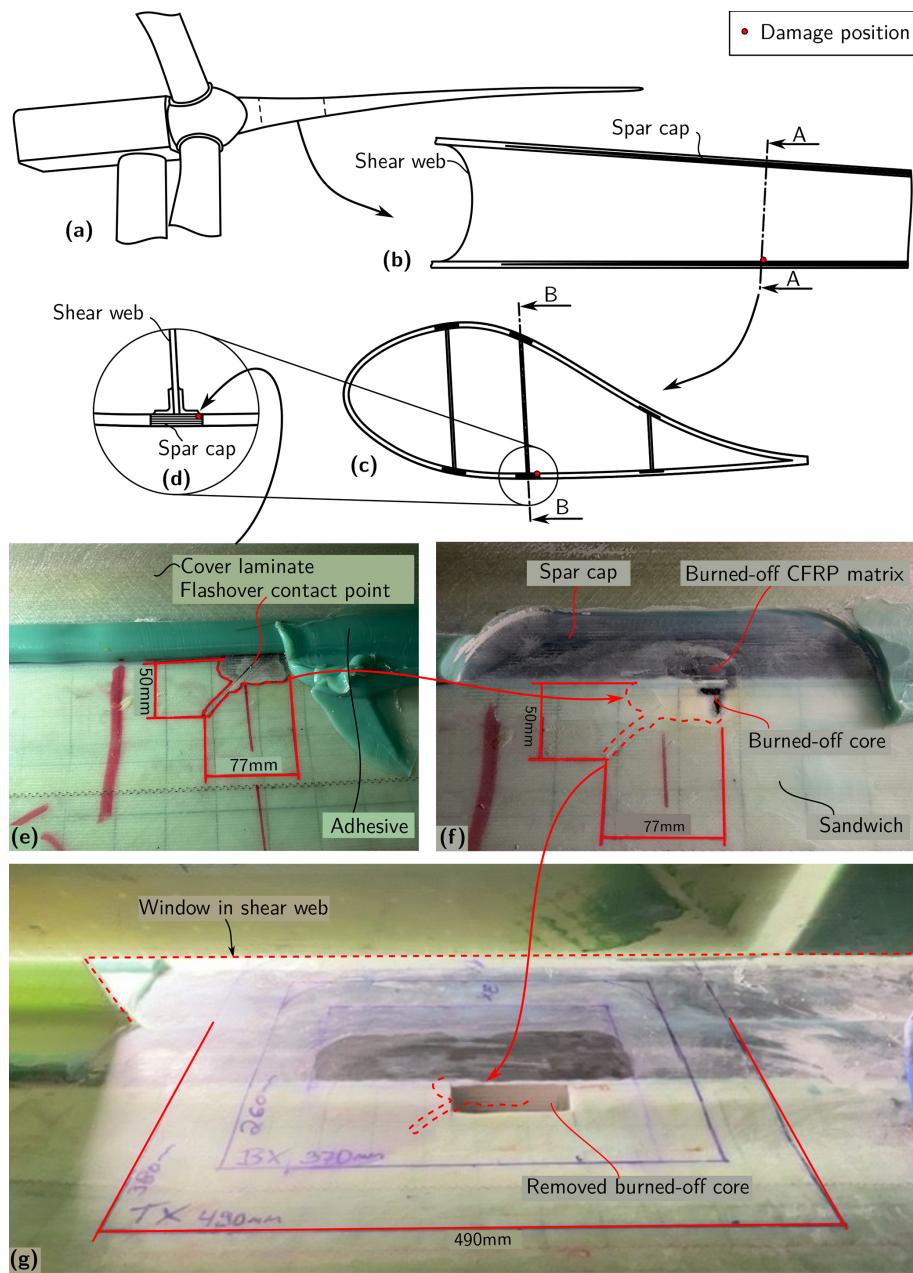
Figure 2. Up-tower repair concept: (a) wind turbine in rotor lock with damaged blade in 3 o'clock position, (b) longitudinal repair zone view through cut line B–B, (c) cross-sectional repair zone view through cut line A–A, (d) zoom into damage position, (e) damage observed as consequence of internal lightning flashover, (f) damage after grinding off cover laminate and adhesive, revealing burned-off spar cap matrix and core material, (g) damage after grinding off CFRP and window cut-out in shear web, based on Rosemeier et al. (2024); Lessa (2023).

When CFRP planks near the inner blade surface are damaged in the inboard blade region (Fig. 2), the repair must be carried out from the inside, whereby the damaged CFRP planks must be ground off and a window cut out of the shear web (Fig. 3). Currently, the repair of a damaged area on pultruded CFRP spar caps is carried out by removing the affected rotor blade from the wind turbine, i.e., performing a down-tower repair, where suitable supports are used to relieve the load on the damaged structure during repair. This can result in significant costs for dismantling or assembly, transportation, and downtime, depending further on whether the wind turbine is operated on land or at sea, e.g., on a floating or fixed platform. Therefore, it is desirable to provide repair and preparation methods, as well as devices and systems suitable for use in such methods, that can reduce such costs. Consequently, an up-tower repair is generally preferred

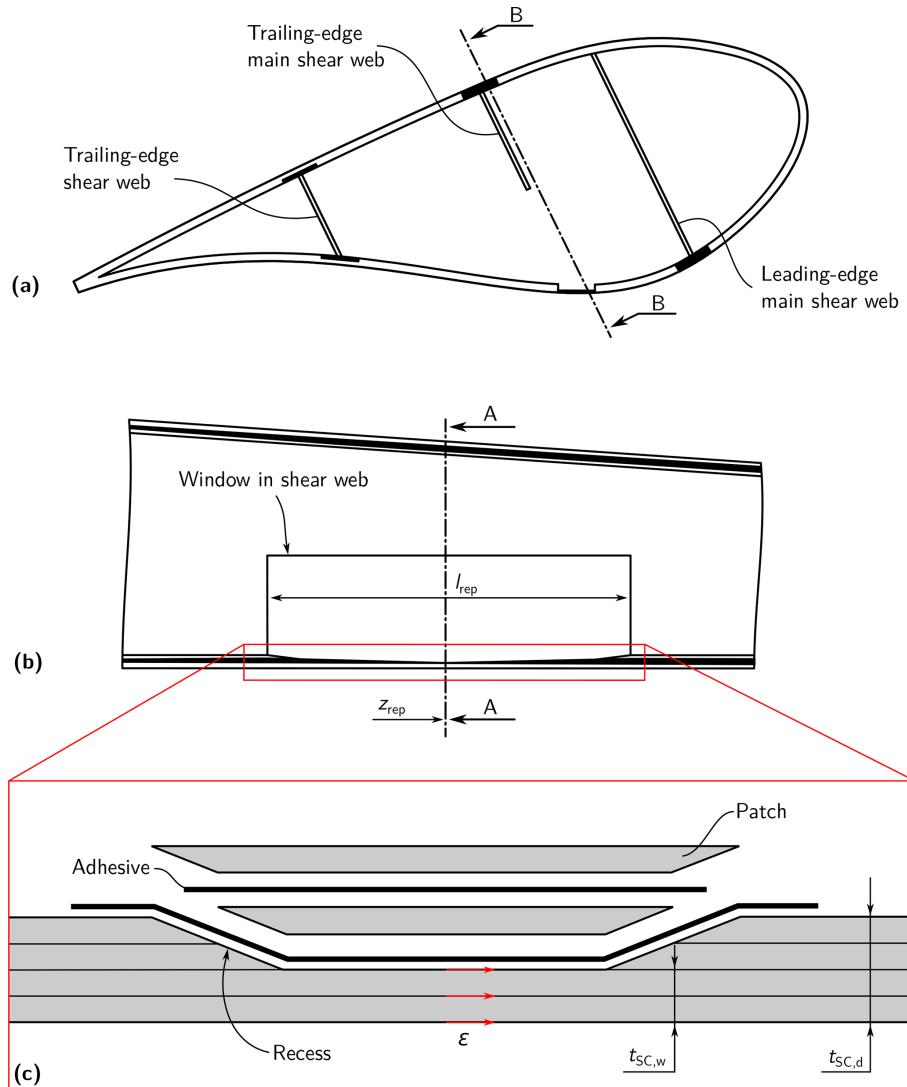
Figure 3. Weakened repair zone in (a) cross-sectional view through cut line A–A and (b) longitudinal view through cut line B–B; (c) exploded view of repair, based on Rosemeier et al. (2024) and Girolamo (2020).

by destructive means, i.e., grinding off the CFRP planks until no damage is visible. The length of the repair zone l_{rep} , i.e., the recess and the web window, can then be determined (Fig. 3b).

The FE shell model was subjected to mechanical extreme load situations stemming from the aeroelastic load simulations (Fig. 5a). The bending moment distributions from the aeroelastic simulations were converted into shear forces F_x and F_y at 50 positions along the entire blade span. Rigid-body elements of type RBE3 transferred the forces from the master node(s), positioned along the blade reference axis, to the slave nodes, positioned at the load-carrying structures, i.e., the CFRP spar caps – cf. Fig. 5b. Blade root nodes were constrained in all degrees of freedom. The repair zone was modeled by eliminating the web along the repair zone l_{rep} as well as reducing the spar cap thickness to $t_{\text{SC},w}$ in the middle, considering chamfer angles as a function of l_{rep} – cf. Fig. 3.

To investigate how the weakened spar cap affects the buckling resistance reduction, we calculated the buckling resistance for the window cut-out only, without including the weakening of the spar cap – cf. orange dots in Fig. 8. The removed trailing-edge main web (window) and consequently wider panel between the leading-edge main web and the trailing-edge web (Fig. 3a) is the major factor reducing the

Girolamo (2020) suggested filling the recess of a spar cap made from CFRP planks using patches made from chamfered CFRP planks – cf. Fig. 3c. Other fabrics could also possibly be used. However, we would like to emphasize that it is also necessary to restore electrical properties adversely affected by damage, provided that the load-bearing structures exhibit such properties. For example, CFRP pultrusions are electrically conductive, which is why their use in rotor blades requires either electrical separation, i.e., through insulation and physical separation, from the lightning protection system of the wind turbine, or the provision of defined equipotential bonding connections with components of the lightning protection system, cf. IEC (2019b), such as lightning conductor cables and/or metal grid foils arranged on the surface of the rotor blade – cf. Thwaites et al. (2022). CFRP spar caps can also be used as a main down conductor along portions of the blade (Nauheimer and Ponnada, 2023). If equipotential bonding connections are provided or the spar cap is used as a main down conductor, any adverse effects on the electrical conductivity of the load-bearing structure and/or the associated equipotential bonding connections must be remedied during the repair.

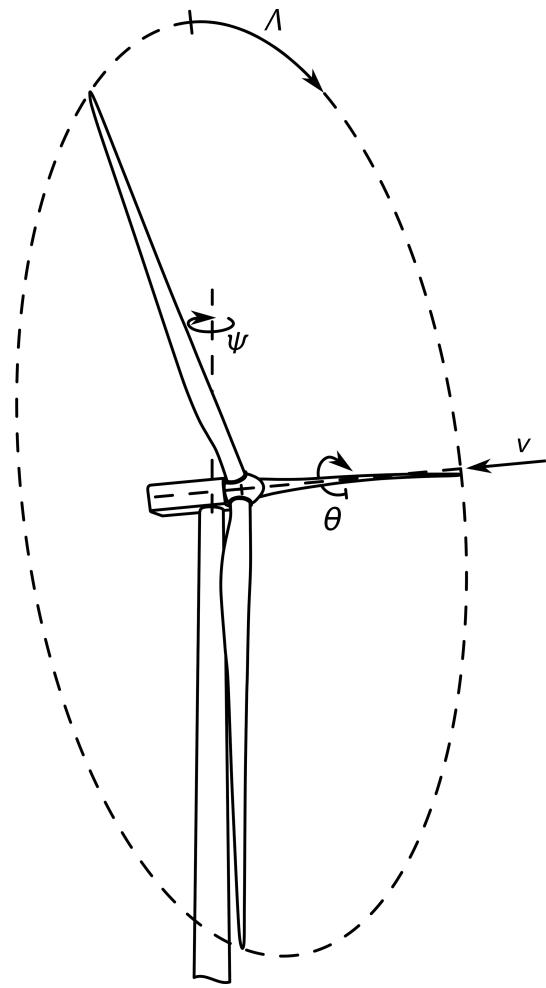
Figure 4. Repair position of rotor: yaw angle Ψ , azimuth angle Λ , and pitch angle θ ; mean wind speed direction v shown normal to rotor plane, based on Rosemeier et al. (2024).

- Determine a rotor blade position such that the load on the weakened blade structure is minimized and the buckling resistance of the structure is maximized. A rotor blade position can be defined by a set of angles: the pitch angle, the azimuth angle, and the yaw angle (Fig. 4). This step can be conducted by means of aeroelastic simulations resulting in extreme load envelopes.

Bending moments due to gravity loads dominate strains in the repair zone under maintenance DLC. Consequently, rotor azimuth positions of $\Lambda = 90$ and 270° were investigated, where 0° denotes the blade pointing upwards (Fig. 4). The 0 and 180° azimuth positions were not relevant because in this case, gravity mostly acts in the longitudinal direction of the blade, while the aerodynamic loads contribute little to the loading. Consequently, the 6 o'clock position was not investigated further. While a yaw misalignment of $\Psi = 8^\circ$ in both directions relative to the mean wind direction v was considered, the highest loads occurred at a yaw angle of $\Psi = 0^\circ$. Vertical upflow of the wind field was taken into account for upflow angles of attack of $\alpha = 0^\circ$ and 8° with respect to the horizontal plane, where an upflow of 0° led to higher loads. In all load cases, the blade was feathered at $\theta = 90^\circ$ pitch.

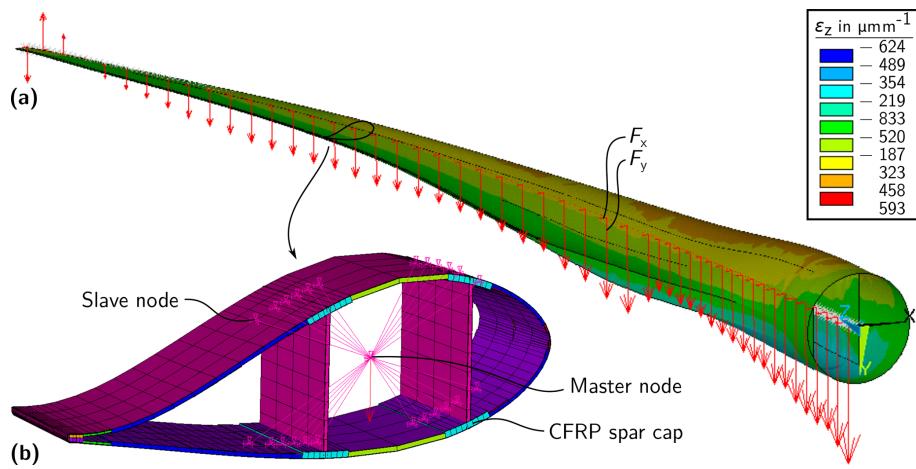
Figure 5. Finite-element model: (a) shear forces F_x , F_y along blade span, and (b) rigid-body element (RBE3) transferring forces from master to slave nodes connected to the load-carrying structure, i.e., CFRP spar caps. The color scale shows longitudinal strain ε_z ; shell elements are shown as extruded.

A 3-D FE shell model was generated in Ansys Parametric Design Language (APDL) with the help of the FEPROC toolbox (Rosemeier, 2018). The blade laminate was modeled using 27 528 elements, i.e., quadratic shell elements of type SHELL281 and quadratic solid elements of type SOLID186 for the trailing-edge adhesive layer – cf. Fig. 5b. The average element edge length was ≈ 280 mm.

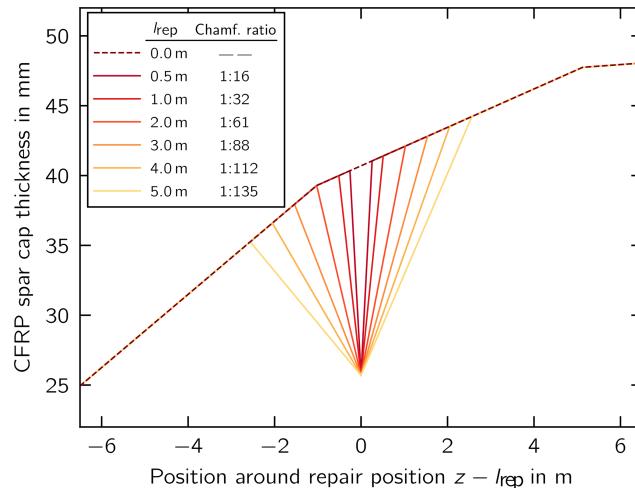
Figure 6. Spar cap thickness around the repair zone of length l_{rep} with corresponding chamfer ratios.

This section describes the impact of the worst maintenance load envelope on the longitudinal strain and the buckling resistance of the weakened blade structure. To this end, the length of the repair zone l_{rep} was increased step-wise from 0 m to 5 m , while the central damage position was chosen to be at a relative blade length of $z_{\text{rep}}/l_B = 17\%$ – cf. Figs. 2 and 3. Within the length of l_{rep} , the original spar cap thickness of $t_{\text{SC},d} = 41\text{ mm}$ was reduced to $t_{\text{SC},w} = 26\text{ mm}$, while the shear web was removed completely. The step-wise increase of the repair zone length decreased the chamfer ratio from $1 : 16$ ($l_{\text{rep}} = 0.5\text{ m}$) to $1 : 135$ ($l_{\text{rep}} = 5\text{ m}$) – cf. Fig. 6.

As the spar cap increases in thickness from rootward start to tipward end around the repair position, the recess introduces a dimple in the spar cap at the rootward start of the recess (Fig. 6). The dimple introduces a stiffness jump, which explains why we observed larger strain fluctuations for longer repair lengths (Fig. 7), i.e., strain increase and strain decrease compared to the intact situation.

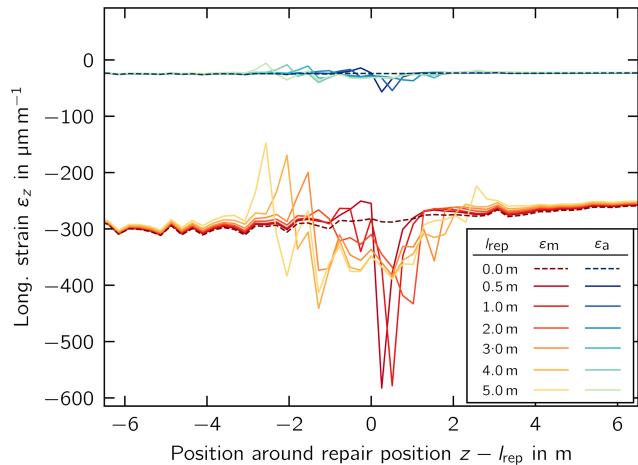
Figure 7. Longitudinal strain along weakened spar cap as a function of repair zone length l_{rep} .

Considering the longitudinal strain along the spar cap of the intact structure ($l_{\text{rep}} = 0\text{ m}$ in Fig. 7), the strain amplitude is relatively low, i.e., $\varepsilon_a \approx 25\text{ }\mu\text{m m}^{-1}$, when compared to the compressive mean strain of $\varepsilon_m \approx -300\text{ }\mu\text{m m}^{-1}$. When the structure was weakened, the strain amplitude increased toward $\approx 50\text{ }\mu\text{m m}^{-1}$ and the mean strain toward $\approx -600\text{ }\mu\text{m m}^{-1}$. The longer the repair zone l_{rep} , the smaller the strain increase, i.e., for $l_{\text{rep}} = 5\text{ m}$, the average mean strain was $\approx -350\text{ }\mu\text{m m}^{-1}$. Moreover, the strain rootward from the repair position fluctuated more than the strain tipward from the repair position.

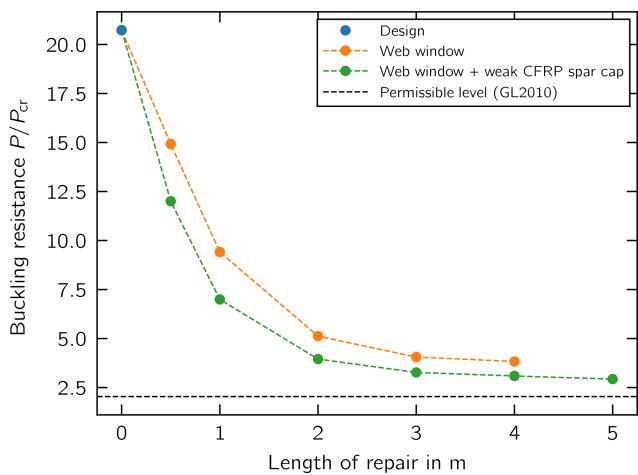
Figure 8. Buckling resistance.

Considering the buckling resistance as a function of the repair length (Fig. 8), the resistance reduces significantly from $P/P_{cr} = 20.7$ to $P/P_{cr} = 4.0$ when the web window is cut out for $l_{rep} = 2$ m and the spar cap is weakened. For $l_{rep} > 2$ m, the resistance reduces linearly with a relatively small change and approaches the permissible level. The largest deformation magnitude of the buckling mode (Fig. 9) develops at z_{rep} (Fig. 3b).

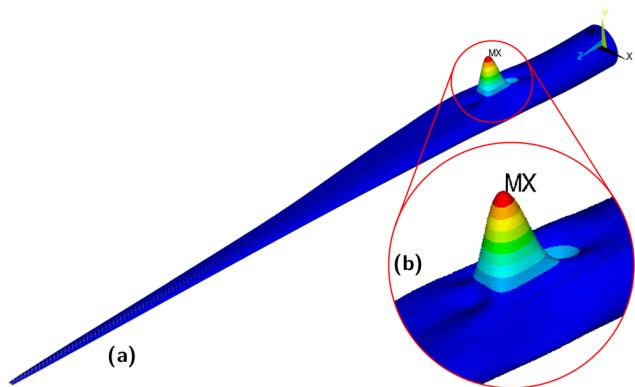
Figure 9. Buckling mode for 5 m long repair, with the largest deformation indicated by MX.

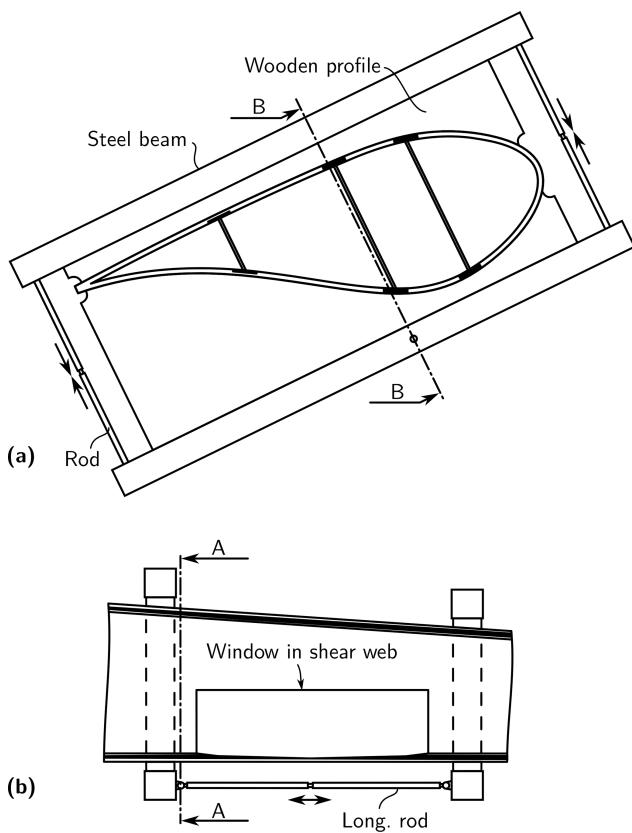
Figure 10. Span-wise pretensioning structure that solves P1: (a) cross-sectional view through cut line A–A and (b) longitudinal view through cut line B–B, based on Rosemeier et al. (2024).

To reduce the mean strain and address P1, a span-wise pretensioning structure, as shown in Fig. 10, can be applied from the outside of the blade. The support structure comprises two clamping frames arranged exterior to the rotor blade and conceptualized to exert a clamping force on the rotor blade. The clamping frames are connected by a longitudinal support rod pretensioned to reduce the mechanical load, particularly the strain, on the load-bearing structure, i.e., the spar cap. Thus, the load-bearing structure can be relieved by clamping the rotor blade on both sides of the damaged area. However, installation concepts to lift the frames, e.g., into the 6 o'clock position by winches, need to be developed. The clamping frames are spaced apart in the longitudinal direction of the rotor blade. Their concept is similar to that of load frames familiar from rotor blade testing, for example, where they are used to apply a load to the rotor blade – cf. Klaenfoth et al. (2023). Shear webs may require reinforcement to withstand the clamping force from the load frame. Each of the clamping frames includes a clamping jaw adapted to the outer contour of the rotor blade, which is arranged between two clamping beams. The clamping beams of each clamping frame are connected by two clamping elements to exert a force transferable to the rotor blade by the clamping jaw.

The clamping frames are connected to the longitudinal support rod by ball or universal joints. The longitudinal support rod includes pretensioning means (indicated as a thinner section of the rod in Fig. 10) for exerting a pretensioning force in the longitudinal direction on the rotor blade in such a way that the mechanical load, particularly the strain, on the load-bearing structure is reduced. The pretensioning means are adjustable to set the respective pretensioning force in the longitudinal direction, and are also conceptualized to adjust the length of the respective rod. The pretensioning means can include, for example, tension screws and/or turnbuckles and/or telescopic rods.

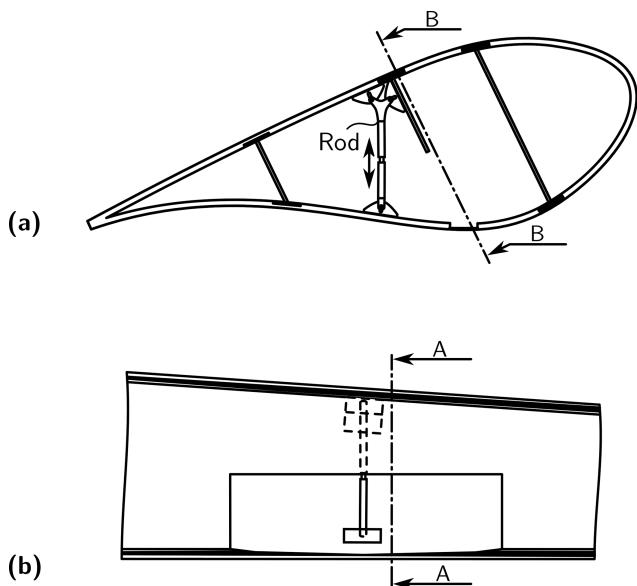
Figure 11. Buckling support structure – push rods that solves P2: (a) cross-sectional view through cut line A–A and (b) longitudinal view through cut line B–B, based on Rosemeier et al. (2024).

The support structure shown in Fig. 11 addresses P2 and consists of a support rod arranged inside the rotor blade, with a transverse support rod to increase the mechanical resistance, specifically buckling resistance, of the load-bearing structure. For this purpose, the transverse support rod is connected with a clamping foot to the panel that requires the buckling support. Using additional clamping feet, the transverse support rod is connected to a panel opposite and to the web arranged above the damaged pultruded stack. The transverse support rod includes a pretensioning means to exert a transverse pretensioning force on the rotor blade in such a

way that the buckling resistance is increased by supporting the buckling field of the panel, and thus also the damaged pultruded stack of the adjacent load-bearing structure. The support structure may prevent buckling modes that develop toward the interior of the blade but not those that develop outward; it may even invert the buckling mode from inward to outward deformation. This drawback can be overcome by adding a buckling support structure on the outer surface, e.g., a stringer, as illustrated in Fig. 12.

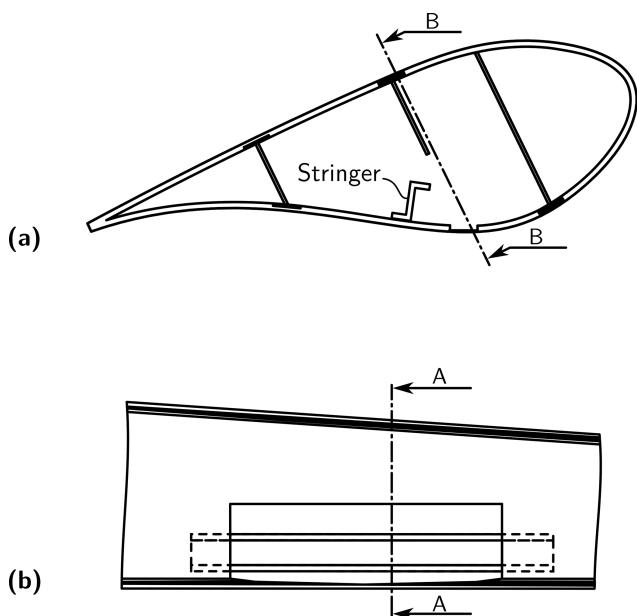
Figure 12. Buckling support structure – stringer that solves P2: (a) cross-sectional view through cut line A–A and (b) longitudinal view through cut line B–B, based on Rosemeier et al. (2024).

Figure 12 shows a support assembly that addresses P2 and is arranged interior or exterior to the rotor blade. The support assembly includes one or more support profiles, also called stringers, arranged to increase the mechanical resistance, particularly buckling resistance, of the load-bearing structure and/or the non-load-bearing structure. The support profile consist of an FRP material, such as glass, carbon fiber, and/or metal. Shown are support profiles with a Z-shaped cross-section. Other cross-sections are possible, such as T-shaped, C-shaped, or L-shaped cross-sections. The support assemblies are connected to the interior of the rotor blade by a detachable adhesive connection, for example, using a thermoplastic material, or a magnetic arrangement is provided for a simple, reversible, and repositionable connection.
