1 **Repair of wind turbine blades: Experience and** 2 **observations from India – A Review**

11 **Abstract.** A large expansion of wind energy is planned in India. On the other side, older wind turbines are
12 approaching the end of their lifetime. Improvement and quality of maintenance technologies of wind turbines
13 are therefore significant for the successful expansion and support of wind energy generation in India. This paper
14 summarizes the strategies, main challenges, and procedures of wind turbine blade repair in India. The influence
15 of location and climate, methods of damage identification, and evaluation of the severity of blade damage, in
16 addition to steps involved in leading-edge erosion, laminate, foam, web, and serration damage repair are
17 presented. This overview of the current situation, methods, and technologies should provide the basis for the
18 optimization of repair technologies, the development of new techniques, and thus the improvement of the
19 reliability of wind energy generation in India.

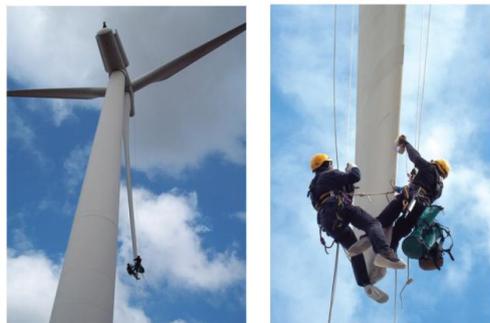
Figure 5: Blade Technicians inspect the blade using the rope access method. Image courtesy - Meeting the Challenge of Wind Turbine Blade Repair, reprinted from (Marsh, 2011).

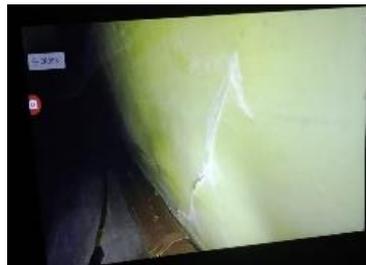
Figure 16: Shear web damaged portion of the wind turbine blade.

1 **4.5. Shear Web Damage**
2 Shear webs are structural elements inside the wind turbine blades that offer shear stiffness (Cox and
3 Echtermeyer, 2012). They transfer shear loads between the upper and the lower surfaces of the blade. If the
4 damage in the web is more than 2m the blade is considered inoperable and it will be scrapped. Figure 12 shows
5 two shear webs, one on the leading edge and the other on the trailing edge. The damaged shear web will be
6 identified through the endoscopic camera approach. Figure 16 shows the image taken by the endoscopic camera
7 of shear web damage. To evaluate the extent of the damage, a 50mm x 50mm hole will be created on the
8 pressure side, either on the trailing or leading edge (depending on the shear web damage). If the hole is
9 inadequate to assess the damage, it will be enlarged. Following inspection, the hole will be further expanded
10 (approximately 100mm larger than the web damage size). The cross-section of the web structure shows that the

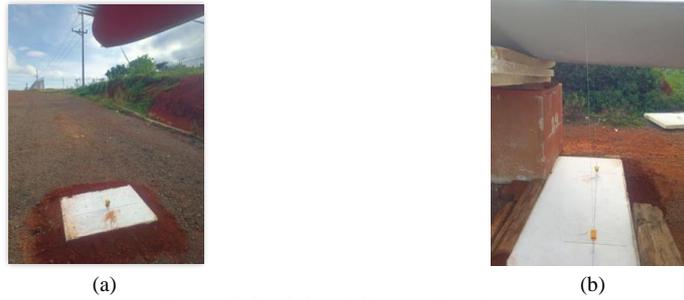
Figure 18: Pendulum holding (a) Tip, (b) center.

27 As shown in Fig. 18, a pendulum-like device will be suspended at the tip and center of the blades before the
28 repair operation begins. These pendulums will ensure the orientational changes the blades go through before and
29 after repair.

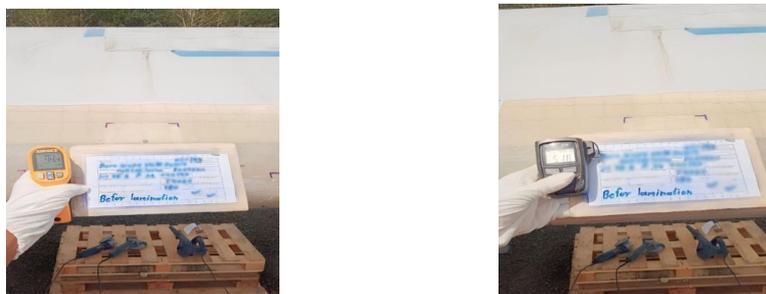
Figure 20: Before lamination during blade repair (a) Temperature check, (b) Humidity check.

3 Before applying cleaner and glue during the serration replacement work and before the lamination process
 4 during blade repair, technicians carry out checks for temperature and humidity as shown in Fig 19. While
 5 checking the temperature should be within the range of 25 to 30 degrees Celsius and the humidity level should
 6 be above 70%. Figure 20 shows the temperature and humidity checking process during blade repair work.

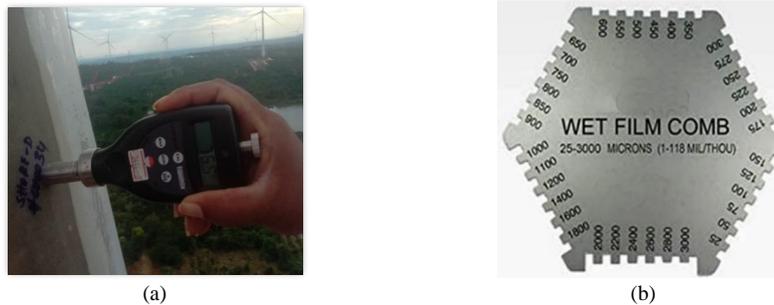
1 **Figure 21: (a) Hardness test check, (b) Wet film thickness gauge.**

12 The hardness test is used to determine the curing state of the laminates. The Shore D hardness technique is used for
 13 testing. After lamination work, gel coat application, or glue application for endoscope camera assessment, we
 14 use this method to assess the curing state. The curing is completed once the value of 75N or more is reached.
 15 Figure 21 (a) shows the shore D hardness test gauge.

4 Gel Coat thickness is measured using a Wet Film Thickness Gauge. The thickness of the Gel coat should be at
5 least 600 microns. Figure 21 (b) shows the wet film thickness gauge.

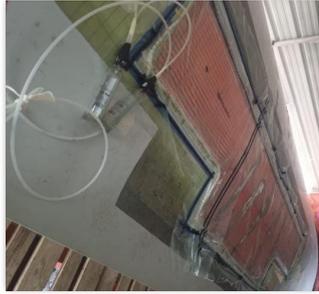
9.	Vacuum infusion	<ul style="list-style-type: none"> • Vacuum infusion is a technique that uses vacuum pressure to drive the resin into laminate (Thomas et al., 2019). • Vacuum infusion will be performed only if the foam is damaged or laminates (inner) below the sandwich panel are damaged.

<p>Vacuum infusion process.</p>
