Feasibility of up-tower repair concepts for pultruded carbon spar cap planks in wind turbine blades

Abstract. While modern wind turbine blades utilize pultruded carbon fiber-reinforced polymer (CFRP) planks for structural integrity in spar caps, these materials can sustain damage from operational stresses, leading to potential failures if unaddressed. Traditional down-tower repairs result in significant costs related to dismantling and transportation, especially for offshore installations, emphasizing the need for efficient up-tower repair methods. The research utilizes a finite element model of an

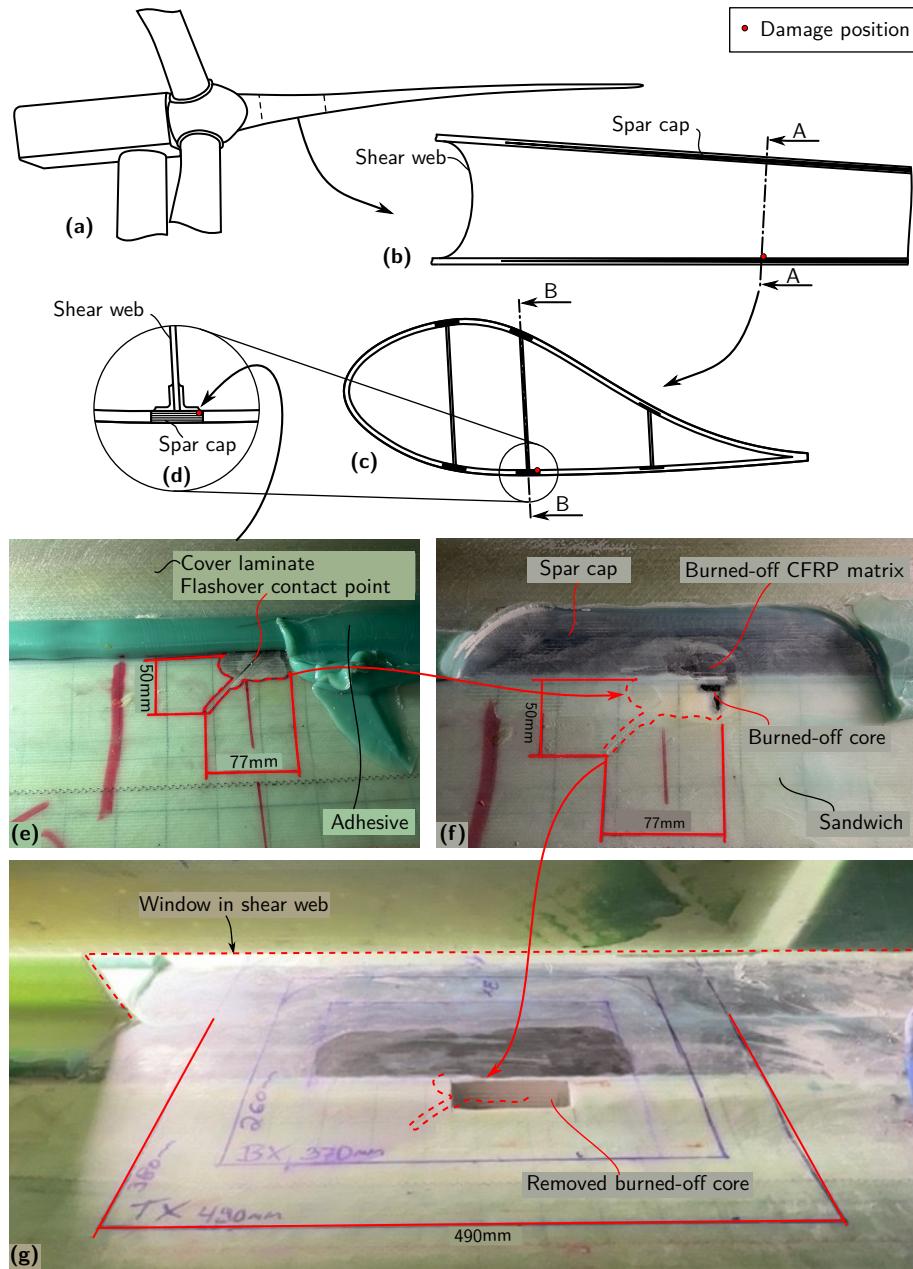
Figure 2. Up-tower repair concept: (a) wind turbine in rotor lock with damaged blade in 3 o'clock position, (b) longitudinal repair zone view through cut line B-B, (c) cross-sectional repair zone view through cut line A-A, (d) zoom into damage position, (e) damage observed as consequence of internal lightning flashover, (f) damage after grinding off cover laminate and adhesive, revealing burned-off spar cap matrix and core material, (g) damage after grinding off CFRP and window cut-out in shear web; based on Rosemeier et al. (2024); Lessa (2023).

When CFRP planks near the inner blade surface are damaged in the inboard blade region (Fig. 2), the repair must be carried 20 out from the inside, whereby the damaged CFRP planks must be ground off and a window cut out of the shear web (Fig. 3). Currently, a repair of a damaged area on pultruded CFRP spar caps is carried out by removing the affected rotor blade from

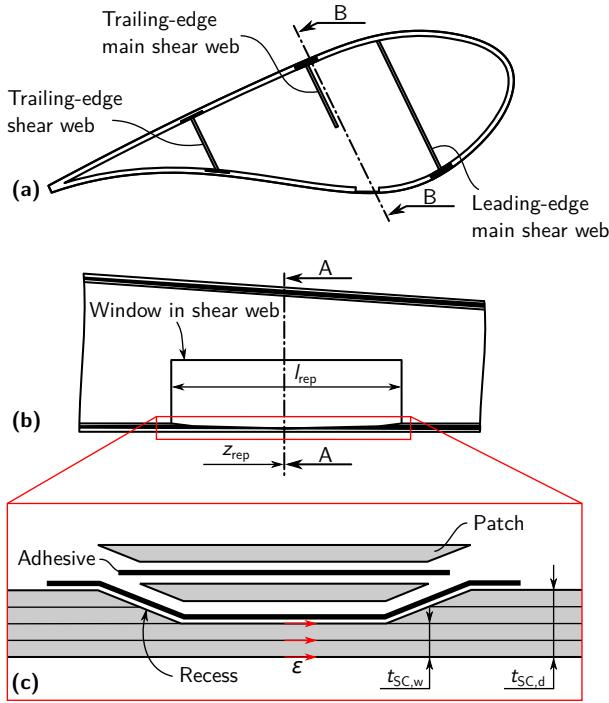
Figure 3. Weakened repair zone in (a) cross-sectional view through cut line B-B-A-A and (b) longitudinal view through cut line A-A-B-B; (c) exploded view of repair; based on Rosemeier et al. (2024) and Girolamo (2020).

Identify the depth of the spar cap damage, i.e., the number of damaged planks through the spar cap thickness. This can be done by a visual inspection, e.g., after a lightning strike on the rotor blade, by non-destructive testing (NDT) means such as ultrasonic testing (UT), or by destructive means, i.e., grinding off the CFRP planks until no damage is visible. The length of the repair zone l_{rep} , i.e., the recess and the web window, can then be determined (Fig. 3b).

The FE shell model was subjected to mechanical extreme load situations stemming from the aeroelastic load simulations. The resulting shear force distribution was transferred from the load simulation to the FE shell model using rigid-body (Fig. 5a). The bending-moment distributions from the aeroelastic simulations were converted into shear forces F_x and F_y at 50 positions along the entire blade span. Rigid-body elements of type RBE3 transferred the forces from the master node(s), positioned 95 along the blade reference axis, to the slave nodes positioned at the load-carrying structures, i.e., the CFRP spar caps, cf. Fig. 5b. Blade root nodes were constrained in all degrees of freedom. The repair zone was modeled by eliminating the web along the repair zone l_{rep} as well as reducing the spar cap thickness to $t_{\text{SC},w}$ in the middle, considering chamfer angles as a function of l_{rep} , cf. Fig. 3.

130 the resistance reduces linearly with a relatively small change and approaches the permissible level. The largest deformation magnitude of the buckling mode (Fig. 9) develops at z_{rep} (Fig. 3b).

Girolamo (2020) suggested filling the recess of a spar cap made from CFRP planks using patches made from chamfered CFRP planks, cf. Fig. 3c. Other fabrics could also possibly be used. However, we would like to emphasize that it is also necessary to restore electrical properties adversely affected by damage, provided that the load-bearing structures exhibit such properties. For example, CFRP pultrusions are electrically conductive, which is why their use in rotor blades requires either electrical separation, i.e., through insulation and physical separation, from the lightning protection system of the wind turbine, or the provision of defined equipotential bonding connections with components of the lightning protection system, cf. IEC (2019b), such as lightning conductor cables and/or metal grid foils arranged on the surface of the rotor blade, cf. Thwaites et al. (2022). CFRP spar caps can also be used as a main down conductor along portions of the blade (Nauheimer and Ponnada, 2023). If equipotential bonding connections are provided or the spar cap is used as a main down conductor, any adverse effects on the the electrical conductivity of the load-bearing structure and/or the associated equipotential bonding connections must be remedied during the repair.

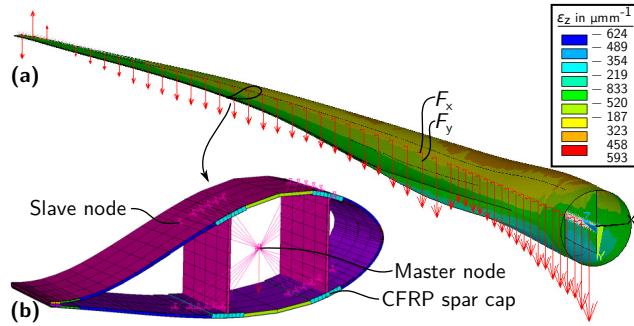
Figure 5. Finite-element model: (a) shear forces F_x , F_y along blade span, and (b) rigid-body element (RBE3) transferring forces from master to slave nodes connected to the load-carrying structure, i.e., CFRP spar caps; color scale shows longitudinal strain ε_z ; shell elements are shown as extruded.

A 3D FE shell model was generated in Ansys Parametric Design Language (APDL) with the help of the FEPROC toolbox (Rosemeier, 2018). The blade laminate was modeled using 27 528 elements, i.e., quadratic shell elements of type SHELL281, and quadratic solid elements of type SOLID186 for the trailing-edge adhesive layer, cf. Fig. 5b. The average element edge 90 length was $\approx 280 \text{ mm}$.

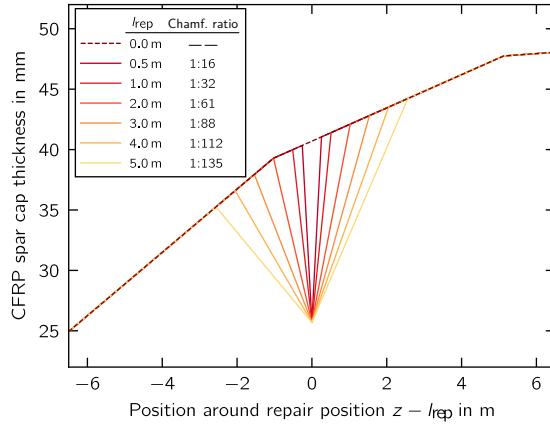
Figure 6. Spar cap thickness around repair zone of length l_{rep} with corresponding chamfer ratios.

completely. The step-wise increase of the repair zone length decreased the chamfer ratio from 1:16 ($l_{rep} = 0.5\text{ m}$) to 1:135 ($l_{rep} = 5.0\text{ m}$), cf. Fig. 6.

As the spar cap increases in thickness from rootward start to tipward end around the repair position, the recess introduces a dimple in the spar cap at the rootward start of the recess (Fig. 6). The dimple introduces a stiffness jump which explains why we observed larger strain fluctuations for longer repair lengths (Fig. 7), i.e., strain increase and strain decrease compared to the intact situation.

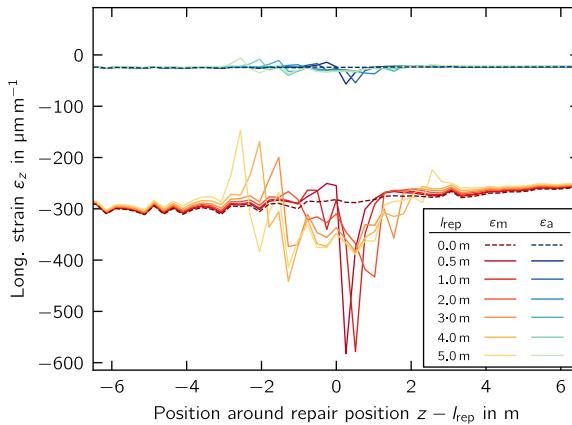
Figure 7. Longitudinal strain along weakened spar cap as function of repair zone length l_{rep} .

Considering the longitudinal strain along the spar cap of the intact structure ($l_{rep} = 0\text{ m}$ in Fig. 7), the strain amplitude is relatively low, i.e., $\epsilon_a \approx 25\text{ }\mu\text{m m}^{-1}$, when compared to the compressive mean strain of $\epsilon_m \approx -300\text{ }\mu\text{m m}^{-1}$. When the structure 125 was weakened, the strain amplitude increased toward $\approx 50\text{ }\mu\text{m m}^{-1}$ and the mean strain toward $\approx -600\text{ }\mu\text{m m}^{-1}$. The longer the repair zone l_{rep} , the smaller the strain increase, i.e., for $l_{rep} = 5\text{ m}$ the average mean strain was $\approx -350\text{ }\mu\text{m m}^{-1}$. Moreover, the strain rootward from the repair position fluctuated more than the strain tipward from the repair position.

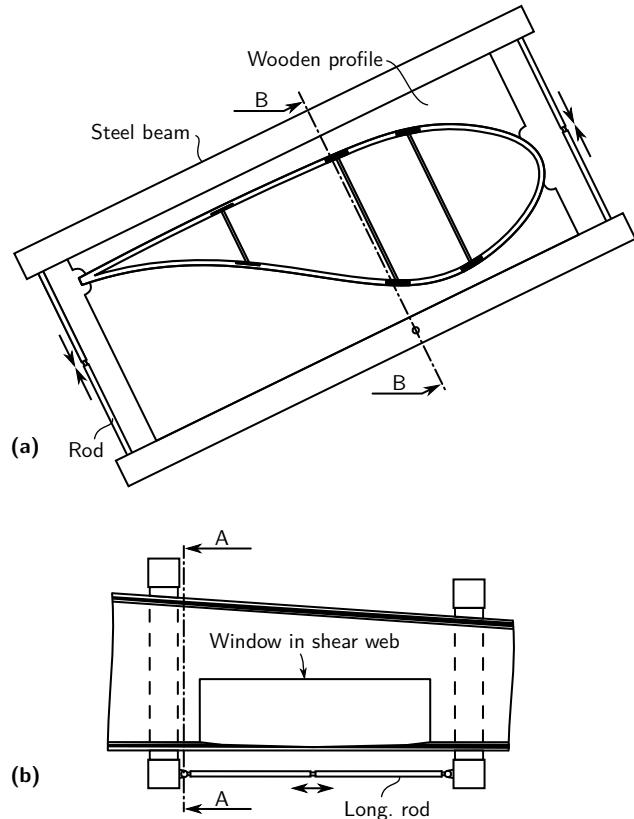
Figure 10. Span-wise pretensioning structure that solves P1: (a) cross-sectional view through cut line A-A and (b) longitudinal view through cut line B-B; based on Rosemeier et al. (2024).

To reduce the mean strain and address P1, a span-wise pretensioning structure as shown in Fig. 10 can be applied from the outside of the blade. The support structure comprises two clamping frames arranged exterior to the rotor blade and ~~designed~~
185 conceptualized to exert a clamping force on the rotor blade. The clamping frames are connected by a longitudinal support rod pretensioned to reduce the mechanical load, particularly the strain, on the load-bearing structure, i.e., the spar cap. Thus, the load-bearing structure can be relieved by clamping the rotor blade on both sides of the damaged area. However, installation concepts to lift the frames, e.g., into the 6 o'clock position by winches, need to be developed. The clamping frames are spaced apart in the longitudinal direction of the rotor blade. Their ~~design concept~~ is similar to that of load frames familiar from rotor
190 blade testing, for example, where they are used to apply a load to the rotor blade, cf. Klaenfoth et al. (2023). Shear webs may require reinforcement to withstand the clamping force from the load frame. Each of the clamping frames includes a clamping jaw adapted to the outer contour of the rotor blade, which is arranged between two clamping beams. The clamping beams of each clamping frame are connected by two clamping elements to exert a force transferable to the rotor blade by the clamping jaw.

195 The clamping frames are connected to the longitudinal support rod by ball or universal joints. The longitudinal support rod includes pretensioning means (indicated as a thinner section of the rod in Fig. 10) for exerting a pretensioning force in the longitudinal direction on the rotor blade in such a way that the mechanical load, particularly the strain, on the load-bearing structure is reduced. The pretensioning means are adjustable to set the respective pretensioning force in the longitudinal direction, and are also ~~designed~~conceptualized to adjust the length of the respective rod. The pretensioning means can include,
200 for example, tension screws and/or turnbuckles and/or telescopic rods.

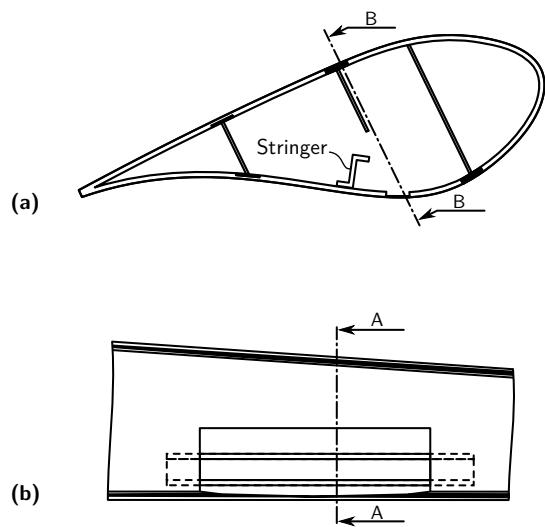
Figure 12. Buckling support structure - stringer that solves P2: (a) cross-sectional view through cut line A-A and (b) longitudinal view through cut line B-B; based on Rosemeier et al. (2024).

Fig. 12 shows a support assembly which addresses P2 and is arranged interior or exterior to the rotor blade. The support assembly includes one or more support profiles, also called stringers, arranged to increase the mechanical resistance, particularly buckling resistance, of the load-bearing structure and/or the non-load-bearing structure. The support profile consist of an FRP material, such as glass or carbon fiber, and/or metal. Shown are support profiles with an S-shapedZ-shaped cross-section. Other 215 cross-sections are possible, such as T-shaped, C-shaped, or L-shaped cross-sections. The support assemblies are connected to

the interior of the rotor blade by a detachable adhesive connection, for example, using a thermoplastic material, or a magnetic arrangement is provided for a simple, reversible, and repositionable connection.
