Feasibility of up-tower repair concepts for pultruded carbon spar cap planks in wind turbine blades

Malo Rosemeier¹, Matthias Saathoff², Johannes Kolsch³, Pablo Buriticá⁴, Enno Petersen¹, and Christopher Beer²

Abstract. While modern wind turbine blades utilize pultruded carbon fiber-reinforced polymer (CFRP) planks for structural integrity in spar caps, these materials can sustain damage from operational stresses, leading to potential failures if unaddressed. Traditional down-tower repairs result in significant costs related to dismantling and transportation, especially for offshore installations, emphasizing the need for efficient up-tower repair methods. The research utilizes a finite element model of an 5 81.6 m rotor blade designed for a 7 MW offshore turbine, subjected to aeroelastic simulations to evaluate load conditions during maintenance. The analysis focuses on a step-wise increased repair zone, assessing susceptibility to buckling, cyclic strains, and permissible wind speeds. Results indicate that while substantial repairs can endanger structural stability, turbulence-induced strain amplitudes are manageable. Recommendations include installing temporary pretensioning a

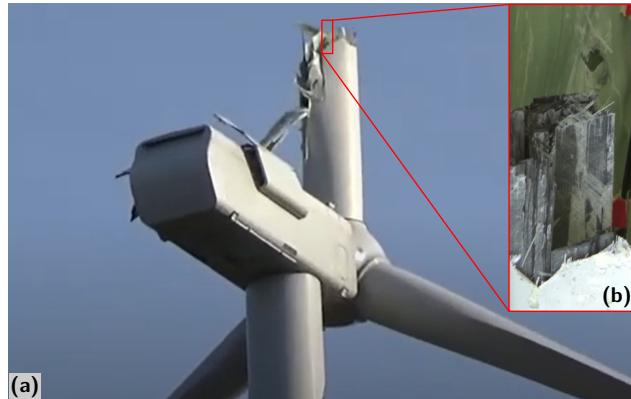
Figure 1. Blade loss incident after 2 years of operation (Pierrot, 2022) showing typical damage resulting from a lightning strike event; Ylikoski (2020).

Modern wind turbine blades utilize carbon fiber-reinforced polymer (CFRP) planks in their load-carrying structures, i.e., the spar caps. These CFRP planks are pre-manufactured in a pultrusion process and stacked into the blade structure. The pultrusion process ensures high quality fiber alignment and fiber volume fraction, and low numbers of manufacturing defects. It can further 15 ensure that all these properties are produced with high reproducibility, leading to outstanding mechanical properties. CFRP planks can be damaged during operation due to stress concentration resulting from insufficient bonding between planks, voids, defects, dielectric breakdowns (Harrell, 2020), or flashovers caused by a lightning strike (Girolamo, 2020). If such damage is not repaired, it can lead to blade loss (Fig. 1).

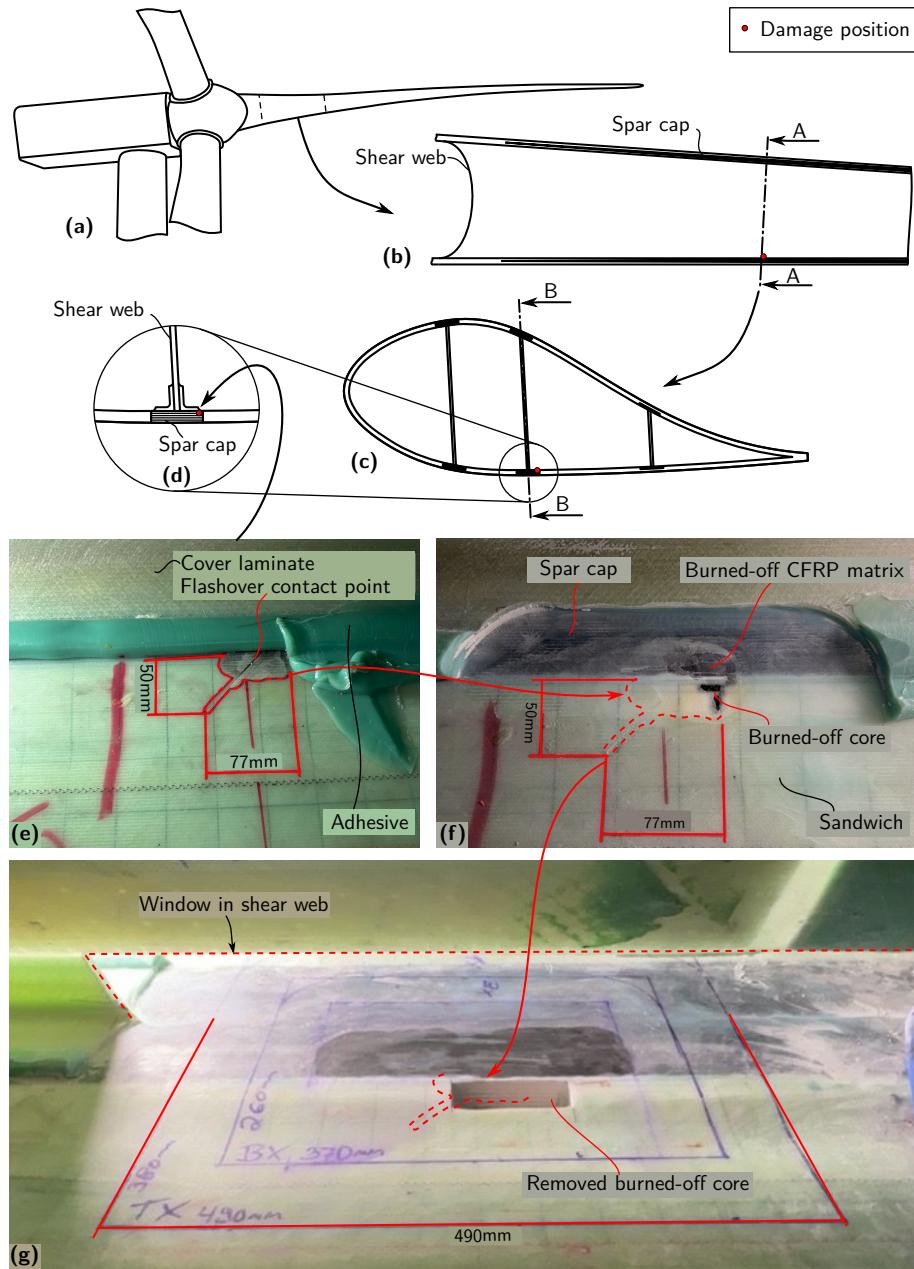
Figure 2. Up-tower repair concept: (a) wind turbine in rotor lock with damaged blade in 3 o'clock position, (b) longitudinal repair zone view through cut line B-B, (c) cross-sectional repair zone view through cut line A-A, (d) zoom into damage position, (e) damage observed as consequence of internal lightning flashover, (f) damage after grinding off cover laminate and adhesive, revealing burned-off spar cap matrix and core material, (g) damage after grinding off CFRP and window cut-out in shear web; based on Rosemeier et al. (2024); Lessa (2023).

When CFRP planks near the inner blade surface are damaged in the inboard blade region (Fig. 2), the repair must be carried 20 out from the inside, whereby the damaged CFRP planks must be ground off and a window cut out of the shear web (Fig. 3). Currently, a repair of a damaged area on pultruded CFRP spar caps is carried out by removing the affected rotor blade from

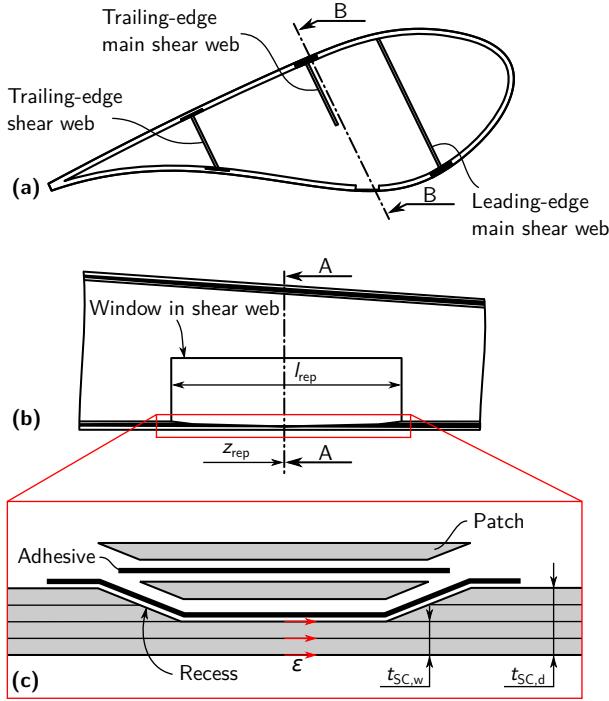
Figure 3. Weakened repair zone in (a) cross-sectional view through cut line A-A and (b) longitudinal view through cut line B-B; (c) exploded view of repair; based on Rosemeier et al. (2024) and Girolamo (2020).

Identify the depth of the spar cap damage, i.e., the number of damaged planks through the spar cap thickness. This can be done by a visual inspection, e.g., after a lightning strike on the rotor blade, by non-destructive testing (NDT) means such as ultrasonic testing (UT), or by destructive means, i.e., grinding off the CFRP planks until no damage is visible. The length of the repair zone l_{rep} , i.e., the recess and the web window, can then be determined (Fig. 3b).

The FE shell model was subjected to mechanical extreme load situations stemming from the aeroelastic load simulations (Fig. 5a). The bending-moment distributions from the aeroelastic simulations were converted into shear forces F_x and F_y at 50 positions along the entire blade span. Rigid-body elements of type RBE3 transferred the forces from the master node(s), positioned along the blade reference axis, to the slave nodes positioned at the load-carrying structures, i.e., the CFRP spar caps, 95 cf. Fig. 5b. Blade root nodes were constrained in all degrees of freedom. The repair zone was modeled by eliminating the web along the repair zone l_{rep} as well as reducing the spar cap thickness to $t_{\text{SC},w}$ in the middle, considering chamfer angles as a function of l_{rep} , cf. Fig. 3.

the resistance reduces linearly with a relatively small change and approaches the permissible level. The largest deformation
 130 magnitude of the buckling mode (Fig. 9) develops at z_{rep} (Fig. 3b).

155 Girolamo (2020) suggested filling the recess of a spar cap made from CFRP planks using patches made from chamfered CFRP planks, cf. Fig. 3c. Other fabrics could also possibly be used. However, we would like to emphasize that it is also necessary to restore electrical properties adversely affected by damage, provided that the load-bearing structures exhibit such properties. For example, CFRP pultrusions are electrically conductive, which is why their use in rotor blades requires either electrical separation, i.e., through insulation and physical separation, from the lightning protection system of the wind turbine, 160 or the provision of defined equipotential bonding connections with components of the lightning protection system, cf. IEC (2019b), such as lightning conductor cables and/or metal grid foils arranged on the surface of the rotor blade, cf. Thwaites et al. (2022). CFRP spar caps can also be used as a main down conductor along portions of the blade (Nauheimer and Ponnada, 2023). If equipotential bonding connections are provided or the spar cap is used as a main down conductor, any adverse effects on the the electrical conductivity of the load-bearing structure and/or the associated equipotential bonding connections must 165 be remedied during the repair.

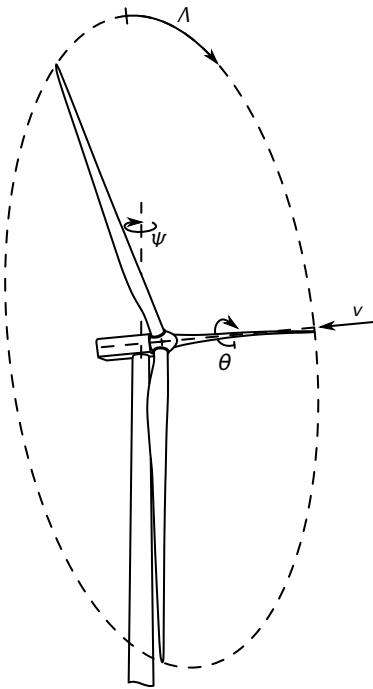
Figure 4. Repair position of rotor: yaw angle Ψ , azimuth angle Λ , and pitch angle θ ; mean wind speed direction v shown normal to rotor plane; based on Rosemeier et al. (2024).

45 Determine a rotor blade position such that the load on the weakened blade structure is minimized and the buckling resistance of the structure is maximized. A rotor blade position can be defined by a set of angles: the pitch angle, the azimuth angle, and the yaw angle (Fig. 4). This step can be conducted by means of aeroelastic simulations resulting in extreme load envelopes.

Bending moments due to gravity loads dominate strains in the repair zone under maintenance DLC. Consequently, rotor azimuth positions of $\Lambda = 90^\circ$ and 270° were investigated, where 0° denotes the blade pointing upwards (Fig. 4). The 0° and 180° azimuth positions were not relevant as in this case, gravity mostly acts in longitudinal direction of the blade, while the 105 aerodynamic loads contribute little to the loading. Hence the 6 o'clock position was not investigated further. While a yaw misalignment of $\Psi = 8^\circ$ in both directions relative to the mean wind direction v was considered, the highest loads occurred at a yaw angle of $\Psi = 0^\circ$. Vertical upflow of the wind field was taken into account for upflow angles of attack of $\alpha = 0^\circ$ and 8° with respect to the horizontal plane, where an upflow of 0° led to higher loads. In all load cases, the blade was feathered at $\theta = 90^\circ$ pitch.

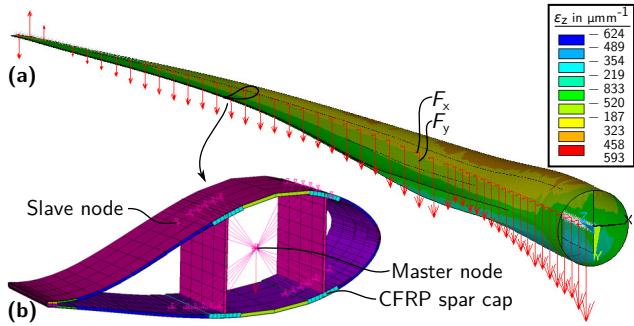
Figure 5. Finite-element model: (a) shear forces F_x , F_y along blade span, and (b) rigid-body element (RBE3) transferring forces from master to slave nodes connected to the load-carrying structure, i.e., CFRP spar caps; color scale shows longitudinal strain ε_z ; shell elements are shown as extruded.

A 3D FE shell model was generated in Ansys Parametric Design Language (APDL) with the help of the FEPROC toolbox (Rosemeier, 2018). The blade laminate was modeled using 27 528 elements, i.e., quadratic shell elements of type SHELL281, and quadratic solid elements of type SOLID186 for the trailing-edge adhesive layer, cf. Fig. 5b. The average element edge 90 length was $\approx 280 \text{ mm}$.

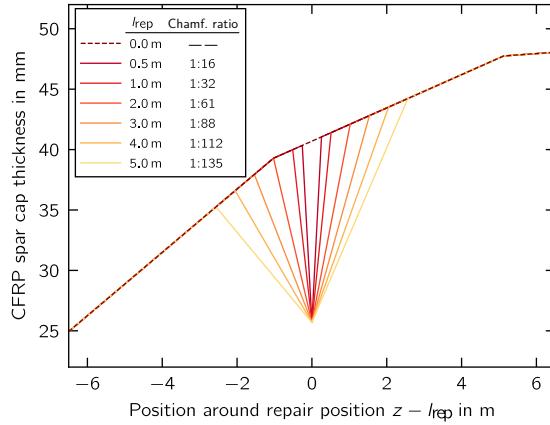
Figure 6. Spar cap thickness around repair zone of length l_{rep} with corresponding chamfer ratios.

120 completely. The step-wise increase of the repair zone length decreased the chamfer ratio from 1:16 ($l_{rep} = 0.5$ m) to 1:135 ($l_{rep} = 5.0$ m), cf. Fig. 6.

As the spar cap increases in thickness from rootward start to tipward end around the repair position, the recess introduces a dimple in the spar cap at the rootward start of the recess (Fig. 6). The dimple introduces a stiffness jump which explains why we observed larger strain fluctuations for longer repair lengths (Fig. 7), i.e., strain increase and strain decrease compared to the intact situation.

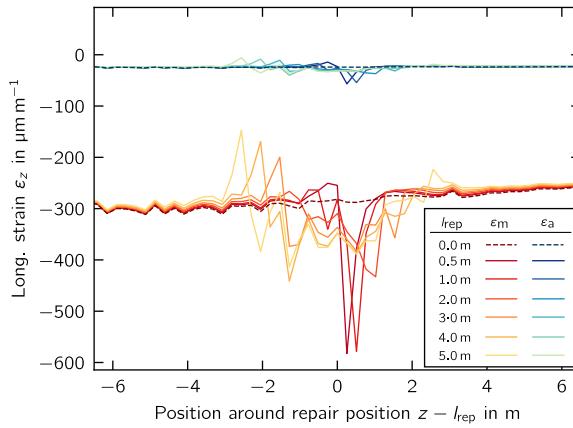
Figure 7. Longitudinal strain along weakened spar cap as function of repair zone length l_{rep} .

Considering the longitudinal strain along the spar cap of the intact structure ($l_{rep} = 0$ m in Fig. 7), the strain amplitude is relatively low, i.e., $\varepsilon_a \approx 25 \mu\text{m m}^{-1}$, when compared to the compressive mean strain of $\varepsilon_m \approx -300 \mu\text{m m}^{-1}$. When the structure was weakened, the strain amplitude increased toward $\approx 50 \mu\text{m m}^{-1}$ and the mean strain toward $\approx -600 \mu\text{m m}^{-1}$. The longer 125 the repair zone l_{rep} , the smaller the strain increase, i.e., for $l_{rep} = 5$ m the average mean strain was $\approx -350 \mu\text{m m}^{-1}$. Moreover, the strain rootward from the repair position fluctuated more than the strain tipward from the repair position.

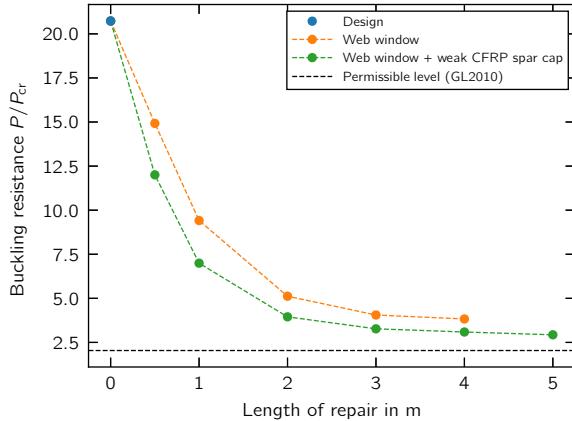
Figure 8. Buckling resistance.

Considering the buckling resistance as a function of the repair length (Fig. 8), the resistance reduces significantly from $P/P_{cr} = 20.7$ to $P/P_{cr} = 4.0$ when the web window is cut out for $l_{rep} = 2$ m and the spar cap is weakened. For $l_{rep} > 2$ m

To investigate how the weakened spar cap affects the buckling resistance reduction, we calculated the buckling resistance for
 the window cut-out only without including the weakening of the spar cap, cf. orange dots in Fig. 8. The removed trailing-edge
 135 main web (window) and consequently wider panel between the leading-edge main web and the trailing-edge web (Fig. 3a) is
 the major factor reducing the buckling resistance. At shorter repair lengths of less than 1 m, the weakened spar cap made a
 larger contribution to the reduction, i.e., between 18% and 33%, than at longer lengths, where the figure was <7%.

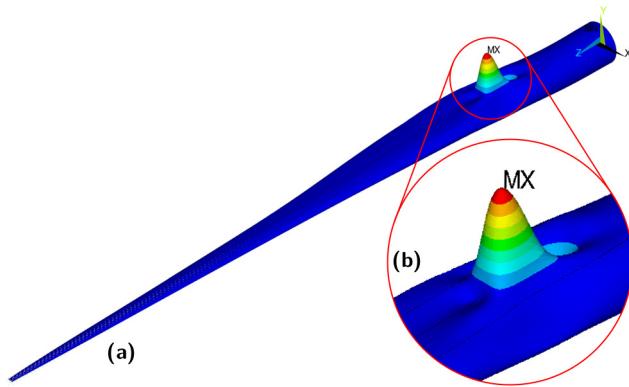
Figure 9. Buckling mode for 5 m long repair with the largest deformation indicated by MX.

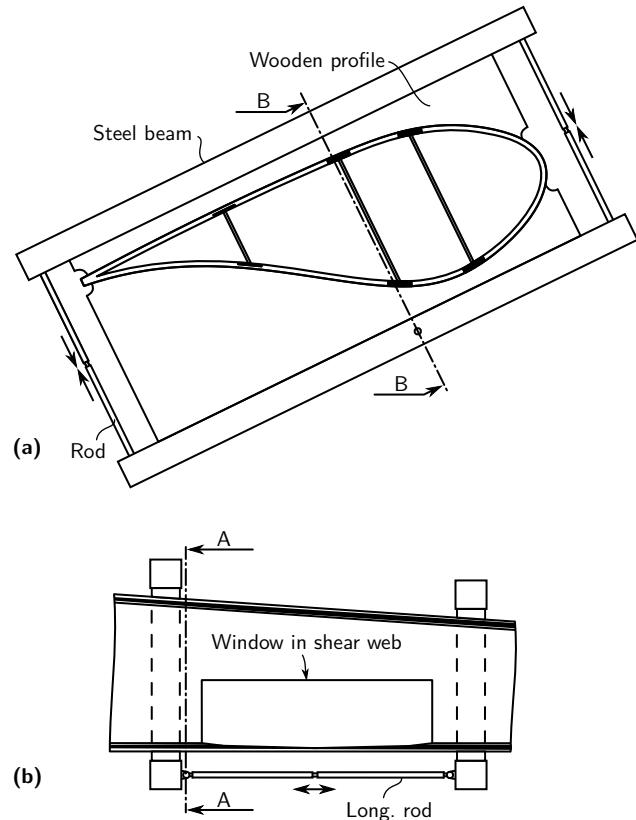
Figure 10. Span-wise pretensioning structure that solves P1: (a) cross-sectional view through cut line A-A and (b) longitudinal view through cut line B-B; based on Rosemeier et al. (2024).

To reduce the mean strain and address P1, a span-wise pretensioning structure as shown in Fig. 10 can be applied from the outside of the blade. The support structure comprises two clamping frames arranged exterior to the rotor blade and conceptualized to exert a clamping force on the rotor blade. The clamping frames are connected by a longitudinal support rod 185 pretensioned to reduce the mechanical load, particularly the strain, on the load-bearing structure, i.e., the spar cap. Thus, the load-bearing structure can be relieved by clamping the rotor blade on both sides of the damaged area. However, installation concepts to lift the frames, e.g., into the 6 o'clock position by winches, need to be developed. The clamping frames are spaced apart in the longitudinal direction of the rotor blade. Their concept is similar to that of load frames familiar from rotor blade testing, for example, where they are used to apply a load to the rotor blade, cf. Klaenfoth et al. (2023). Shear webs may require 190 reinforcement to withstand the clamping force from the load frame. Each of the clamping frames includes a clamping jaw adapted to the outer contour of the rotor blade, which is arranged between two clamping beams. The clamping beams of each clamping frame are connected by two clamping elements to exert a force transferable to the rotor blade by the clamping jaw.

The clamping frames are connected to the longitudinal support rod by ball or universal joints. The longitudinal support rod includes pretensioning means (indicated as a thinner section of the rod in Fig. 10) for exerting a pretensioning force 195 in the longitudinal direction on the rotor blade in such a way that the mechanical load, particularly the strain, on the load-bearing structure is reduced. The pretensioning means are adjustable to set the respective pretensioning force in the longitudinal direction, and are also conceptualized to adjust the length of the respective rod. The pretensioning means can include, for example, tension screws and/or turnbuckles and/or telescopic rods.

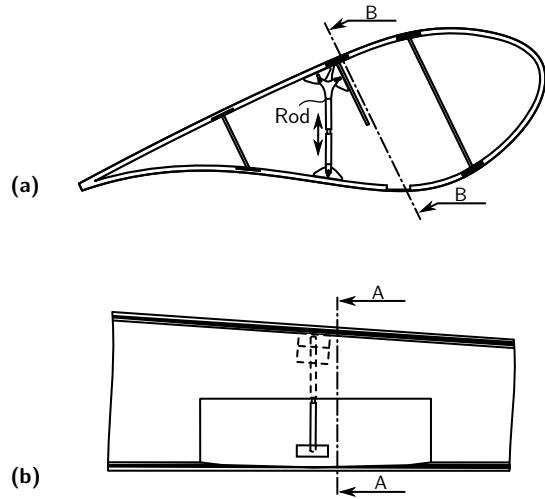
Figure 11. Buckling support structure - push rods that solves P2: (a) cross-sectional view through cut line A-A and (b) longitudinal view through cut line B-B; based on Rosemeier et al. (2024).

The support structure shown in Fig. 11 addresses P2 and consists of a support rod arranged inside the rotor blade with a 200 transverse support rod to increase the mechanical resistance, specifically buckling resistance, of the load-bearing structure. For this purpose, the transverse support rod is connected with a clamping foot to the panel which requires the buckling support.

Using additional clamping feet, the transverse support rod is connected to a panel opposite and to the web arranged above the damaged pultruded stack. The transverse support rod includes a pretensioning means to exert a transverse pretensioning force on the rotor blade in such a way that the buckling resistance is increased by supporting the buckling field of the panel, and thus 205 also the damaged pultruded stack of the adjacent load-bearing structure. The support structure may prevent buckling modes that develop toward the interior of the blade but not those that develop outward; it may even invert the buckling mode from inward to outward deformation. This drawback can be overcome by adding a buckling support structure on the outer surface, e.g., a stringer, as illustrated in Fig. 12.

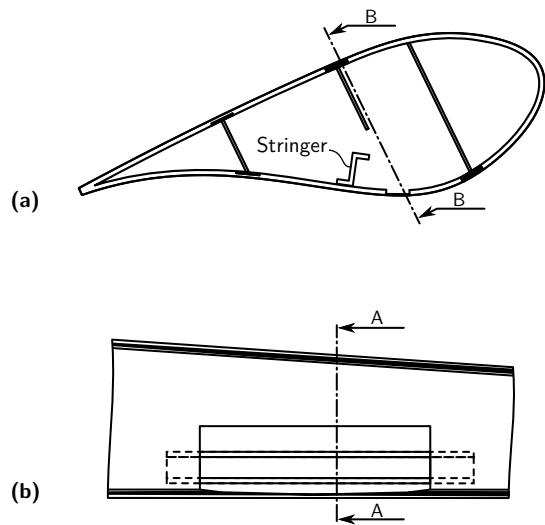
Figure 12. Buckling support structure - stringer that solves P2: (a) cross-sectional view through cut line A-A and (b) longitudinal view through cut line B-B; based on Rosemeier et al. (2024).

Fig. 12 shows a support assembly which addresses P2 and is arranged interior or exterior to the rotor blade. The support 210 assembly includes one or more support profiles, also called stringers, arranged to increase the mechanical resistance, particularly buckling resistance, of the load-bearing structure and/or the non-load-bearing structure. The support profile consist of an FRP material, such as glass or carbon fiber, and/or metal. Shown are support profiles with an Z-shaped cross-section. Other cross-sections are possible, such as T-shaped, C-shaped, or L-shaped cross-sections. The support assemblies are connected to

the interior of the rotor blade by a detachable adhesive connection, for example, using a thermoplastic material, or a magnetic
215 arrangement is provided for a simple, reversible, and repositionable connection.
