Feasibility of up-tower repair concepts for pultruded carbon spar cap planks in wind turbine blades

Abstract. While modern wind turbine blades utilize pultruded carbon fiber-reinforced polymer (CFRP) planks for structural integrity in spar caps, these materials can sustain damage from operational stresses, leading to potential failures if unaddressed. Traditional down-tower repairs result in significant costs related to dismantling and transportation, especially for offshore installations, emphasizing the need for efficient up-tower repair methods. The research utilizes a finite element model of an

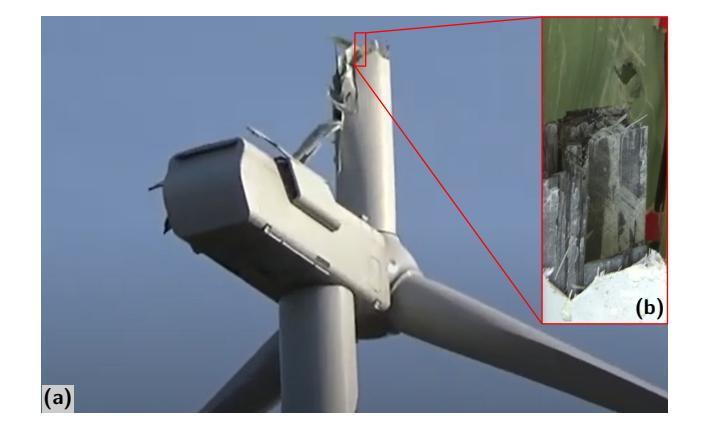
Figure 1. Blade loss incident after 2 years of operation (Pierrot, 2022) showing typical damage resulting from a lightning strike event; Ylikoski (2020).

not repaired, it can lead to blade loss (Fig. 1).

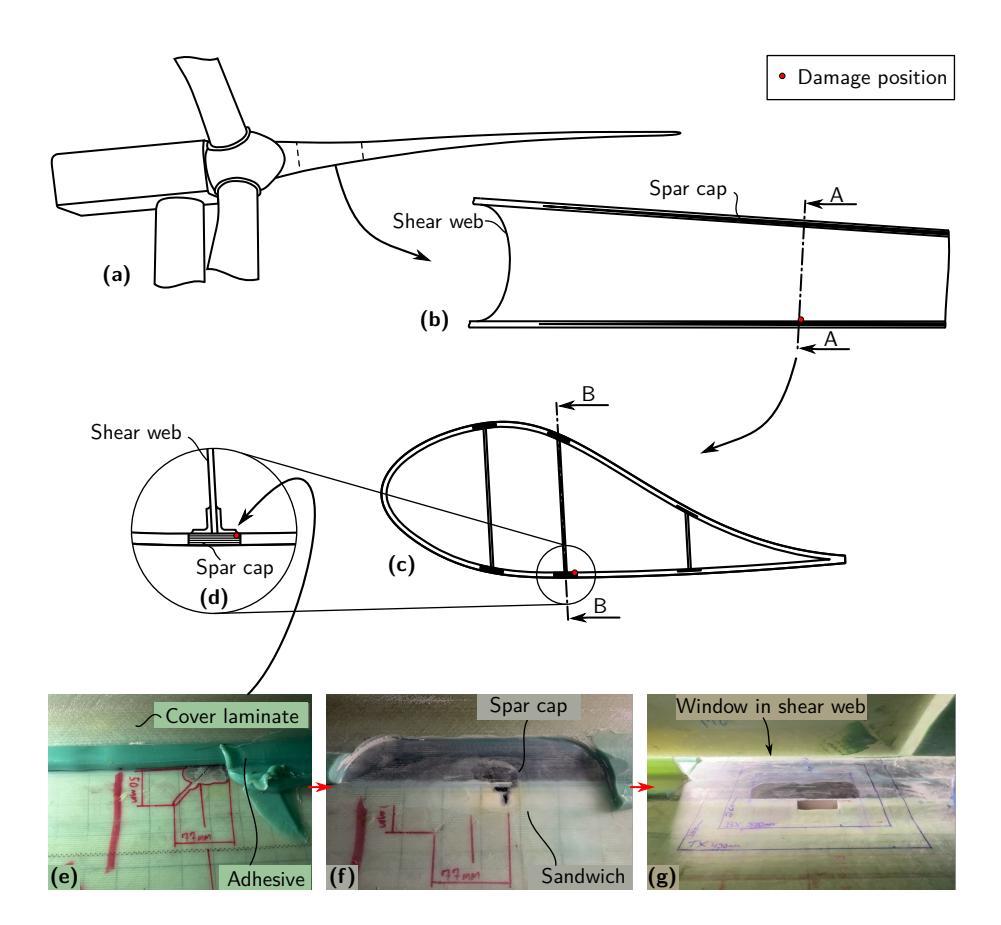
Figure 2. Up-tower repair concept: (a) wind turbine in rotor lock with damaged blade in 3 o'clock position, (b) longitudinal repair zone view through cut line B-B, (c) cross-sectional repair zone view through cut line A-A, (d) zoom into damage position, (e) damage observed, (f) damage after grinding off cover laminate and adhesive, (g) damage after grinding off CFRP and window cut-out in shear web; based on Rosemeier et al. (2024); Lessa (2023).

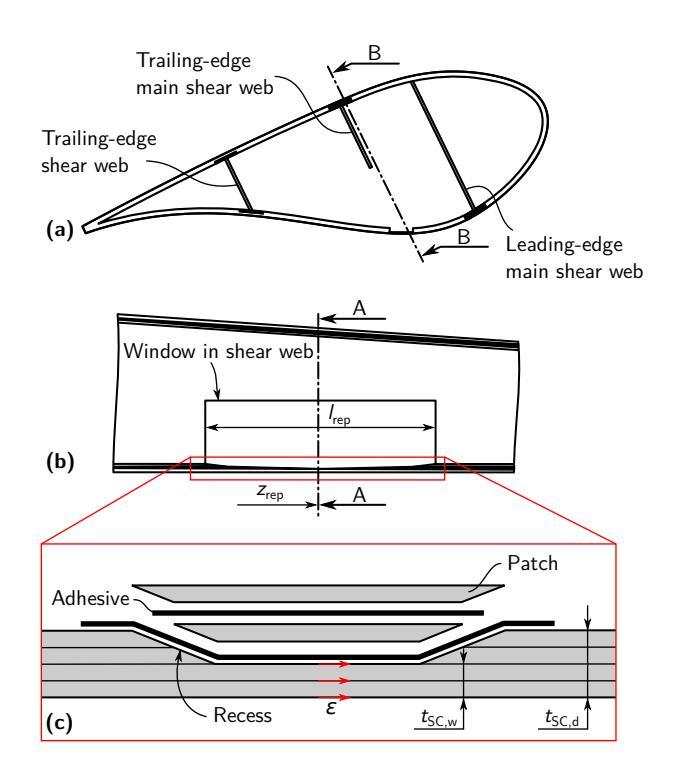
Figure 3. Weakened repair zone in (a) cross-sectional view through cut line B-B and (b) longitudinal view through cut line A-A; (c) exploded view of repair; based on Rosemeier et al. (2024) and Girolamo (2020).

45 the repair zone l_{rep} , i.e., the recess and the web window, can then be determined (Fig. 3b).

> The FE shell model was subjected to mechanical extreme load situations stemming from the aeroelastic load simulations. The resulting shear force distribution was transferred from the load simulation to the FE shell model using rigid-body elements of type RBE3. The repair zone was modeled by eliminating the web along the repair zone l_{rep} as well as reducing the spar cap thickness to $t_{SC,w}$ in the middle, considering chamfer angles as a function of l_{rep} , cf. Fig. 3.

Girolamo (2020) suggested filling the recess of a spar cap made from CFRP planks using patches made from chamfered CFRP planks, cf. Fig. 3c. Other fabrics could also possibly be used. However, we would like to emphasize that it is also necessary to restore electrical properties adversely affected by damage, provided that the load-bearing structures exhibit such properties. For example, CFRP pultrusions are electrically conductive, which is why their use in rotor blades requires either electrical separation, i.e., through insulation and physical separation, from the lightning protection system of the wind turbine,

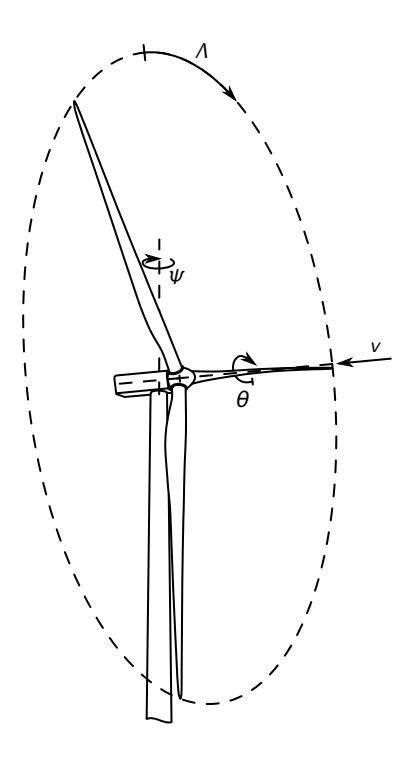
Figure 4. Repair position of rotor: yaw angle Ψ , azimuth angle Λ , and pitch angle θ ; mean wind speed direction v shown normal to rotor plane; based on Rosemeier et al. (2024).

Bending moments due to gravity loads dominate strains in the repair zone under maintenance DLC. Consequently, rotor azimuth positions of $\Lambda = 90^{\circ}$ and 270° were investigated, where 0° denotes the blade pointing upwards (Fig. 4). The 0° and 100 180° azimuth positions were not relevant as in this case, gravity mostly acts in longitudinal direction of the blade, while the aerodynamic loads contribute little to the loading. Hence the 6 o'clock position was not investigated further. While a yaw misalignment of $\Psi = 8^{\circ}$ in both directions relative to the mean wind direction v was considered, the highest loads occured at a yaw angle of $\Psi = 0^{\circ}$. Vertical upflow of the wind field was taken into account for upflow angles of attack of $\alpha = 0^{\circ}$ and 8°

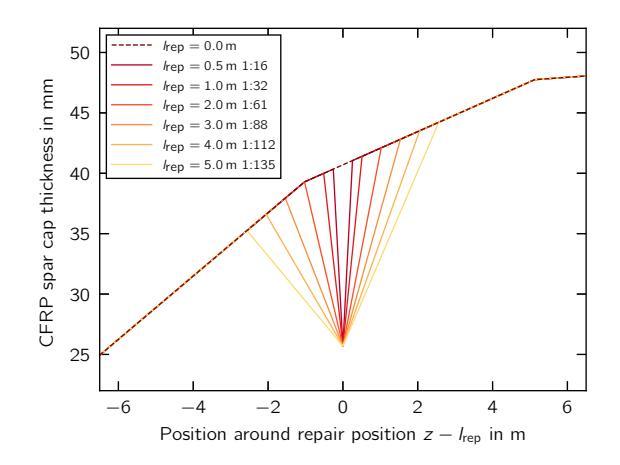
Figure 5. Spar cap thickness around repair zone with corresponding chamfer ratios.

This section describes the impact of the worst maintenance load envelope on the longitudinal strain and the buckling resistance of the weakenend blade structure. To this end, the length of the repair zone l_{rep} was increased step-wise from 0 m to 5 m while
the central damage position was chosen to be at a relative blade length of z_{rep}/l_B=17%, cf. Fig. 2 and Fig. 3. Within the length of l_{rep}, the original spar cap thickness of t_{SC,d} = 41 mm was reduced to t_{SC,w} = 26 mm while the shear web was removed completely. The step-wise increase of the repair zone length decreased the chamfer ratio from 1:16 (l_{rep} = 0.5 m) to 1:135 (l_{rep} = 5.0 m), cf. Fig. 5.

As the spar cap increases in thickness from rootward start to tipward end around the repair position, the recess introduces a dimple in the spar cap at the rootward start of the recess (Fig. 5). The dimple introduces a stiffness jump which explains why we observed larger strain fluctuations for longer repair lengths (Fig. 6), i.e., strain increase and strain decrease compared to the intact situation.

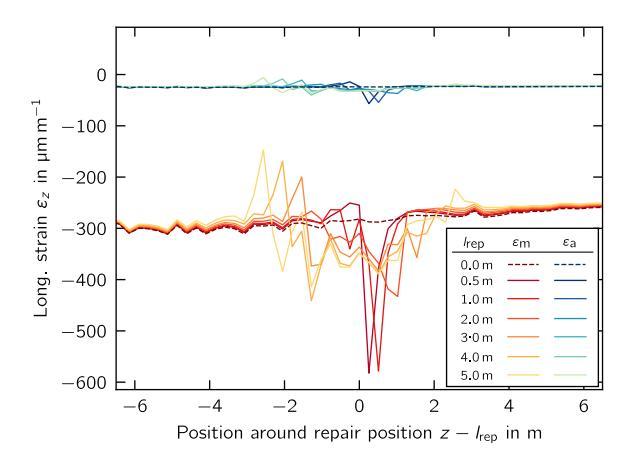
Figure 6. Longitudinal strain along weakened spar cap as function of repair zone length l_{rep} .

- Considering the longitudinal strain along the spar cap of the intact structure ($l_{rep} = 0 \text{ m}$ in Fig. 6), the strain amplitude is relatively low, i.e., $\varepsilon_a \approx 25 \,\mu\text{m}\,\text{m}^{-1}$, when compared to the compressive mean strain of $\varepsilon_m \approx -300 \,\mu\text{m}\,\text{m}^{-1}$. When the structure was weakened, the strain amplitude increased toward $\approx 50 \,\mu\text{m}\,\text{m}^{-1}$ and the mean strain toward $\approx -600 \,\mu\text{m}\,\text{m}^{-1}$. The longer the repair zone l_{rep} , the smaller the strain increase, i.e., for $l_{rep} = 5 \,\text{m}$ the average mean strain was $\approx -350 \,\mu\text{m}\,\text{m}^{-1}$. Moreover, the strain rootward from the repair position fluctuated more than the strain tipward from the repair position.

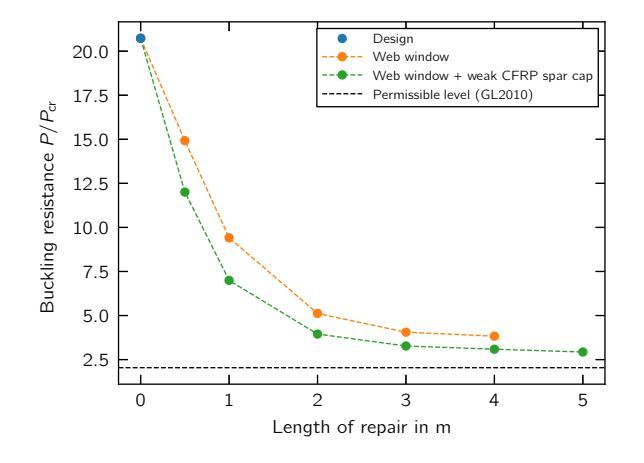
Figure 7. Buckling resistance.

- Considering the buckling resistance as a function of the repair length (Fig. 7), the resistance reduces significantly from 125 $P/P_{cr} = 20.7$ to $P/P_{cr} = 4.0$ when the web window is cut out for $l_{rep} = 2$ m and the spar cap is weakened. For $l_{rep} > 2$ m the resistance reduces linearly with a relatively small change and approaches the permissible level. The largest deformation magnitude of the buckling mode (Fig. 8) develops at z_{rep} (Fig. 3b).

To investigate how the weakened spar cap affects the buckling resistance reduction, we calculated the buckling resistance for the window cut-out only without including the weakening of the spar cap, cf. orange dots in Fig. 7. The removed trailing-edge main web (window) and consequently wider panel between the leading-edge main web and the trailing-edge web (Fig. 3a) is the major factor reducing the buckling resistance. At shorter repair lengths of less than 1 m, the weakened spar cap made a larger contribution to the reduction, i.e., between 18% and 33%, than at longer lengths, where the figure was <7%.

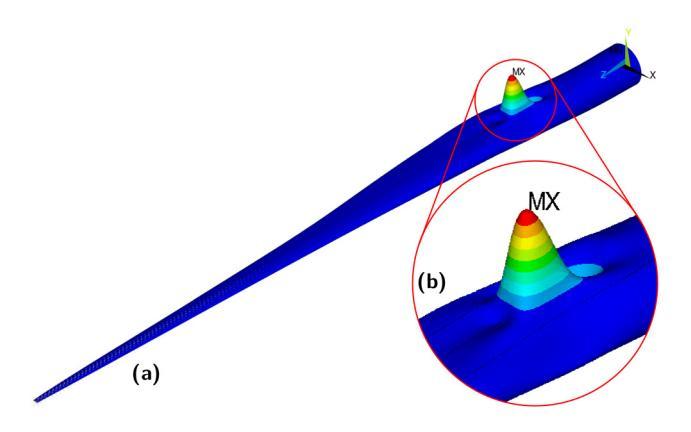
Figure 8. Buckling mode for 5 m long repair with the largest deformation indicated by MX.

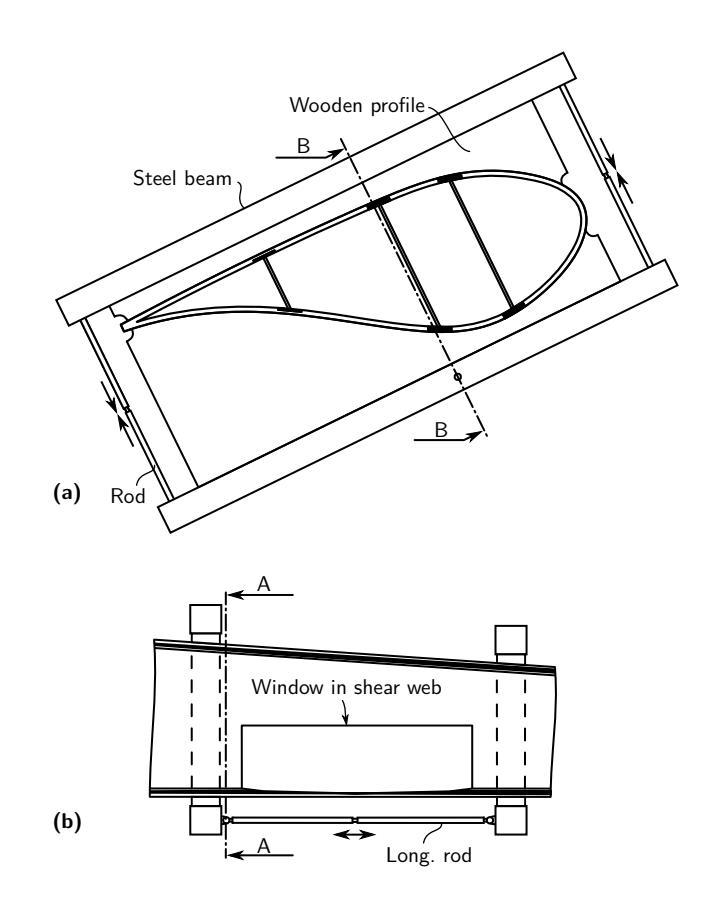
Figure 9. Span-wise pretensioning structure that solves P1: (a) cross-sectional view through cut line A-A and (b) longitudinal view through cut line B-B; based on Rosemeier et al. (2024).

To reduce the mean strain and address P1, a span-wise pretensioning structure as shown in Fig. 9 can be applied from the outside of the blade. The support structure comprises two clamping frames arranged exterior to the rotor blade and designed to exert a clamping force on the rotor blade. The clamping frames are connected by a longitudinal support rod pretensioned

- 180 to reduce the mechanical load, particularly the strain, on the load-bearing structure, i.e., the spar cap. Thus, the load-bearing structure can be relieved by clamping the rotor blade on both sides of the damaged area. However, installation concepts to lift the frames, e.g., into the 6 o'clock postion by winches, need to be developed. The clamping frames are spaced apart in the longitudinal direction of the rotor blade. Their design is similar to that of load frames familiar from rotor blade testing, for example, where they are used to apply a load to the rotor blade, cf. Klaenfoth et al. (2023). Each of the clamping frames

- 185 includes a clamping jaw adapted to the outer contour of the rotor blade, which is arranged between two clamping beams. The clamping beams of each clamping frame are connected by two clamping elements to exert a force transferable to the rotor blade by the clamping jaw.

The clamping frames are connected to the longitudinal support rod by ball or universal joints. The longitudinal support rod includes pretensioning means (indicated as a thinner section of the rod in Fig. 9) for exerting a pretensioning force in the longitudinal direction on the rotor blade in such a way that the mechanical load, particularly the strain, on the load-bearing structure is reduced. The pretensioning means are adjustable to set the respective pretensioning force in the longitudinal direction, and are also designed to adjust the length of the respective rod. The pretensioning means can include, for example, tension screws and/or turnbuckles and/or telescopic rods.

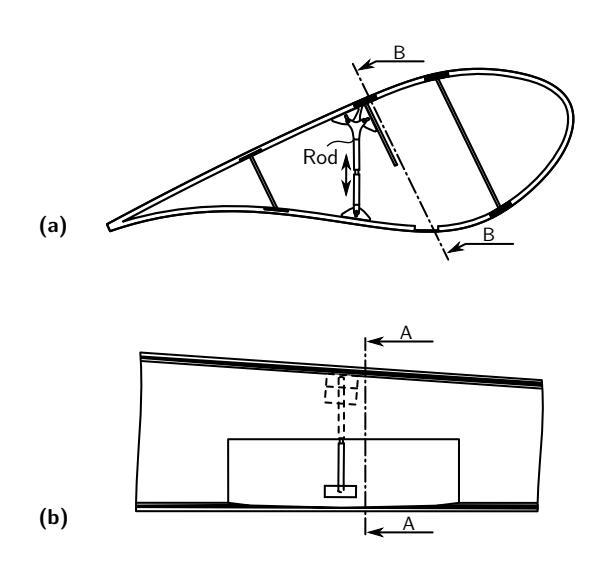
Figure 10. Buckling support structure - push rods that solves P2: (a) cross-sectional view through cut line A-A and (b) longitudinal view through cut line B-B; based on Rosemeier et al. (2024).

The support structure shown in Fig. 10 addresses P2 and consists of a support rod arranged inside the rotor blade with a 195 transverse support rod to increase the mechanical resistance, specifically buckling resistance, of the load-bearing structure. For this purpose, the transverse support rod is connected with a clamping foot to the panel which requires the buckling support. Using additional clamping feet, the transverse support rod is connected to a panel opposite and to the web arranged above the damaged pultruded stack. The transverse support rod includes a pretensioning means to exert a transverse pretensioning force on the rotor blade in such a way that the buckling resistance is increased by supporting the buckling field of the panel, and thus

200 also the damaged pultruded stack of the adjacent load-bearing structure.

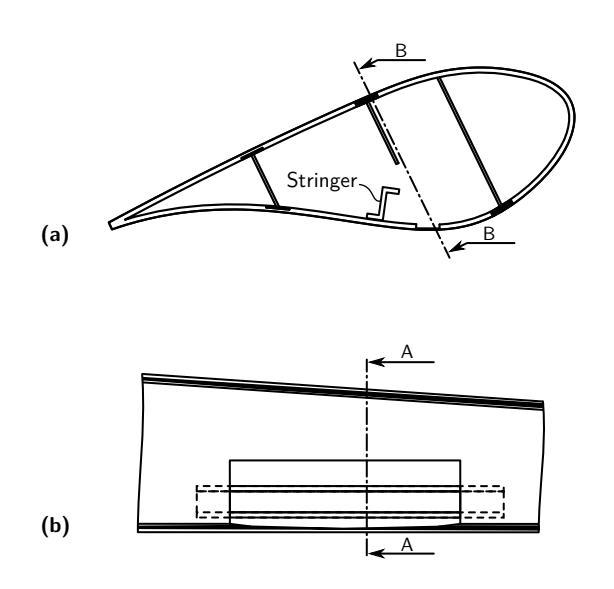
Figure 11. Buckling support structure - stringer that solves P2: (a) cross-sectional view through cut line A-A and (b) longitudinal view through cut line B-B; based on Rosemeier et al. (2024).

Fig. 11 shows a support assembly which addresses P2 and is arranged interior or exterior to the rotor blade. The support assembly includes one or more support profiles, also called stringers, arranged to increase the mechanical resistance, particularly buckling resistance, of the load-bearing structure and/or the non-load-bearing structure. The support profile consist of an FRP material, such as glass or carbon fiber, and/or metal. Shown are support profiles with an S-shaped cross-section. Other cross-sections are possible, such as T-shaped, C-shaped, or L-shaped cross-sections. The support assemblies are connected to the interior of the rotor blade by a detachable adhesive connection, for example, using a thermoplastic material, or a magnetic arrangement is provided for a simple, reversible, and repositionable connection.
