Estimating microplastic emissions from offshore wind turbine blades in the Dutch North Sea

Marco Caboni¹, Anna Elisa Schwarz², Henk Slot³, and Harald van der Mijle Meijer¹

¹TNO, Wind Energy Technology, Westerduinweg 3, 1755 LE Petten, the Netherlands

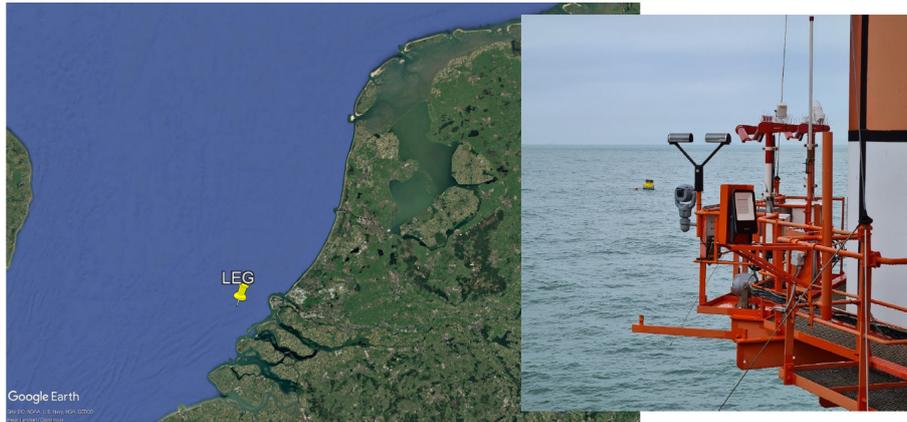
Figure 1. A map showing the location of the Lichteiland Goeree (LEG) platform, where concurrent rain and wind speed measurements were conducted (Caboni et al., 2024), and a picture of the OTT Parsivel² disdrometer installed on the platform are shown. Map courtesy of © Google Earth.

Measured offshore weather data supported this work by providing input to the erosion model. Rain measurements provided information on the number and size of droplets, as well as their fall velocity, while wind speed was correlated with rotor speed, dictating the impact speed between raindrops and blades. Concurrent measurements of rain and wind at the Dutch North Sea are scarce. The only available source of measurements is provided by TNO (Caboni et al., 2024) for a relatively short period. More specifically, over a period of 1 year, from March 2022 to March 2023, TNO carried out concurrent rainfall and wind speed measurements at the offshore Lichteiland Goeree (LEG) platform. Figure 1 depicts the exact location of the platform. Rainfall measurements were carried out by means of an OTT Parsivel² disdrometer. Wind speed was measured by means of a Leosphere WindCube V2 lidar. Since the current investigation focuses only on rain-induced erosion, measured events with snow and hail have been filtered out, retaining just rainy intervals. Hailstones, being larger, heavier, and harder than raindrops, can cause delamination, indentations, and surface cracking depending on their size and falling velocity (Verma et al., 2023). The impact of hailstones on blade erosion in the North Sea is not yet fully understood, so this topic has been excluded from the scope of this work. In 2022, the average wind speed at 140 m above sea level at LEG was 9.3 ms^{-1} , which is slightly lower than the 2015–2022 average of 9.9 ms^{-1} (Vitulli et al., 2023). 2022 was a relatively dry year in the Netherlands, with a national average rainfall of 729 mm (KNMI, 2022). Typically, the country's average annual rainfall is 795 mm.

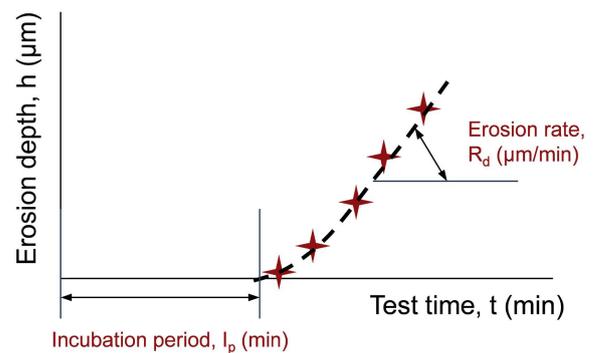
Figure 2. The figure illustrates the leading edge erosion process, showing a schematic of erosion depth over time during a droplet erosion test. Figure reproduced from Slot et al. (2015).

The LEE process is influenced by the fatigue properties of the blade LEP systems and the size and number of droplets impacting the surface at a given speed. Wear particle emissions from the leading edge begin once the incubation period is complete. Figure 2 illustrates a schematic of erosion depth over time during a droplet erosion test, performed under specific impact conditions such as drop size, impact velocity, and volume concentration. The figure indicates the incubation period and erosion rate. Methods for accurately calculating the incubation periods and erosion rates of currently applied LEP systems, including the effects of drop size, are limited. The available models are Slot's physical- and fatigue-based model for the droplet impingement erosion incubation period (Slot, 2021; Slot et al., 2015); Springer's semi-empirical, fatigue-based model (Springer, 1976); and the "ASTM – multiple linear regression fit equations" derived from a round robin test program, as detailed in Heymann's work (Heymann, 1979, 1970). Both Slot's and Springer's models necessitate the material and fatigue properties of the LEP system in use. However, these properties are rarely available or easily determined for most current LEP systems. Consequently, this study estimates the incubation period and erosion rate using the ASTM – multiple linear regression fit equations, incorporating a modified drop size dependence.

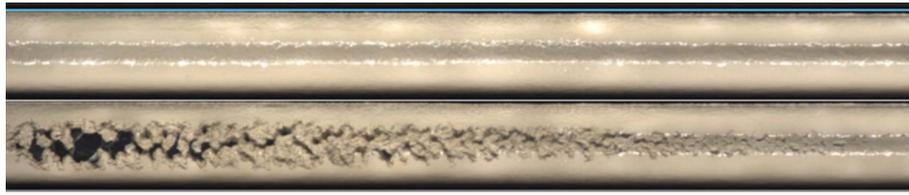
Figure 3. Examples of an initial and a tested specimen in the rotating arm tester. This figure is adapted from Hawkins and Nyboe (2019).

wind turbine blades. The RET method, as detailed in DNV-RP-0171 (2008) (DNV, 2021), demonstrates the highest accuracy and reliability when compared to real rain conditions. Figure 3 illustrates an example of a specimen both at the initial stage and after prolonged exposure in the rotating arm test. For example, Fig. 4 collects the results of regular inspections of the specimen surface at intervals during a rain erosion test conducted on a Teknos' LEP system. The graph correlates the number of drop impacts at a specific specimen location, thus characterized by a certain tangential velocity, that lead to the end of incubation, defined as the onset of material loss (see Fig. 2). The graph illustrates that as the local velocity decreases, the incubation period, measured by the number of drop impacts, increases. The local drop impact velocity is considered equal to the local specimen tangential velocity. Depending on the type of LEP system sometimes large scatters in obtained data points have been observed. The best fit using a power function for these data points gives the relation between the incubation period and drop impact velocity resulting in the fit constants exponent m (–) and a constant C (m s^{-1}) (see Eq. 13).

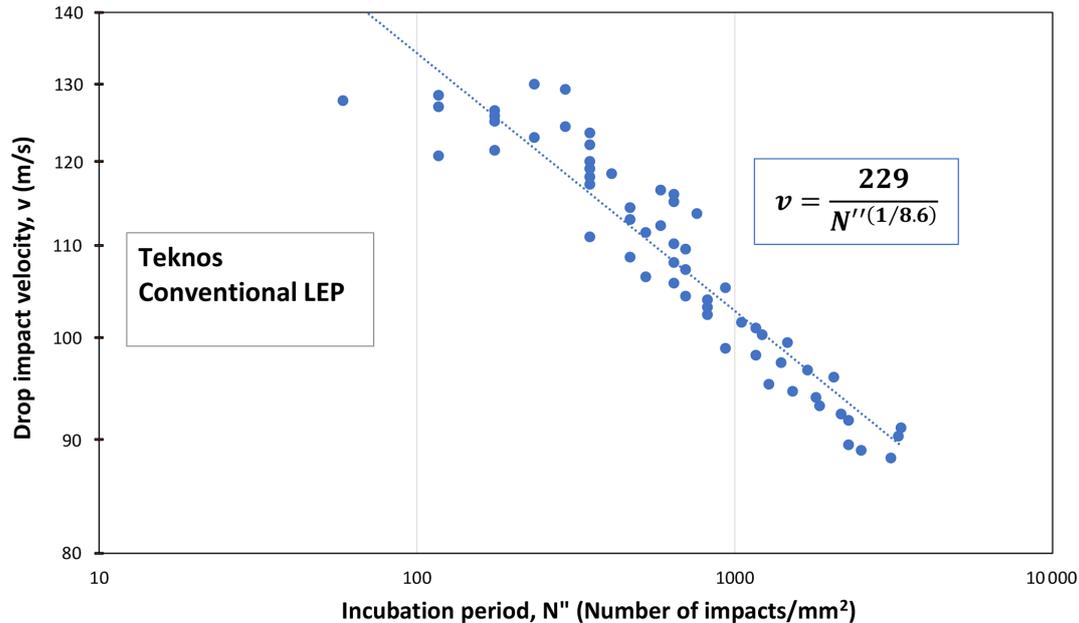
Figure 4. The results of periodic inspections of the specimen surface during a rain erosion test on Teknos' LEP system are presented. The fitting equation is displayed.

For each LEP system or material documented in the literature, within the present work we established graphs and best-fit functions. The incubation period, expressed as the volume of water per unit area at a velocity of 100 m^{-1} , is determined as follows:

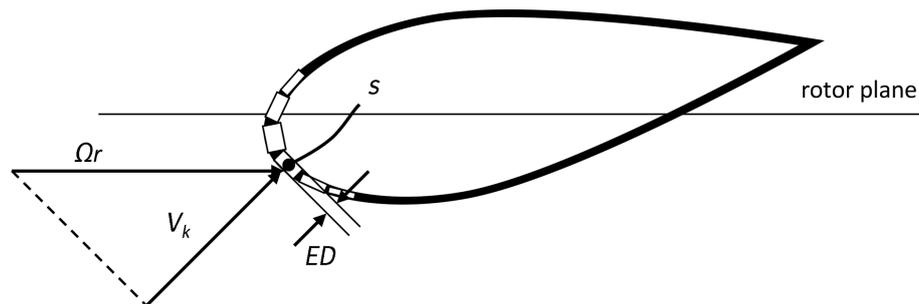
**Figure 5.** A sketch illustrating the parameters used to evaluate the erosion depth of a generic chord-wise element. Ωr represents the assumed relative velocity between the raindrop and the blade section, where Ω is the rotor's angular velocity and r is the radial distance of the section from the rotor center. V_k is the component of Ωr normal to the surface element. ED and s denote the eroded depth and eroded surface area of the generic element, respectively.

The first challenge is determining the relative velocity between raindrops and the blade. Given the complexity of obtaining precise estimates of this parameter, certain assumptions were necessary. As mentioned earlier, the relative velocity between raindrops and the blade is primarily influenced by the blade's tangential velocity. However, the terminal velocity of the droplets (which is equal to around 6 m s^{-1} for a 2 mm droplet) and aerodynamic effects also play a role (Barfknecht and von Terzi, 2024). Small droplets are expected to be completely advected by the wind, whereas larger, heavier droplets experience less advection. Using a numerical methodology, Gires et al. (2022) estimated that rain droplets exceeding 0.6 mm in size experience minimal advection in a turbulent wind field. For simplicity, we assumed that the terminal velocity of the droplets and aerodynamic effects, including advection, are negligible compared to the blade's tangential velocity. In other words, we assumed that raindrops remain stationary in space from an absolute reference frame. Under these assumptions, the relative velocity between raindrops and a blade section is equal to the tangential velocity of that blade section. The tangential velocity, Ωr , is aligned with the rotor plane, as illustrated in

Fig. 5. Due to the curved shape of the blade profiles, each section around the leading edge encounters the drops at different normal speeds, V_k . We discretized the shape of each blade profile into very small straight elements and calculated the normal component of the tangential velocity for each element, as shown in Fig. 5. This component was then used to assess the erosion amount from each element.

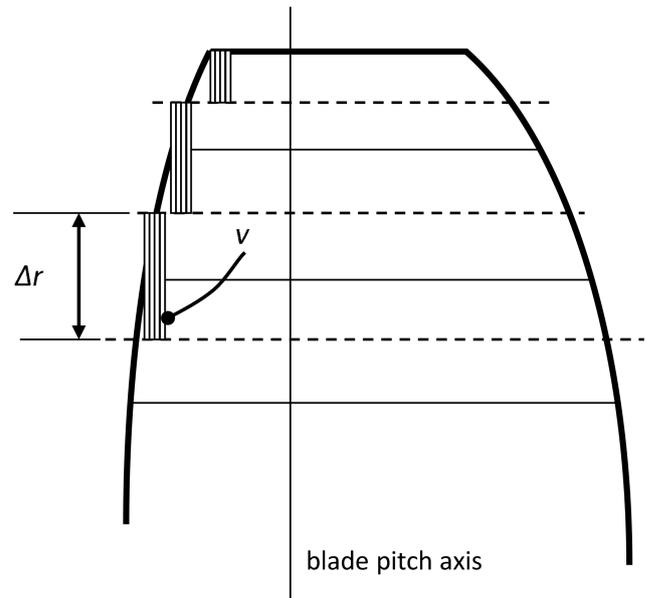
Figure 6. A sketch illustrating the parameters used to evaluate the eroded volume of a generic span-wise element. Δr represents the span-wise dimension of a generic element, and v denotes the eroded volume from that element.

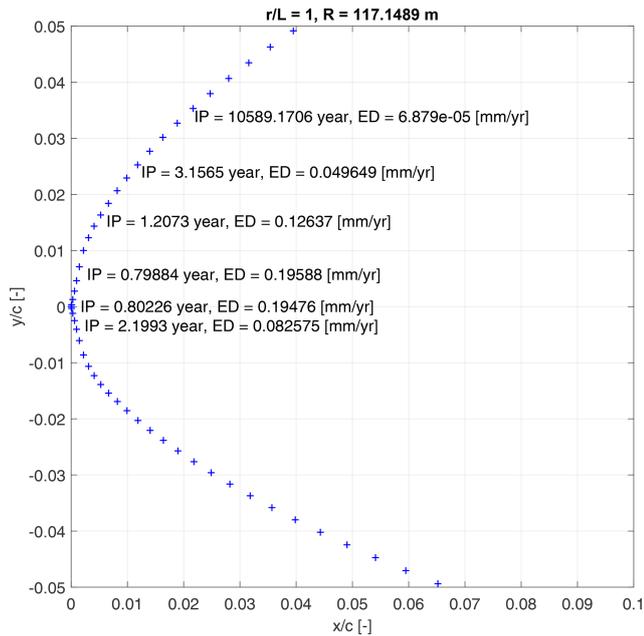
Figure 7. The figure illustrates the discretization of chord-wise elements of the tip airfoil. For certain elements, the incubation period, IP, and the yearly accumulated erosion depth, ED, are shown. r/L represents the relative position of the profile along the blade length, while R denotes the radial distance of the airfoil from the blade root. x/c and y/c are the airfoil coordinates, non-dimensional using the local chord length.

Figures 7 and 8 illustrate the leading edge discretization elements of the tip airfoil and an airfoil located at 75 % of the blade length from the root, respectively. For each element, the figures show the estimated incubation period and the yearly erosion depth using the aforementioned measured weather conditions. The erosion depth is expressed in millimeters of material removed per year. As expected, the erosion rate is greater around the leading edge, where the normal component of the relative velocity between the droplets and the blade is greater. As we move away from this zone towards the trailing edge, the erosion rate quickly decreases. For both profiles, the highest erosion rate is found on the upper surface. This is due to the section pitch angle (which is not shown in Figs. 7 and 8), rotating the profile counter-clockwise and increasing the exposure of the upper section to droplet impact. This is also evident in Fig. 5, where the rotor plane, representing the direction of the relative velocity between the droplets and the blade, intersects the profile on the upper side. This finding aligns with Vimalakanthan et al. (2023), which presents a 3D profile obtained using an optical scanner of a commercial wind turbine (63 m long) blade near

At the most exposed section of the tip, the incubation period is approximately 0.8 years, with an erosion depth of 0.2 mm yr^{-1} . At the section located 75 % of the blade length from the root, the incubation period for the most vulnerable element ends after 5 years, with the erosion depth progressing at a rate of 0.04 mm yr^{-1} . According to our estimation, erosion reaches a blade section located 75 % of the blade length from the root after approximately 5 years. Thus, to prevent erosion from propagating beyond this section, we assumed that one repair is conducted every 5 years. Under this assumption, we estimated the amount of plastic material eroded by rain from the leading edge of three blades over the assumed 25-year lifetime of the wind turbine. Table 3 summarizes the results. Following blade commissioning and each repair, the accumulated damage resets to zero. No material is removed during the first year, as none of the blade elements reach the incubation period. After 2 years, material begins to be released from the tip. The erosion then progresses inboard, increasing the amount of material lost. Once an erosion depth of 0.55 mm (the assumed thickness of the LEP system) is reached at a specific element of the profile leading edge, we assume that no further material can be released from that area. Indeed, by ensuring that operations and maintenance are effectively carried out, the appropriate maintenance and inspection strategy prevents excessive damage beyond the LEP system. Over the lifetime of

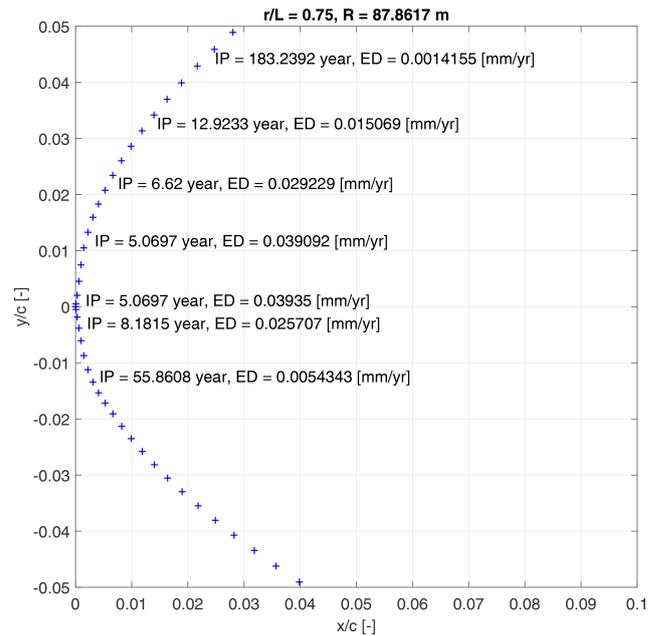
Figure 8. The figure illustrates the discretization of chord-wise elements of a blade profile located at 75% blade length from the blade root. For certain elements, the incubation period, IP, and the yearly accumulated erosion depth, ED, are shown. r/L represents the relative position of the profile along the blade length, while R denotes the radial distance of the airfoil from the blade root. x/c and y/c are the airfoil coordinates, non-dimensional using the local chord length.

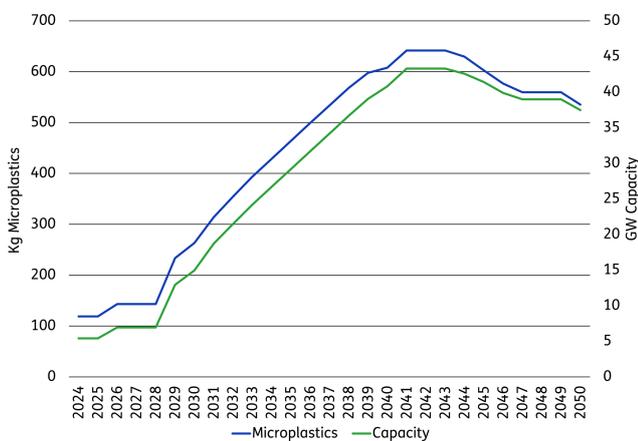
Figure 9. Annual microplastic emissions and the associated yearly capacity from Dutch offshore wind turbines in the North Sea.

stalled capacity of wind turbines in the North Sea, growing from the current 100 kg yr^{-1} to a peak of around 650 kg yr^{-1} by 2041. Approximately, there is a microplastic release of 0.02 kg MW^{-1} installed capacity, with a slight decrease in the future, from 0.021 to 0.014 kg . This is a direct result of improved capacity of turbines, allowing longer wind turbine blades, which reduces the total number of wind turbines required. This results in relatively lower material input for the turbines. The decrease in capacity after 2041, as shown in Fig. 9, is due to the decommissioning of wind farms that have reached the end of their operational life. Potential repowering of existing wind farms or the development of new wind farm areas after 2030 is not included in the data and is therefore not represented here.

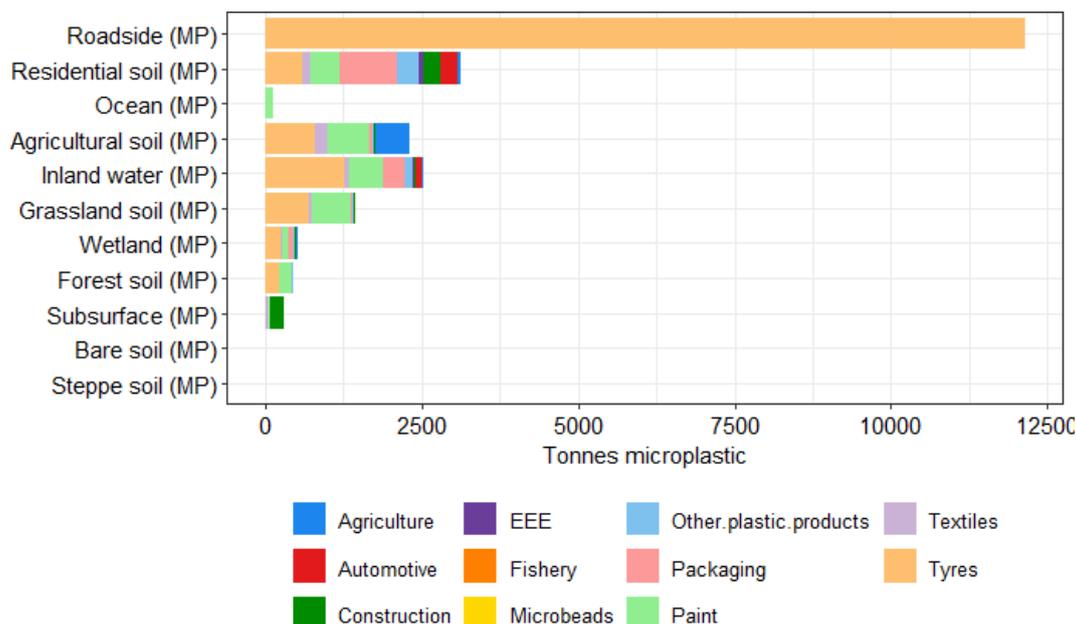
Figure 10. Microplastic emissions to the environment for the Netherlands in 2017, assessed through material flow analysis (Schwarz et al., 2023).

When comparing the yearly offshore wind turbine emissions to other microplastic emission sources in the Netherlands, wind turbines only contribute to small amounts to the total emissions. In 2017, around 23 kt of microplastics was directly released into the environment in the Netherlands, with approximately 70% of that total originating from car tires (see Fig. 10). This value excludes any macroplastic emissions ($> 5 \text{ mm}$), which include littering and improper waste management practices, such as dumping of (plastic) waste. Figure 10 indicates that microplastic losses from Dutch fisheries are assessed to be minimal. Additionally, we

utilized the MFA to evaluate and compare microplastic emissions with all direct emissions to oceanic environments from the Netherlands. This assessment includes emissions from macroplastics but excludes any transport from other compartments, such as river inflows. In 2017, a total of 155 t of micro- and macroplastics was emitted into the Dutch North Sea. These direct plastic emissions originated from both the paints and coatings of marine vessels and the direct loss of fishery equipment. Therefore, the estimated 0.1 t currently emitted from offshore wind turbine blades in the Dutch North Sea represents less than 1‰ (one per mille) of the total annual plastic offshore emissions in the Netherlands.
