Condition Monitoring of roller bearings using Acoustic Emission

Daniel Cornel¹, Francisco Gutiérrez Guzmán¹, Georg Jacobs¹, Stephan Neumann¹

¹Chair for Wind Power Drives (CWD), RWTH Aachen University, Aachen, 52074, Germany

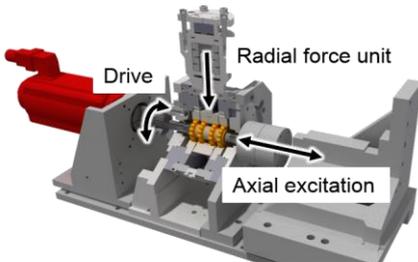
Figure 1: Four-bearing test bench (RLP), shaft diameter 30 mm.

Four-bearing test bench: The investigations regarding the detection of operating conditions were conducted on a four-bearing test bench (Figure 1). This test rig consists mainly of a drive unit, a radial load unit, an oil chamber and four test bearings from type NU206-TVP2 with a bore diameter of 30 mm. The radial load unit consists of a disc spring stack, which can be statically pre-loaded. The radial load is applied through the two middle test bearings. The test bearings are mounted on a shaft, which is driven by an electric motor (max. 6,000 rpm). The loaded shaft itself is mounted in the test head by the outer test bearings, which are each arranged symmetrically to each other ensuring a symmetrical load distribution on the test bearings.

Test bench	RLP
Shaft diameter [mm]	30
No. of test bearings [-]	4
Bearing type	NU206
Radial load [kN]	100
Axial load [kN]	8/100 (high frequency/static)
$P_{Hertz, max}$ [MPa]	3,600
Test temperature [°C]	40-110

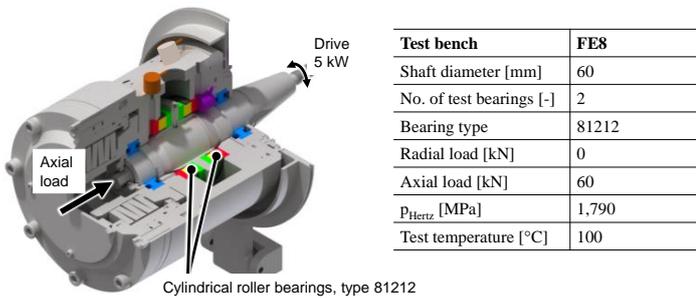
Figure 2: FE8 type test rig with test bearings of type 81212 according to (Deutsches Institut für Normung e. V, 2016).

Thrust bearing test bench: The fatigue related tests in this work were carried out using cylindrical roller thrust bearings of type 81212 in an FE8 type test rig (Deutsches Institut für Normung e. V., 2016), see Figure 2. The standard FE8 uses a constant load spring system, designed for bearing loads up to 100 kN. Using an electrical drive, it is possible to set-up a shaft speed between 7.5-300 rpm. In case of exceeding a limit bearing temperature or vibration level (e.g. caused by a pitting) the test will

be stopped automatically. Two test bearings are used for each test run. These are often distinguished on the basis of their position within the test rig. Thus, there is a bearing at the motor-side and a bearing at the housing side of the test rig. Each bearing consists of two washers, a cage and the rolling elements. One washer is mounted on the shaft and is driven, while the other one is stationary placed in the housing.

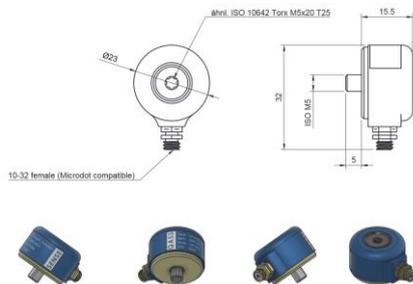
Figure 3: Used Acoustic Emission sensors.

Acoustic Emission sensors: Beside classic vibration sensors, Acoustic Emission sensors were used. The sensors are broadband sensors (Model: QWT-MCX) of the company QASS and shown in Figure 3. Unfortunately, no frequency response diagram of the sensor was available at the time of publication.

Although both methods rely on the same operating principle, the Acoustic Emission (AE) sensors have no seismic mass. As a result, AE sensors can be used in higher frequency bands (Cockerill, 2017), often with range of 100 kHz to 1,000 kHz. On the other hand, vibration sensors operate in a band between 0 and 50 kHz. Therefore, AE operates outside the frequency range of classic machine vibrations and is less sensitive towards typical background noises such as test bench cooling system (PAC, 2015). Nevertheless, our own research has shown that a variety of high frequencies cause noise that reduces the signal-to-noise ratio. To increase the accuracy, the sensors need to be installed as close as possible to the rolling contacts.

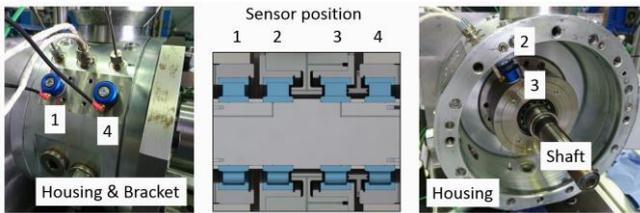
Figure 4: Four-bearing test bench (RLP): position of the installed AE sensors.

In the case of the four-bearing test bench, 4 sensors were installed. For the middle test bearings (# 2 & 3) the sensors can be easily installed within the test head, shown in Figure 4. In the case of the outer test bearings (# 1 & 4) the sensors need to be installed outside the housing due to lack of space.

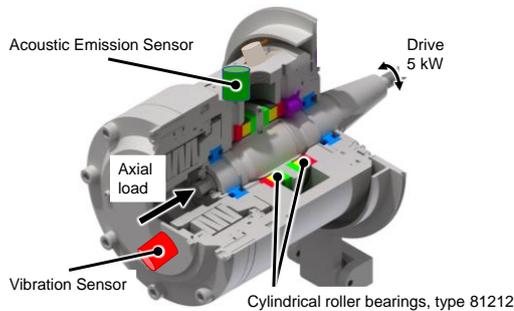
150 **Figure 5: Thrust bearing test bench: position of the AE and vibration sensor.**

For use on the thrust bearing test rig, the sensors had to be installed outside the housing again due to the lack of space. The actual installation position of the sensors is shown in Figure 5. While the vibration sensor is preferably placed in the direction of excitation, our own preliminary investigations show that AE sensors mounted in the displayed position provide the best results due to the short distance to the roller bearings. A positioning in direct proximity to the vibration sensor would be technical possible, but results in a significant increase in the required component crossings and the distance to the bearings in general and thus in a change and lowering of the AE signals.

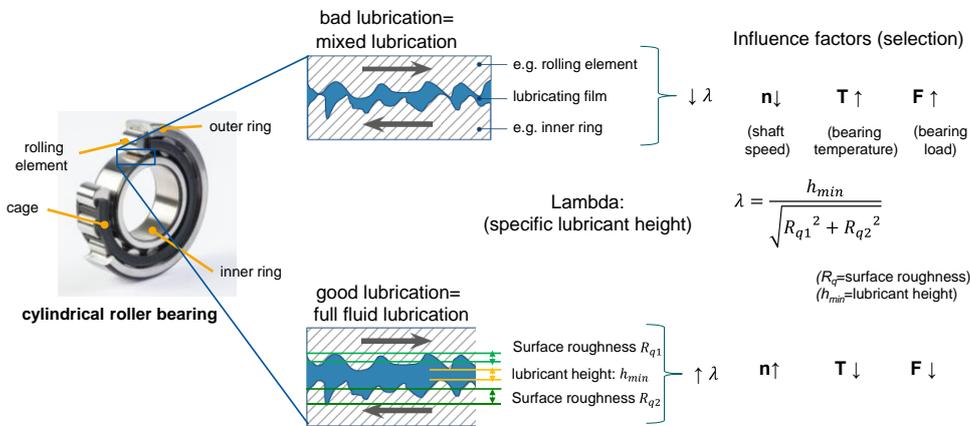
Figure 6: Brief explanation of the lubrication state and the influence factors.

Generally speaking, the operating conditions of a bearing are depending on the load (F), the shaft speed (n), the resulting bearing temperature (T), the lubricant and the roughness of bearing components. In this work a lubricant ISO VG 100 was used. Furthermore, it was ensured that the roughness of the used bearings was between 0.03 and 0.08 μm. The aforementioned

165 factors are used to calculate the specific lubricant film thickness lambda “λ”, which is used as a quantitative indicator of the lubricating conditions prevailing in the contact area. Values of λ ≥ 3 indicate full fluid lubrication conditions, values of λ ≤ 1 indicate boundary lubrication conditions while the range between is referred to as mixed lubrication regime (Czichos and Habig, 2015). An operation under full fluid lubrication is intended in general. For the calculation of lubricant film thickness, the reader is referred to the work of DOWSON and HIGGINSON (Dowson and Higginson, 1966). In the following Figure 6, the

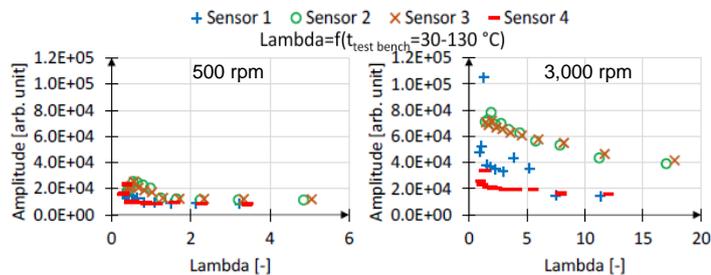
185 **Figure 7: Influence of the lubrication regime and the shaft speed on the AE Energy level.**

180 The following experiment regarding the Influence of the lubrication regime was part of a test series presented in previous work (Cornel, 2018). Due to the strong dependence of the specific lubricant film thickness on the oil temperature was used to adjust different lubrication conditions. To expand the parameter field two different shaft speeds, 500 and 3,000 rpm, were used. The investigations were carried out at a constant pressure of 2.0 GPa while the temperature itself was varied between 30 and 130 °C. Figure 7 shows the results of the experiments.

It can be observed that the amplitude of the AE signals increases as lambda decreases. This is especially noticeable in the areas around $\lambda = 0.5-2$. At 500 rpm (Figure 7 – Left) and $\lambda > 2$ the amplitude remains almost constant. The results meet the expectations that an increasing separation of the surfaces, defined by an increasing lambda, leads to decreased acoustic signals due to the missing interaction of roughness asperities spikes within the contact. On the other hand, at 3,000 rpm (Figure 7-
 190 right) the effect the AE amplitude remaining constant can only be seen by the external sensors, 1 and 4, at λ -values > 5 . Sensor 2 and 3 still show a significant decrease of the amplitude with an increasing lambda. This could be explained as follows: The transfer path of the acoustic signals to the externally mounted sensors has two additional component transitions due to the test rigs design and is about 350 % longer compared to the internally mounted sensors. This consideration can lead to the fact that

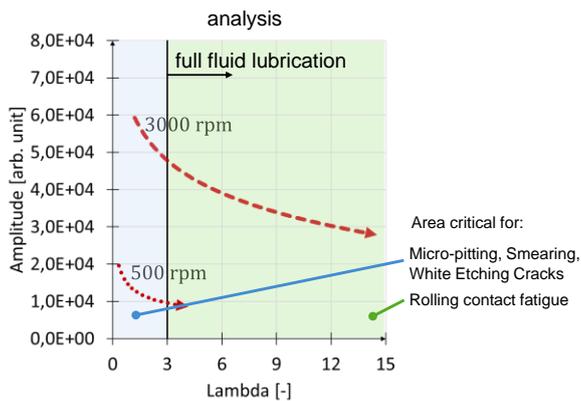
Figure 8: AE results arranged with the lubrication regimes.

195 the signals become weaker and may no longer be detected. Regarding the significant decrease of the amplitude with an increasing lambda at 3,000 rpm, it is assumed that due to the significantly higher shaft speed, the whole system is excited (e.g. the vibration of test rig itself, increase of the bearing over rolling frequencies) much more and therefore resulting in a higher amplitude of the signals. Figure 8 arranges the results with the conducive conditions of the aforementioned failure modes. In conclusion it can be said, that for a known system or test bench the magnitude of the AE amplitude can be used to
 200 approximately/roughly determine the rotation speed range of the system.

In addition, it is possible to distinguish between mixed friction and full fluid lubrication for the corresponding speed level. Therefore it can be concluded, that a first analysis of the criticality of the prevailing conditions accompanied by an estimation of the expected failure mechanism could be carried out by using a CMS based on AE as long as the system is known from previous investigations or a measurement phase is implemented during the set up process.

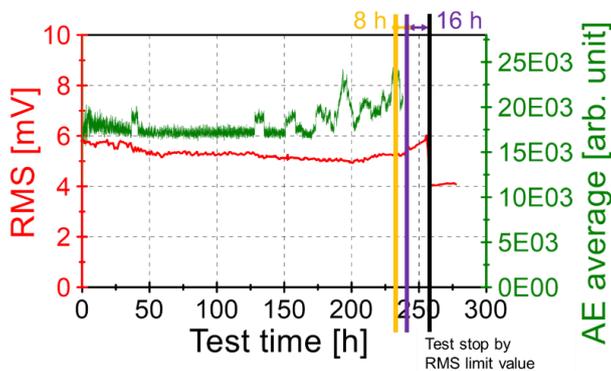
225 **Figure 9: Comparison of vibration and AE signal over the test time.**

During testing and as aforementioned, the signal of a vibration sensor and an AE sensor were monitored continuously during testing. Figure 9 shows both averaged signals from one test over the total test time of ~261 h. The signal of the vibration sensor, shown as a red line, is plotted as root mean square (RMS) and therefore marked as RMS. In contrast the AE signal, plotted as green line, shows the amplitude average and is marked as AE average. The test was stopped after 261 h due to the vibration

signal exceeding the vibration threshold (20 % above the RMS value after run-in). Post-testing analysis confirmed a pitting damage as the source for the increased vibration.

Regarding the signal behaviour, both show a decreasing tendency within the first 50 h. This tendency can be correlated with typical running-in processes (e.g. smoothing of the roughness peaks on the bearing surface). Subsequently, the vibration signal stays at an almost constant level before it rises significantly approx. 16 h before the threshold is exceeded. In contrast, the averaged AE signal shows the first indications of a deviation from its constant level after a test time of 125 h. These deviations increase significantly from about 150 h and 175 h onwards. Unfortunately, it should be noted that the last 16 hours of the AE signal are missing due to a recording error. In comparison with the vibration sensor, it can be concluded that significant activities of the AE system are visible at least 8 h before the vibration signal rises (referred to the latest peak of the AE signal before the test stop). It is assumed, that the latest AE signal activities together with the increased AE signal level in general can be traced back to the formation of the pitting or to the outbreak of the surface. The preceding activities are possibly caused by sub-surface damage initiation and propagation. These deviations were detected up to ~50 % (130 hours) before the test stop and are potentially related to sub-surface damage initiation and might result in an earlier damage detection in the future. In general, AE signals can be associated, on a model level (see [Chapter 2](#)), to damage pre-stages, such as crack initiation, crack-propagation or structural changes inside the bearing components. As described in [Chapter 2](#), the correlation of the AE signals to specific phenomena is however still a research subject. As a basis for the future investigation of the topic, the signals should be examined for characteristic attributes and validated in further experiments.

The investigations regarding the damage detection using a thrust bearing test rig (FE8) have shown that a pitting damage could be detected by the AE system at least ~4 % (8 hours) in advance of the vibration based system. Furthermore, noticeable deviations in the AE signal were detected up to ~50 % (130 hours) before the test stop and are possibly associated with damage pre-stages, such as crack initiation, crack-propagation or structural changes inside the bearing components and might result in an earlier damage detection in future. Besides, it was found that the AE system and the vibration based system are capable to detect the run-in period of a test run.
