Condition Monitoring of roller bearings using Acoustic Emission

Daniel Cornel¹, Francisco Gutiérrez Guzmán¹, Georg Jacobs¹, Stephan Neumann¹

¹Chair for Wind Power Drives (CWD), RWTH Aachen University, Aachen, 52074, Germany

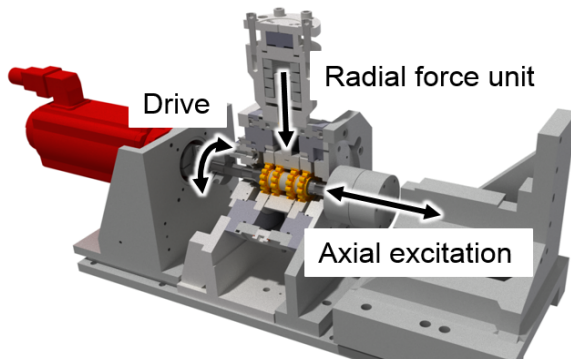
Four-bearing test bench: The investigations regarding the detection of operating conditions were conducted on a four-bearing test bench (Figure 1). This test rig consists mainly of a drive unit, a radial load unit, an oil chamber and four test bearings from type NU206-TVP2 with a bore diameter of 30 mm. The radial load unit consists of a disc spring stack, which can be statically pre-loaded. The radial load is applied through the two middle test bearings. The test bearings are mounted on a shaft, which is driven by an electric motor (max. 6,000 rpm). The loaded shaft itself is mounted in the test head by the outer test bearings, which are each arranged symmetrically to each other ensuring a symmetrical load distribution on the test bearings.

Test bench	RLP
Shaft diameter [mm]	30
No. of test bearings [-]	4
Bearing type	NU206
Radial load [kN]	100
Axial load [kN]	8/100 (high frequency/static)
$p_{Hertz, max}$ [MPa]	3,600
Test temperature [°C]	40-110

115 **Figure 1: Four-bearing test bench (RLP), shaft diameter 30 mm.**

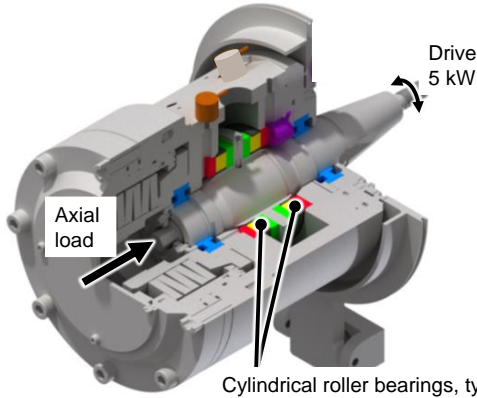
Thrust bearing test bench: The fatigue related tests in this work were carried out using cylindrical roller thrust bearings of type 81212 in an FE8 type test rig (Deutsches Institut für Normung e. V., 2016), see Figure 2. The standard FE8 uses a constant load spring system, designed for bearing loads up to 100 kN. Using an electrical drive, it is possible to set-up a shaft speed between 7.5-300 rpm. In case of exceeding a limit bearing temperature or vibration level (e.g. caused by a pitting) the test will

be stopped automatically. Two test bearings are used for each test run. These are often distinguished on the basis of their position within the test rig. Thus, there is a bearing at the motor-side and a bearing at the housing side of the test rig. Each bearing consists of two washers, a cage and the rolling elements. One washer is mounted on the shaft and is driven, while the other one is stationary placed in the housing.

Test bench	FE8
Shaft diameter [mm]	60
No. of test bearings [-]	2
Bearing type	81212
Radial load [kN]	0
Axial load [kN]	60
P_{Hertz} [MPa]	1,790
Test temperature [°C]	100

Figure 2: FE8 type test rig with test bearings of type 81212 according to (Deutsches Institut für Normung e. V, 2016).

In order to compare the time to failure detection of CMS's based on AE and vibration under known conditions the thrust bearing test rig ("FE8") introduced in Chapter 3, was used. This test rig was chosen because it allows to generate a bearing damage within a short period of time. Due to the recent relevance, conditions were chosen which additionally lead to a WEC damage. A WEC-induced bearing failure can occur after 5-20% of the L_{10} nominal lifetime (Evans, 2015) and is therefore considered particularly critical. Further information can be found in the work of DANIELSEN et al. (Danielsen et al., 2017). The testing was carried out within a short period of time (< 500 h) using well known operating conditions. The test conditions are characterised by an axial load of 60 kN, a shaft speed of 300 rpm and a bearing temperature of 100 °C. These conditions have been previously used in further FE8 related WEC studies such as (Danielsen et al., 2019). As shown in the work of DANIELSEN (Danielsen et al., 2019) these conditions usually lead to failures between 100 h and 300 h.

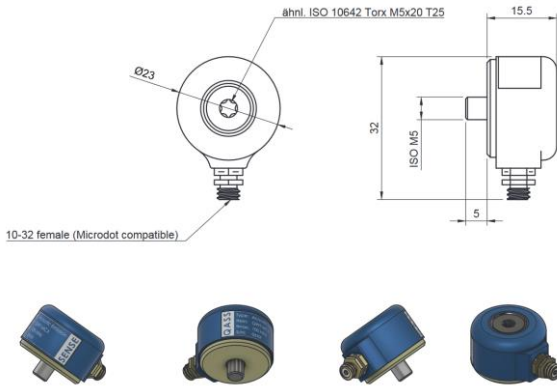
Acoustic Emission sensors: Beside classic vibration sensors, Acoustic Emission sensors were used. The sensors are broadband sensors (Model: QWT-MCX) of the company QASS and shown in Figure 3. Unfortunately, no frequency response diagram of the sensor was available at the time of publication.

Figure 3: Used Acoustic Emission sensors.

Although both methods rely on the same operating principle, the Acoustic Emission (AE) sensors have no seismic mass. As a result, AE sensors can be used in higher frequency bands (Cockerill, 2017), often with range of 100 kHz to 1,000 kHz. On the other hand, vibration sensors operate in a band between 0 and 50 kHz. Therefore, AE operates outside the frequency range of classic machine vibrations and is less sensitive towards typical background noises such as test bench cooling system (PAC, 2015). Nevertheless, our own research has shown that a variety of high frequencies cause noise that reduces the signal-to-noise ratio. To increase the accuracy, the sensors need to be installed as close as possible to the rolling contacts.

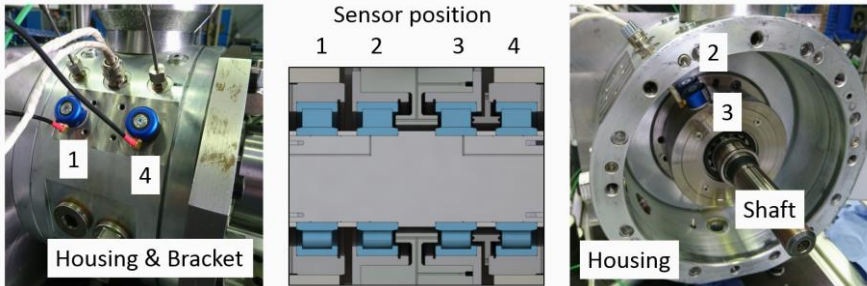
In the case of the four-bearing test bench, 4 sensors were installed. For the middle test bearings (# 2 & 3) the sensors can be easily installed within the test head, shown in Figure 4. In the case of the outer test bearings (# 1 & 4) the sensors need to be installed outside the housing due to lack of space.

Figure 4: Four-bearing test bench (RLP): position of the installed AE sensors.

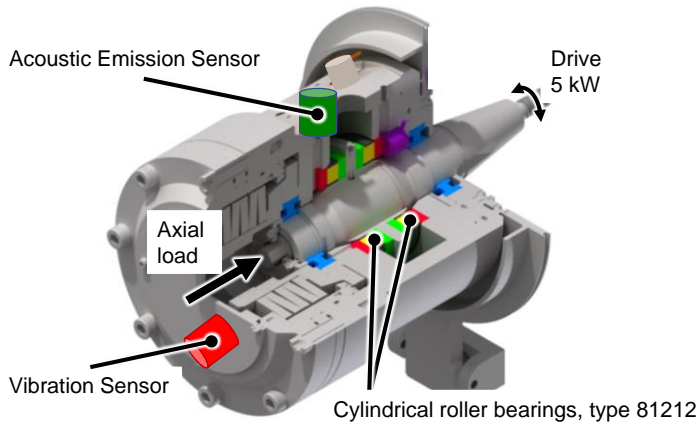
For use on the thrust bearing test rig, the sensors had to be installed outside the housing again due to the lack of space. The actual installation position of the sensors is shown in Figure 5. While the vibration sensor is preferably placed in the direction of excitation, our own preliminary investigations show that AE sensors mounted in the displayed position provide the best results due to the short distance to the roller bearings. A positioning in direct proximity to the vibration sensor would be technical possible, but results in a significant increase in the required component crossings and the distance to the bearings in general and thus in a change and lowering of the AE signals.

Figure 5: Thrust bearing test bench: position of the AE and vibration sensor.

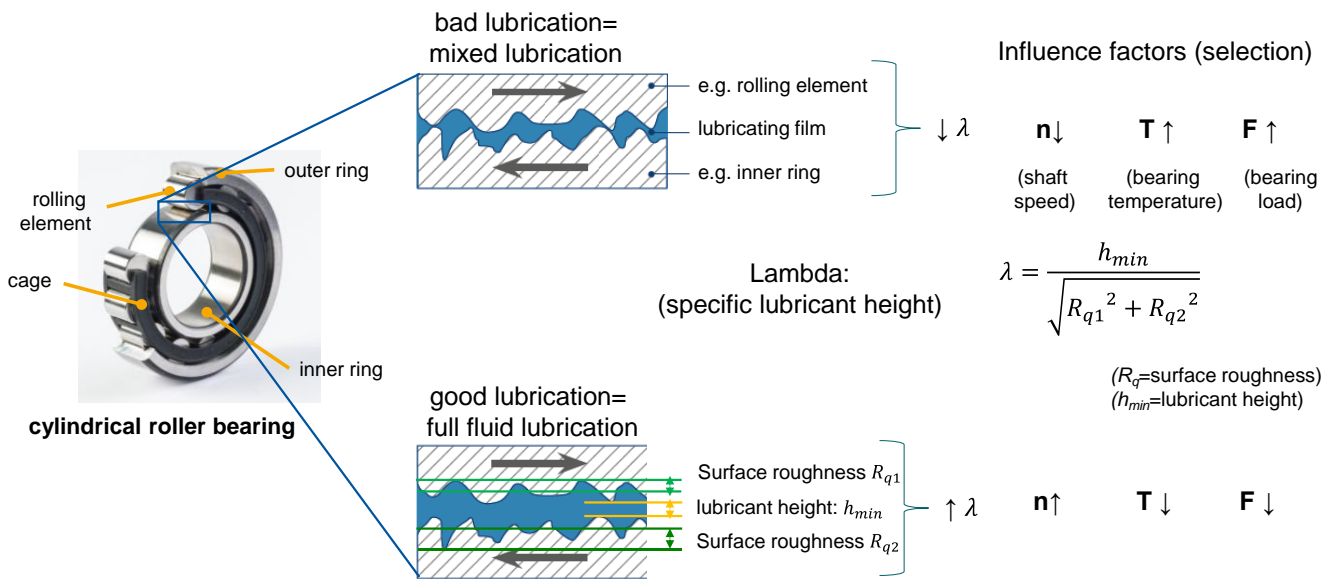
Generally speaking, the operating conditions of a bearing are depending on the load (F), the shaft speed (n), the resulting bearing temperature (T), the lubricant and the roughness of bearing components. In this work a lubricant ISO VG 100 was used. Furthermore, it was ensured that the roughness of the used bearings was between 0.03 and 0.08 μm. The aforementioned factors are used to calculate the specific lubricant film thickness lambda “λ”, which is used as a quantitative indicator of the lubricating conditions prevailing in the contact area. Values of λ ≥ 3 indicate full fluid lubrication conditions, values of λ ≤ 1 indicate boundary lubrication conditions while the range between is referred to as mixed lubrication regime (Czichos and Habig, 2015). An operation under full fluid lubrication is intended in general. For the calculation of lubricant film thickness, the reader is referred to the work of DOWSON and HIGGINSON (Dowson and Higginson, 1966). In the following Figure 6, the main influencing parameters are briefly highlighted.

Figure 6: Brief explanation of the lubrication state and the influence factors.

The above-mentioned failure modes (Micro-pitting, Smearing, White Etching Cracks) are among other things promoted by boundary and mixed lubrication conditions. Under full fluid lubrication conditions, the surfaces are completely separated, and the maximum stress shifts further below the surface, which is a prerequisite for typical rolling contact fatigue damage. Using

the influencing factors on the specific film thickness such as e.g. shaft speed, temperature and load, and specific lubricating conditions can be set on a test bench.

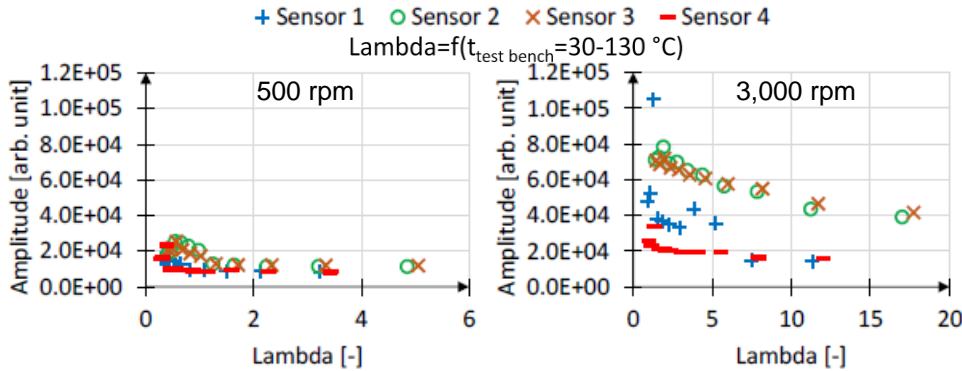
180 The following experiment regarding the Influence of the lubrication regime was part of a test series presented in previous work (Cornel, 2018). Due to the strong dependence of the specific lubricant film thickness on the oil temperature was used to adjust different lubrication conditions. To expand the parameter field two different shaft speeds, 500 and 3,000 rpm, were used. The investigations were carried out at a constant pressure of 2.0 GPa while the temperature itself was varied between 30 and 130 °C. Figure 7 shows the results of the experiments.

185 **Figure 7: Influence of the lubrication regime and the shaft speed on the AE Energy level.**

It can be observed that the amplitude of the AE signals increases as lambda decreases. This is especially noticeable in the areas around $\lambda = 0.5-2$. At 500 rpm (Figure 7 – Left) and $\lambda > 2$ the amplitude remains almost constant. The results meet the expectations that an increasing separation of the surfaces, defined by an increasing lambda, leads to decreased acoustic signals due to the missing interaction of roughness **asperities** within the contact. On the other hand, at 3,000 rpm (Figure 7- right) the effect the AE amplitude remaining constant can only be seen by the external sensors, 1 and 4, at λ -values > 5 . Sensor 2 and 3 still show a significant decrease of the amplitude with an increasing lambda. This could be explained as follows: The transfer path of the acoustic signals to the externally mounted sensors has two additional component transitions due to the test rigs design and is about 350 % longer compared to the internally mounted sensors. This consideration can lead to the fact that the signals become weaker and may no longer be detected. Regarding the significant decrease of the amplitude with an increasing lambda at 3,000 rpm, it is assumed that due to the significantly higher shaft speed, the whole system is excited (e.g. the vibration of test rig itself, increase of the bearing over rolling frequencies) much more and therefore resulting in an higher amplitude of the signals. Figure 8 arranges the results with the conducive conditions of the aforementioned failure modes. In conclusion it can be said, that for a known system or test bench the magnitude of the AE amplitude can be used to approximately

The investigations on the radial bearing test bench have shown that the magnitude of the AE amplitude can be used to roughly determine the rotation speed range of a known system. In addition, it is possible to distinguish between an operation under mixed friction and full fluid lubrication regime for the corresponding rotation speed. Therefore, this study offers a first analysis of the theoretical criticality of the prevailing conditions accompanied by an estimation of the expected failure mechanism.

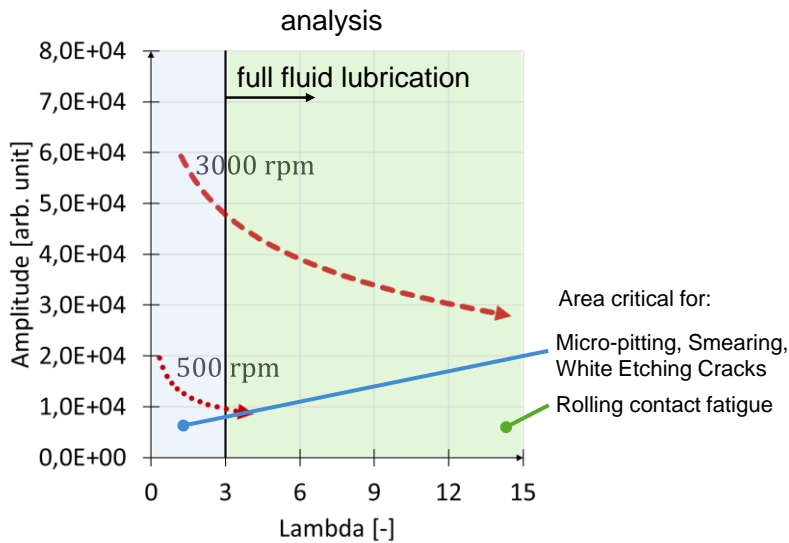
Figure 8: AE results arranged with the lubrication regimes.

In addition, it is possible to distinguish between mixed friction and full fluid lubrication for the corresponding speed level. Therefore it can be concluded, that a first analysis of the criticality of the prevailing conditions accompanied by an estimation of the expected failure mechanism could be carried out by using a CMS based on AE as long as the system is known from previous investigations or a measurement phase is implemented during the set up process.

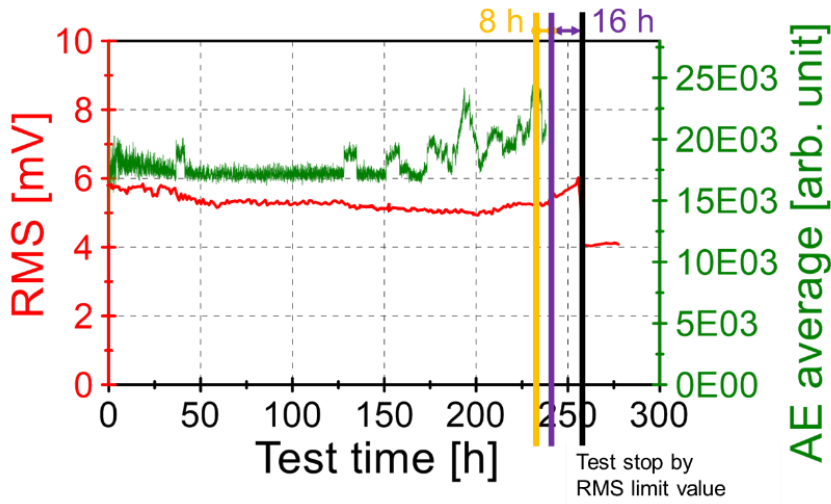
During testing and as aforementioned, the signal of a vibration sensor and an AE sensor were monitored continuously during testing. Figure 9 shows both averaged signals from one test over the total test time of ~261 h. The signal of the vibration sensor, shown as a red line, is plotted as root mean square (RMS) and therefore marked as RMS. In contrast the AE signal, plotted as green line, shows the amplitude average and is marked as AE average. The test was stopped after 261 h due to the vibration

signal exceeding the vibration threshold (20 % above the RMS value after run-in). Post-testing analysis confirmed a pitting damage as the source for the increased vibration.

225 **Figure 9: Comparison of vibration and AE signal over the test time.**

Regarding the signal behaviour, both show a decreasing tendency within the first 50 h. This tendency can be correlated with typical running-in processes (e.g. smoothing of the roughness peaks on the bearing surface). Subsequently, the vibration signal stays at an almost constant level before it rises significantly approx. 16 h before the threshold is exceeded. In contrast, the averaged AE signal shows the first indications of a deviation from its constant level after a test time of 125 h. These deviations increase significantly from about 150 h and 175 h onwards. Unfortunately, it should be noted that the last 16 hours of the AE signal are missing due to a recording error. In comparison with the vibration sensor, it can be concluded that significant activities of the AE system are visible at least 8 h before the vibration signal rises (referred to the latest peak of the AE signal before the test stop). It is assumed, that the latest AE signal activities together with the increased AE signal level in general can be traced back to the formation of the pitting or to the outbreak of the surface. The preceding activities are possibly caused by sub-surface damage initiation and propagation. These deviations were detected up to ~50 % (130 hours) before the test stop and are potentially related to sub-surface damage initiation and might result in an earlier damage detection in the future. In general, AE signals can be associated, on a model level (see Chapter 2), to damage pre-stages, such as crack initiation, crack-propagation or structural changes inside the bearing components. As described in Chapter 2, the correlation of the AE signals to specific phenomena is however still a research subject. As a basis for the future investigation of the topic, the signals should be examined for characteristic attributes and validated in further experiments.

250 The investigations regarding the damage detection using a thrust bearing test rig (FE8) have shown that a pitting damage could be detected by the AE system at least ~4 % (8 hours) in advance of the vibration based system. Furthermore, noticeable deviations in the AE signal were detected up to ~50 % (130 hours) before the test stop and are possibly associated with damage pre-stages, such as crack initiation, crack-propagation or structural changes inside the bearing components and might result in an earlier damage detection in future. Besides, it was found that the AE system and the vibration based system are capable to
255 detect the run-in period of a test run.
