Experimental Evaluation of Wind Turbine Wake Turbulence Impacts on a General Aviation Aircraft

Abstract. Continued development of wind farms near populated areas has led to rising concerns about the potential risk posed to general aviation aircraft when flying through wind turbine wakes. There is an absence of experimental flight test data available with which to assess this potential risk. This paper presents the results of an instrumented flight experiment in which a general aviation aircraft was flown through the wake of a utility-scale wind turbine at an operating wind farm. Wake passes were flown at different downwind distances from the turbine, and data was collected on the orientation disturbances, altitude and speed deviations, and acceleration loads experienced by the aircraft. Videos were also collected providing qualitative information about the disturbances encountered in the wake. Results show that flight disturbances were small in all cases, with no difference observed between flight data inside and outside the wake at distances greater than six rotor diameters from the turbine. Closer than six rotor diameters, small load factor and orientation disturbances were note

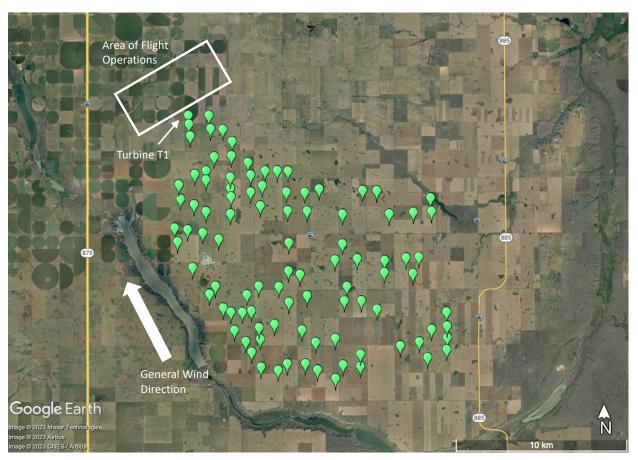
Figure 1: Whitla Wind Facility Turbine Locations and Area of Flight Operations. Turbine T1 (highlighted) is the northwestern-most turbine located at Whitla.

The turbine locations at Whitla are shown in Fig. 1. At the time selected for the test flights, the winds were generally blowing from the southeast. As a result, the turbine wakes were propagating northwest of the project area. The area selected for flight operations was downwind of the farthest turbine at the northwest corner of the project, turbine T1. The location of this turbine and the selected area of flight operations is shown in Figure 1.

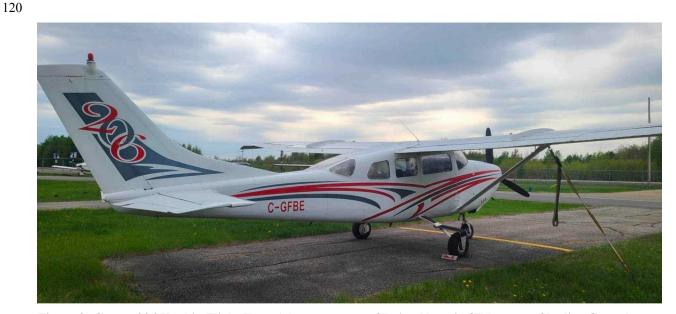
Figure 2: Cessna 206 Used in Flight Tests (photo courtesy of Raina Naomi of Edmonton Skydive Centre).

The aircraft used for the test flights was a Cessna 206 Stationaire owned and operated by Edmonton Skydive Centre. The aircraft used was a Cessna P206 (P stands for passenger model), registration number C-GFBE, S/N P206-044. A picture of the aircraft is shown in Fig. 2. This aircraft was selected as it is similar to other high-winged Cessna aircraft models such as the Cessna 172, Cessna 180, and Cessna 182 commonly flown out of small airports and airstrips in agricultural areas. The Cessna 206 has a nearly identical wing area to the Cessna 172 and 182, but can be operated at a higher maximum gross weight of 3,806 lbs (compared to 2,200 lbs for the Cessna 172 and 2,950 lbs for the Cessna 182). In order to maintain similarity to these smaller aircraft, the Cessna 206 used for the flight tests had all the interior components of the cabin removed and was operated at a gross weight of approximately 2,300 lbs during the wake passes. Note that gross weight and wing area are two of the most important drivers of the response of an airplane to turbulence according to US Air Force

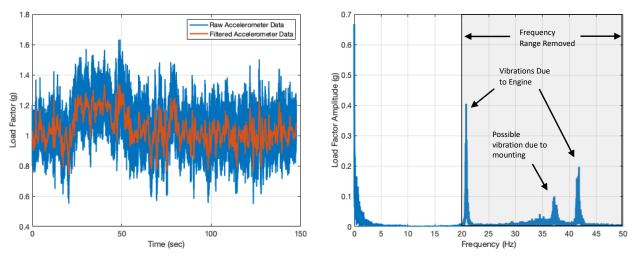
Figure 3: Example Raw and Filtered Accelerometer Data (left), Amplitude Spectrum of Raw Data and Areas of Band-stop Filtering (right).

An accelerometer that is rigidly mounted to the aircraft will measure loads across a wide frequency range. Generally, signal components at frequencies less than 10 Hz are due to turbulence and control inputs, while those at higher frequencies result from engine vibrations or excitation of aircraft structural modes (Mansfield and Aggarwal, 2022). Engine vibrations occur at the propeller rotation frequency (approximately 2500-2700 RPM for this flight) and its harmonics. Figure 3 shows raw vertical-axis accelerometer data for one of the wake passes along with the single-sided amplitude spectrum obtained from the Fourier transform of the data. Note the presence of a peak at the propeller rotation frequency around 42 Hz, and at a subharmonic around 21 Hz. A smaller peak around 37 Hz was also evident in some of the data, and could be due to vibration of the instrument panel on which the sensor was mounted or other aircraft structural vibrations. Note that the peaks at harmonics of the propeller rotation frequency at 21 Hz and 42 Hz match nearly exactly with similar accelerometer data from a piston-engine aircraft shown in Ilic et al. (2017). Because the purpose of this study is to isolate the loads caused by turbulence, a frequency-domain low-pass filter was applied to the accelerometer data to remove frequency components higher than 20 Hz as shown in Fig. 3 (right), resulting in the filtered accelerometer data shown in the orange trace in Fig. 3 (left). This filtered accelerometer data reflects the loads experienced due to turbulence and can be compared against the limit load factor to assess any potential for structural damage.

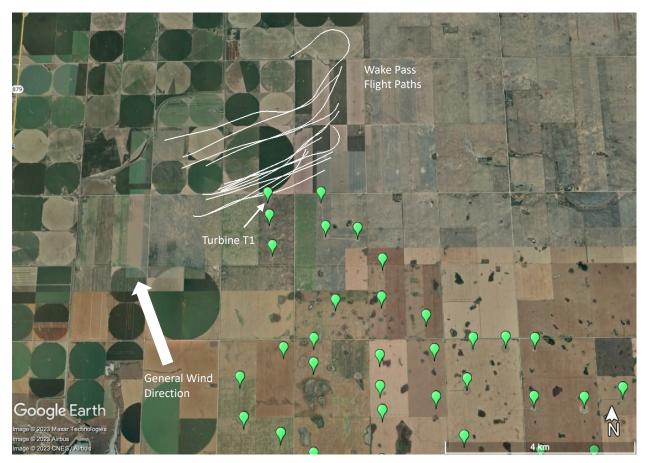
Figure 4: GPS Ground Tracks of Each Wake Pass.

A total of 13 wake passes were performed. Three aircraft speed and flap configurations were used: airspeed of 90 knots (kts) with 0 flaps, airspeed of 80 kts with 10 deg flaps, and airspeed of 75 kts with 10 deg flaps. These flight conditions are representative of departure, approach, or landing operations, which are the flight segments in which a general aviation aircraft is most likely to be flying at low altitude in the vicinity of a wind turbine near an airport. Each flight was flown at a different lateral distance from the turbine ranging from 1.6 RD to 15.6 RD. The flights were flown at altitudes of 45-122 m above the ground, with most flights flown at an altitude near the hub height of the turbine (105 m). Figure 4 shows the GPS ground tracks of the 13 wake passes. Table 4 shows the time, flight configuration, closest point of approach to the turbine, wind speed, wind direction, and turbine power output for each wake pass.

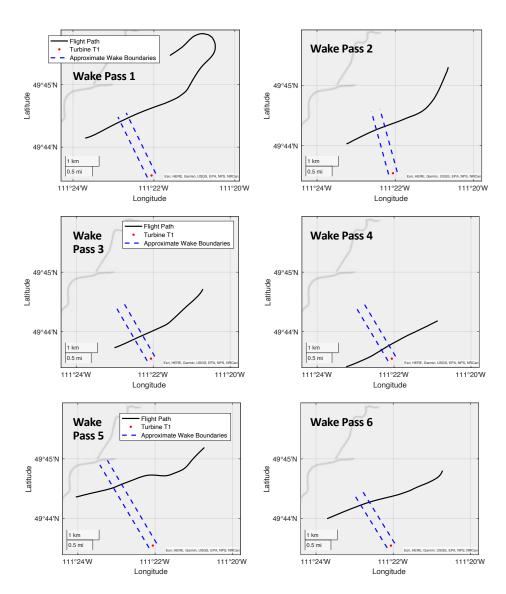
Figure 5: GPS Tracks for Wake Passes 1-6.

This section presents the sensor data recorded during each wake pass. Figures 5 and 6 show the GPS tracks for the wake 220 passes along with the approximate location of the wake. In these figures, the GPS tracks are shown with the black line, the turbine location is shown with the red dot, and the approximate wake boundaries are shown with the blue dashed line. The wake boundaries are approximated as a region that is 2 rotor diameters wide (272 m), directly downwind of the turbine. The wake boundaries shown for each wake pass are computed using the wind direction recorded during that wake pass by the turbine SCADA system. It is acknowledged that the wake does not always propagate directly downwind of the turbine due to effects such as wake meandering, and thus the wake boundaries shown are only approximate.

Several trends are evident in Figs. 5-12 and the figures in the Appendix. The GPS tracks show that the pilot flew nearly perpendicular to the wake in each pass, and Figs. 7-12 show that the aircraft was present in the wake region of T1, as estimated by the above procedure, for between 5-10 sec during each pass. In most wake passes, the level of pitch and roll disturbances, load factor magnitudes, and speed and bearing deviations are not noticeably higher inside the wake compared to outside. In some passes close to the turbine, such as wake pass 7 (Fig. 9), a small roll angle deviation of approximately 7.5 deg and an increase in the magnitude of load factor perturbations are noted inside the wake region. The severity of these disturbances will be compared against relevant benchmarks in a subsequent section.

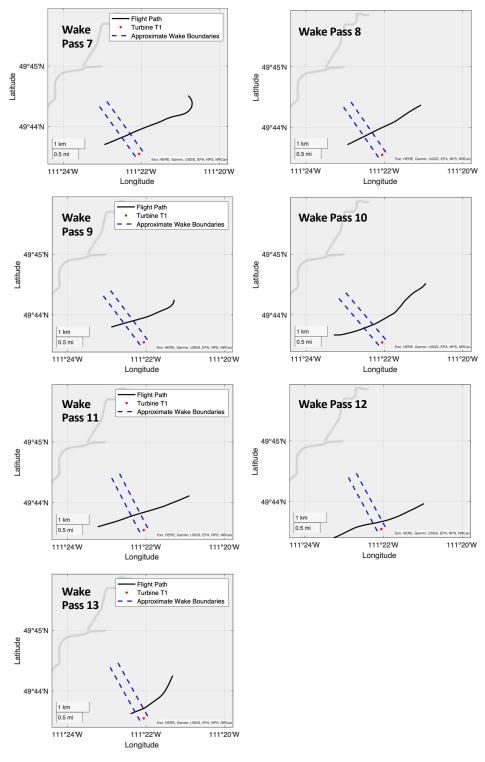
Figure 6: GPS Tracks for Wake Passes 7-13.

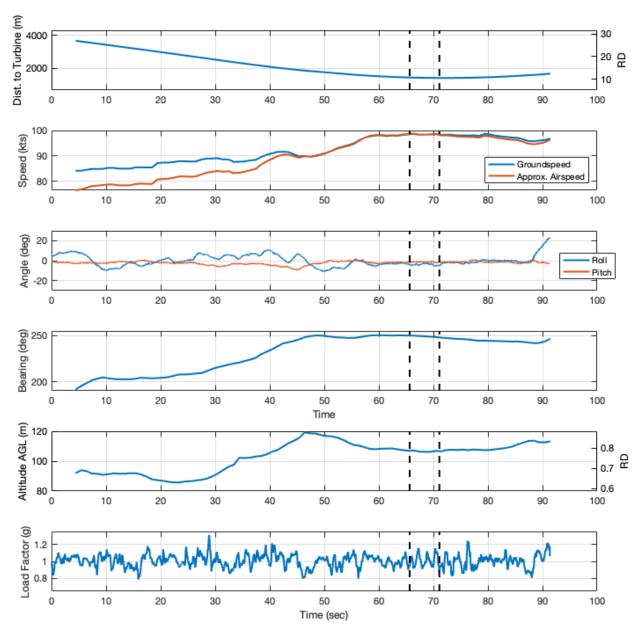
Figure 7: Sensor Data from Wake Pass 2 (closest distance of approach is 10.5 RD).

Figures 7-12 show time histories of distance to the turbine, groundspeed and estimated airspeed, roll and pitch angles, bearing angle, altitude above ground level (AGL), and load factor for wake passes 2, 6, 7, 9, 12, and 13. Flight data from these wake passes are shown to illustrate general trends; data from the remaining wake passes are shown in the Appendix. In the flight data plots, the black vertical dashed lines indicate the approximate times when the aircraft enters and exits the wake. These times are determined from the GPS timestamps recorded when the aircraft crosses the approximate wake boundaries shown in Figs. 5 and 6. Although a target airspeed of either 90 kts, 80 kts, or 75 kts was selected for each wake pass, it is difficult to maintain a target airspeed precisely when flying the aircraft due to normal disturbances and imprecision when controlling the aircraft. Thus, in the results below the airspeed and groundspeed deviate slightly from the selected speeds, both inside and outside the wake.

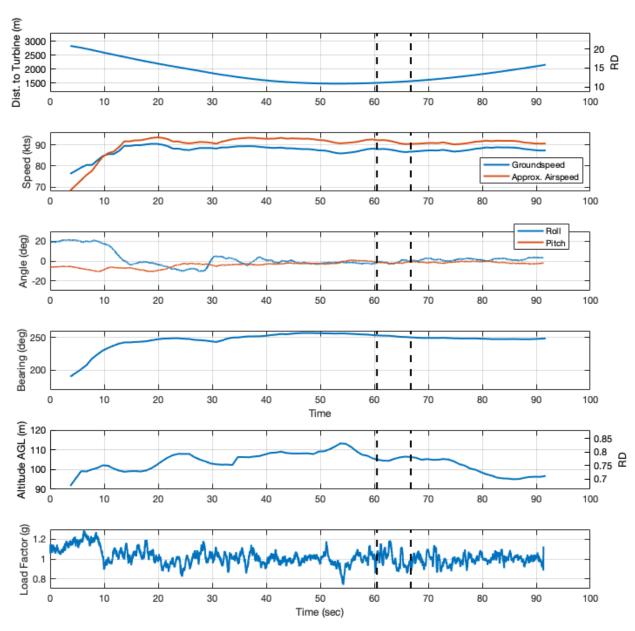
250 Figure 8: Sensor Data from Wake Pass 6 (closest distance of approach is 10.9 RD).

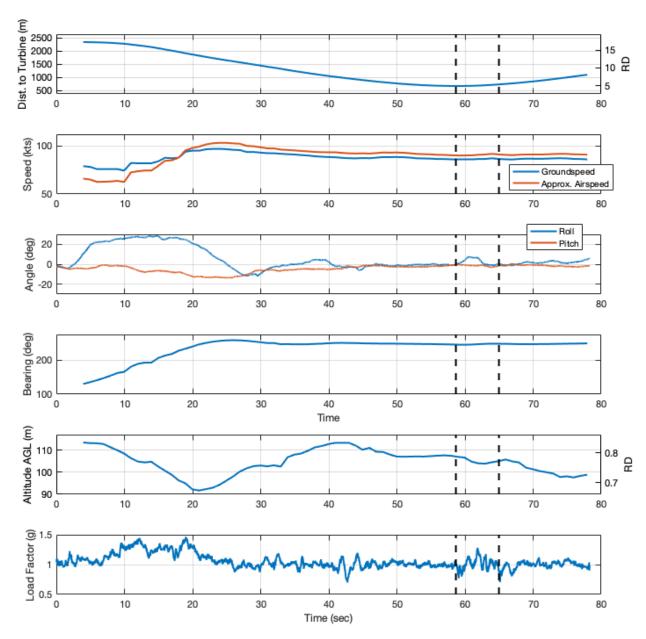
Figure 9: Sensor Data from Wake Pass 7 (closest distance of approach is 5.0 RD).

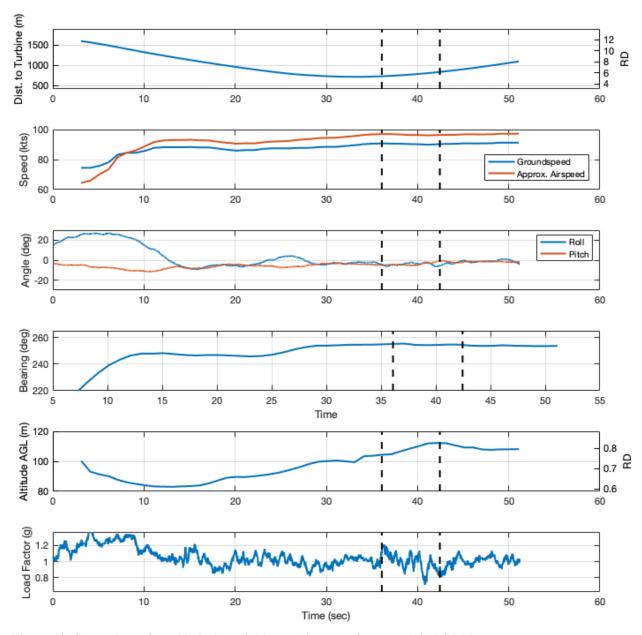
Figure 10: Sensor Data from Wake Pass 9 (closest distance of approach is 5.3 RD).

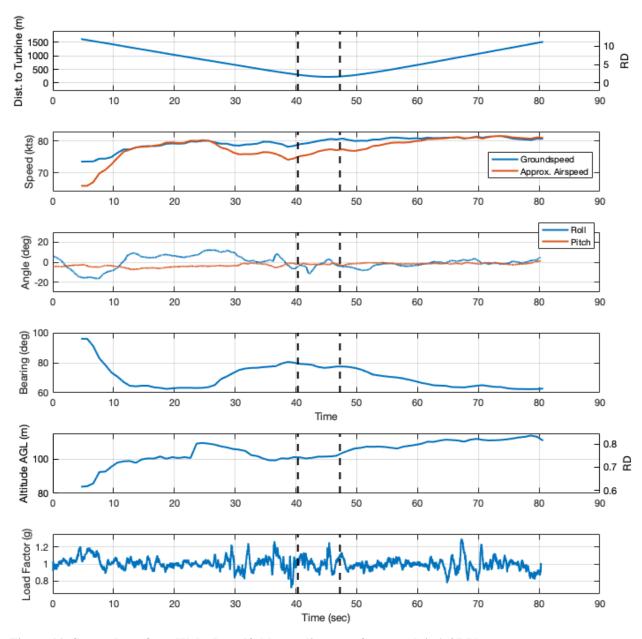
Figure 11: Sensor Data from Wake Pass 12 (closest distance of approach is 1.6 RD).

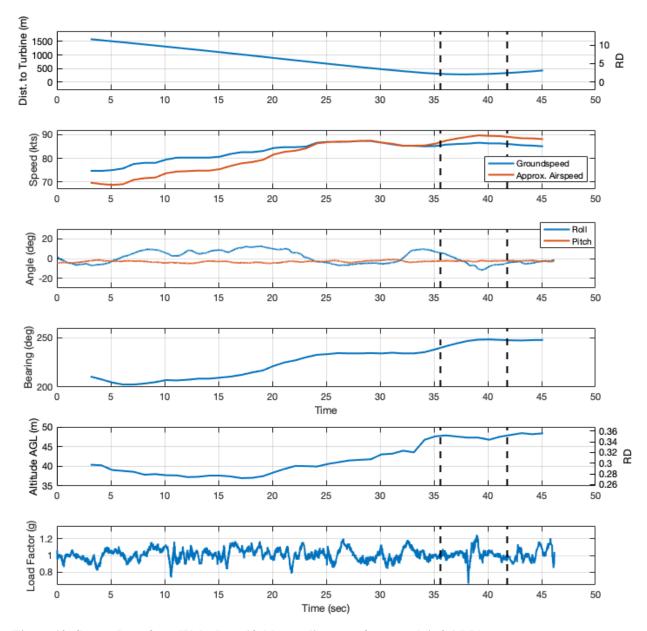
Figure 12: Sensor Data from Wake Pass 13 (closest distance of approach is 2.1 RD).

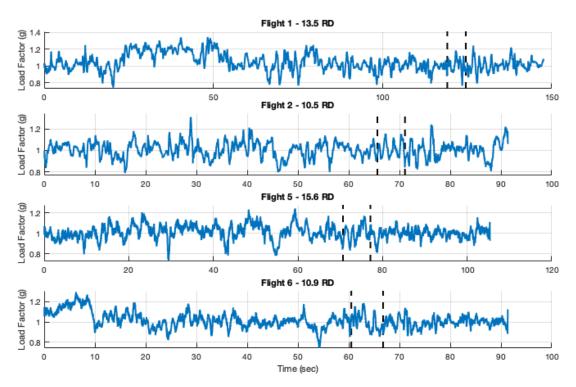
Figure 13: Load Factor vs Time for Wake Passes Farther than 6 RD. Load factors experienced inside the wake region in the dashed lines are indistinguishable from those experienced outside the wake region.

To explore this further, consider the load factor plots from the flight trials flown beyond 6 RD from Turbine T1 in Fig. 13, and the load factor plots from the trials flown closer than 6 RD in Fig. 14. Examining Fig. 13 first, which covers wake passes 1, 2, 5, and 6, it is evident that the load factor perturbations inside the dashed lines are of similar magnitude to those experienced throughout the remainder of the trial, outside the wake. Next, examining Fig. 14, there is still no large difference between the load factor perturbations experienced inside the wake region and outside the wake region. However, in some (but not all) of the wake passes in Fig. 14, the maximum or minimum load factors experienced during the trials occurred in or near the predicted wake region (either inside or near the dashed line region). This occurs in wake passes 4, 7, 9, 11, 12, and 13, but not in wake passes 3, 8, and 10. For instance, in wake pass 9, the load factor reaches its lowest point of about 0.71 g inside the wake region. However, this is only 0.1 g lower than the minimum load factor that occurs outside the wake region in level flight, and is still extremely far from the limit load factor of -1.52 g. Likewise, in wake pass 11, the load factor reaches a minimum value of 0.57 g near the end of the wake region. This is only about 0.1 g less than the 0.68 g disturbance experienced earlier in the flight outside the wake of T1.

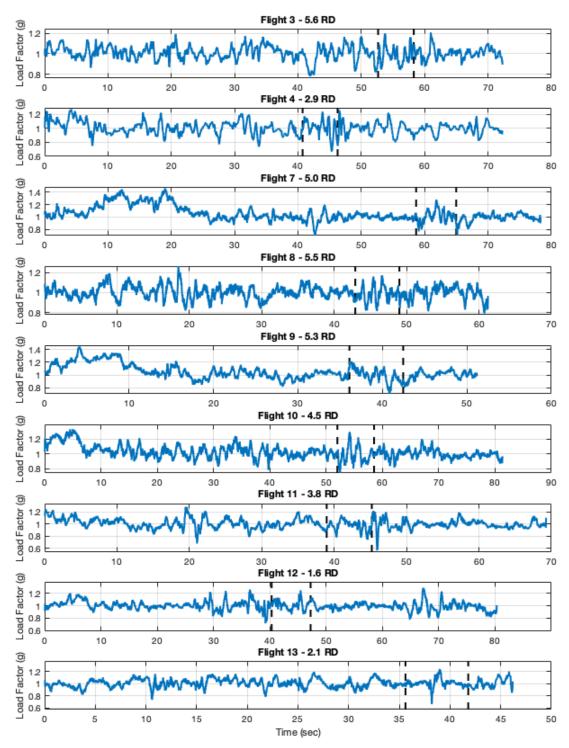
Figure 14: Load Factor vs Time for Wake Passes Closer than 6 RD. Slight increases in load factor magnitudes when inside the wake are evident in wake passes 4, 7, 9, 11, 12, and 13, but not in wake passes 3, 8, and 10.

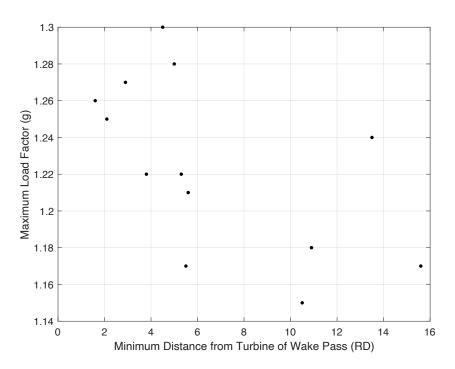
400 Figure 15: Maximum Load Factor vs Minimum Aircraft-Turbine Distance.

Another way to view this data is in terms of the maximum and minimum load factors experienced during each trial, as a function of the closest distance of approach of each wake pass. This data is shown in Figs. 15 and 16. Although there is

some scatter in the data, both figures show noticeable trends that larger load factor disturbances (both maximum and minimum) are experienced as the aircraft flies closer to the turbine, with maximum load factors reaching 1.25-1.30 g and minimum load factors reaching 0.5-0.75 g within 4 RD of the turbine.

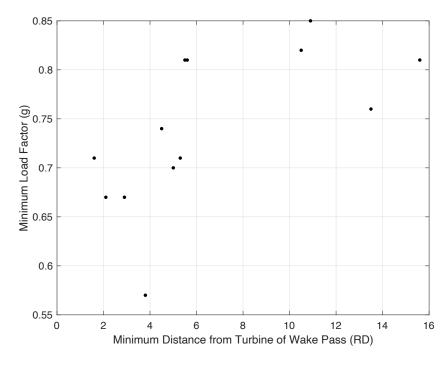
Figure 16: Minimum Load Factor vs Minimum Aircraft-Turbine Distance.

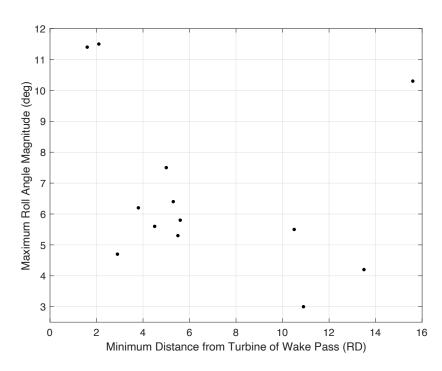
Figure 17: Maximum Roll Angle Magnitude vs Minimum Aircraft-Turbine Distance.

Turning to orientation disturbances, Table 5 shows the maximum roll and pitch magnitudes recorded inside the wake during each wake pass. As shown in Table 5, the maximum roll and pitch angles experienced were bounded by +/-11.5 deg in roll and +/-5.3 deg in pitch. Figures 17 and 18 show the maximum roll angle and pitch angle magnitudes versus the minimum aircraft-turbine separation distance for all wake passes. Except for the outlier in wake pass 5, there is a clear trend in the results that flying closer to the turbine results in larger maximum roll and pitch angle deviations.

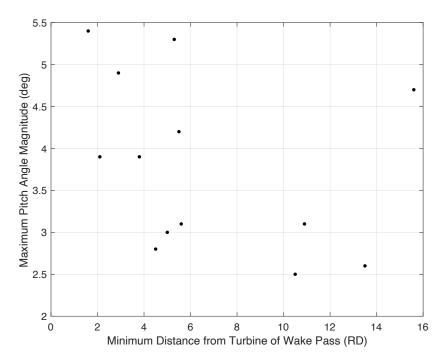
Figure 18: Maximum Pitch Angle Magnitude vs Minimum Aircraft-Turbine Distance.

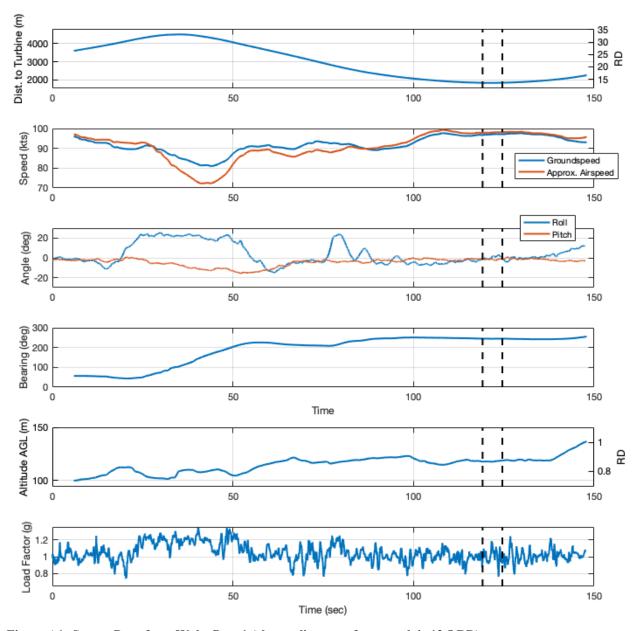
Figure A1: Sensor Data from Wake Pass 1 (closest distance of approach is 13.5 RD).

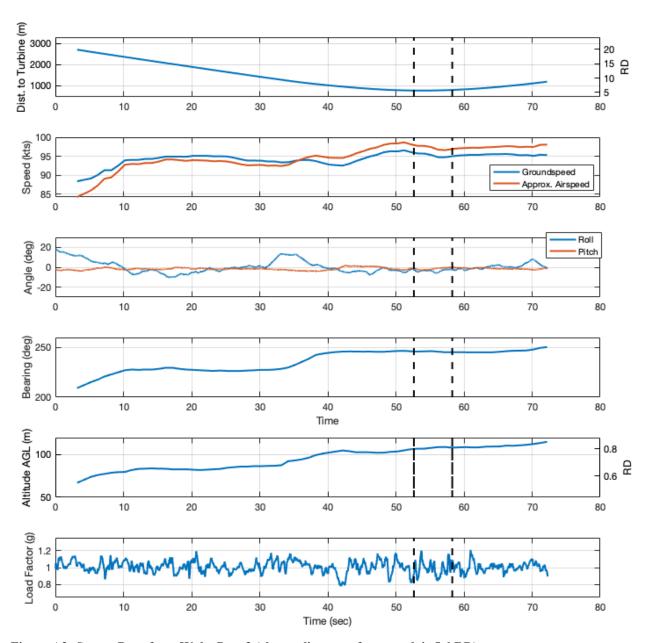
Figure A2: Sensor Data from Wake Pass 3 (closest distance of approach is 5.6 RD).

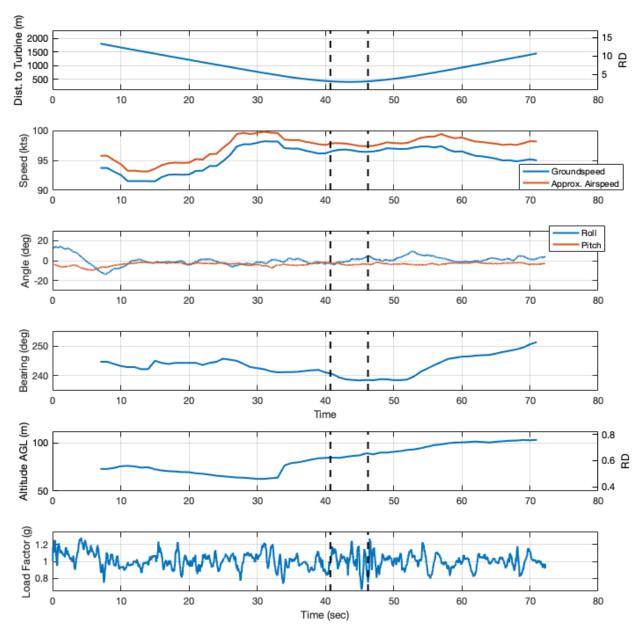
525 Figure A3: Sensor Data from Wake Pass 4 (closest distance of approach is 2.9 RD).

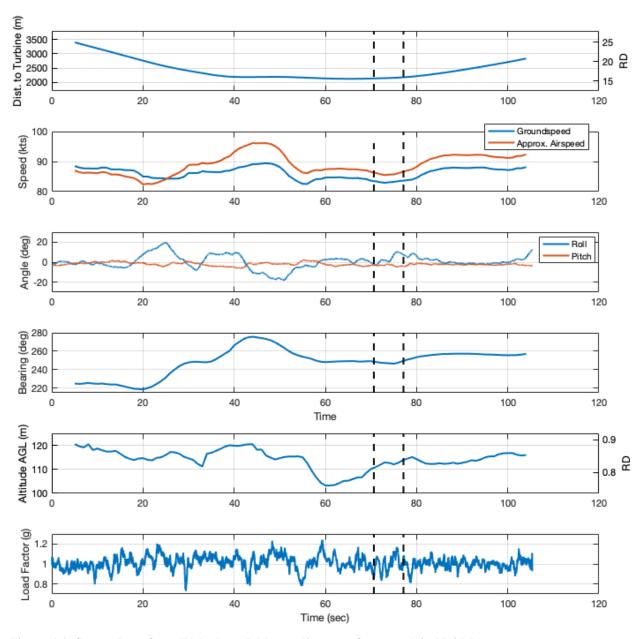
Figure A4: Sensor Data from Wake Pass 5 (closest distance of approach is 15.6 RD).

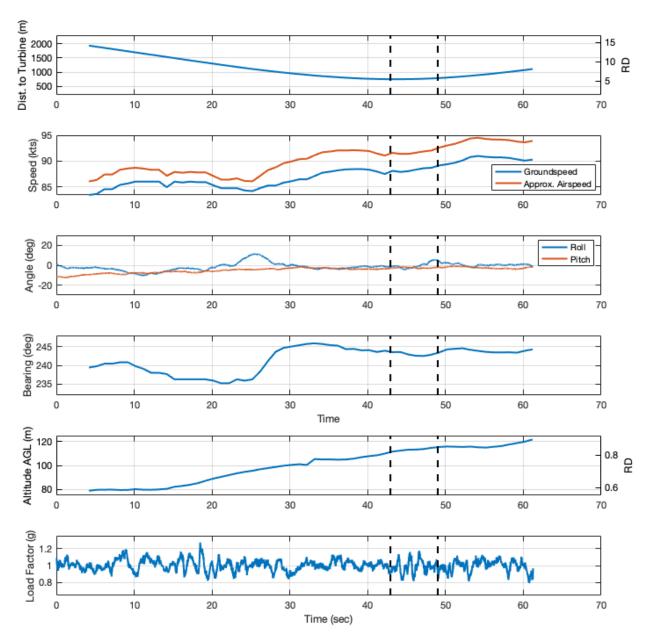
Figure A5: Sensor Data from Wake Pass 8 (closest distance of approach is 5.5 RD).

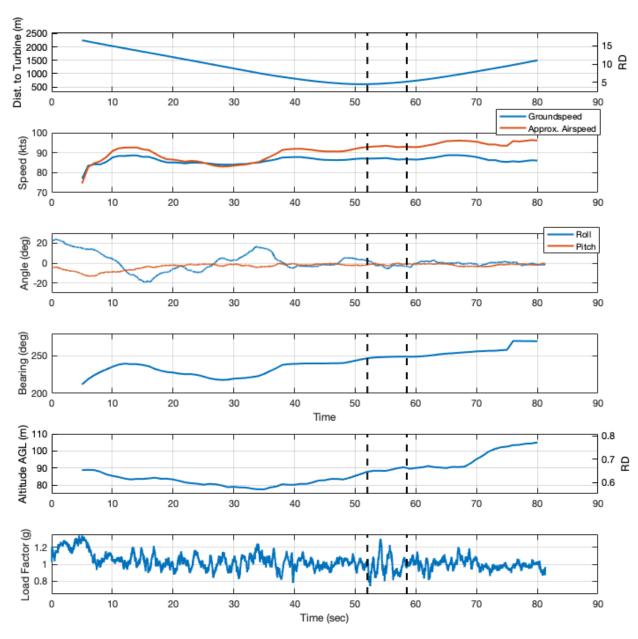
Figure A6: Sensor Data from Wake Pass 10 (closest distance of approach is 4.5 RD).

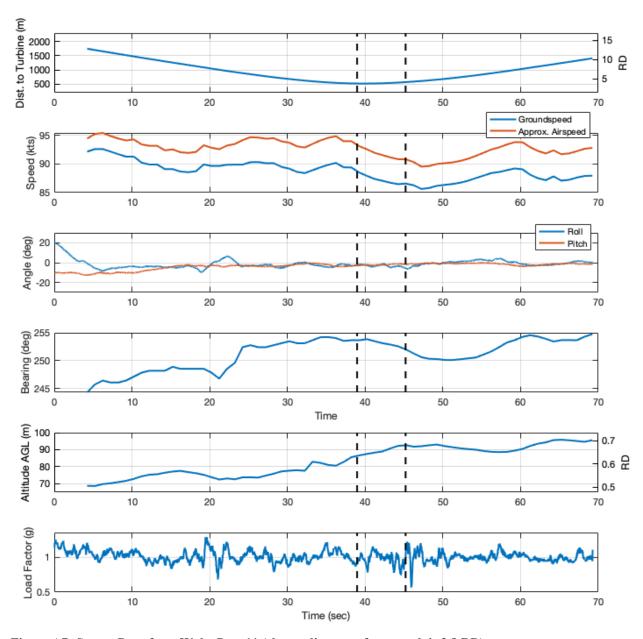
Figure A7: Sensor Data from Wake Pass 11 (closest distance of approach is 3.8 RD).
