Wind Turbine Gearbox Operation Monitoring Using High-Resolution Distributed Fiber Optic Sensing

Abstract. Efficient gearbox monitoring is vital for improving fault detection, enhancing design, and reducing operation and maintenance (O&M) costs, particularly for offshore wind turbines. This paper introduces an innovative approach using high-resolution Distributed Fiber Optic Sensing (DFOS) based on Optical Frequency Domain Reflectometry (OFDR) to measure gearbox strain in real time. By bonding a single optical fiber around the full circumference of ~~a-the outer surface of a~~ 2.152 m diameter ~~ring gear of the first~~ planetary stage in a 3.75 MW wind turbine gearbox, we captured millimeter-scale distributed strain profiles of ~~the ring gear from~~ planetary gears ~~passage~~ under different input torque levels. Our results show accurate identification of planet gear locations in real time and rotation speed (10.42 revolutions per minute) and a strong linear correlation between applied torque and measured strain across all monitored locations ($R^2 = 0.9997$), with data collected every 2.6 mm. Strain variations of approximately 200 microstrain were observed ~~on the ring gear ex

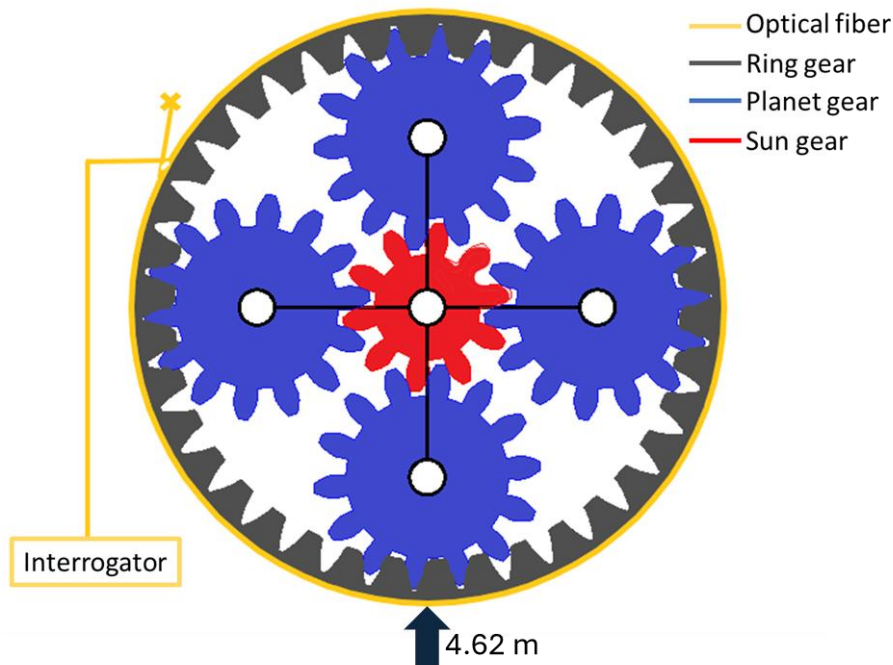
Figure 14. The planetary gear stage and the optical fiber attached to the outer surface of the gearbox. The black arrow indicates the location at the bottom of the gearbox used for strain profile demonstration. The point at 4.62 m refers to the distance from the starting point of the optical fiber attachment on the gearbox.

Temperature changes were evident in the strain data, as shown in Figure 4 , which depicts the response at a single location (bottom of the gearbox in Figure 1 or 4.62 m in Figure 3). Before 9:15 am, the strain exhibited a downward drift of approximately 30 microstrain, corresponding to a cooling effect of about 3°C from the gearbox's overnight test. After 9:15 am, strain rose by approximately 150 microstrain, equivalent to a 15°C temperature increase, caused by heat generated during operation. The maximum drift rate occurred between 9:19 and 9:41 am, coinciding with the transition from idle to maximum speed. Temperature effects were removed using a 0.01 Hz high-pass filter to isolate dynamic strain variations from slower thermal processes. The filtered data, shown in Figure 5 and Figure 6, highlights the strain behavior under varying loads.

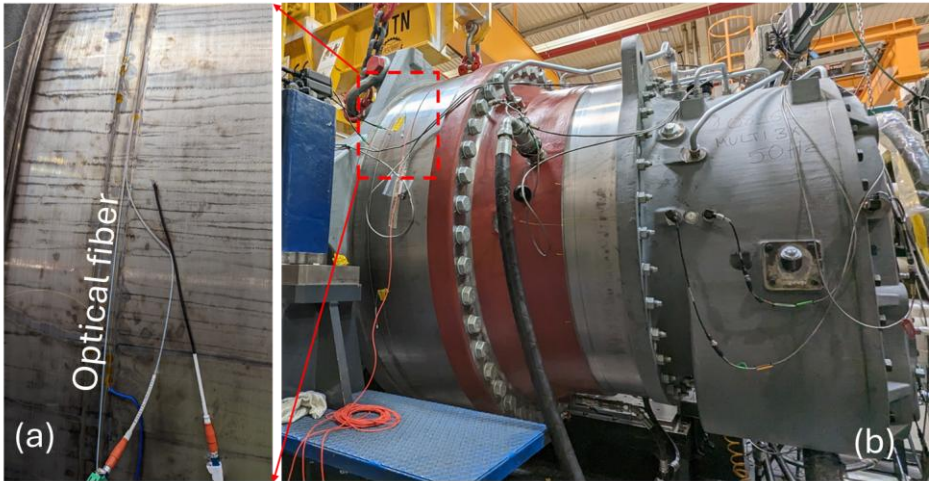
155 **Figure 22** Photo of the installed optical fibers, one for strain and one for temperature, attached to the outer surface of the gearbox. (a) A close look of the installed optical fibers. (b) The full size of the gearbox.

130 A 175 μm polyimide-coated single-mode optical fiber was attached to the outer surface of the ring gear in the first planetary stage ([Figure 2Figure 2](#)). The fiber was bonded using Loctite EA 3423 epoxy, providing strong adhesion while remaining removable. This approach allowed the fiber to be detached after testing, as the gearbox was a production model intended for operational deployment. The fiber was connected via an extension cable to the OFDR interrogator, located outside the testing area. The system was used to measure strain and temperature changes during the loading test, with specific setup parameters detailed in Table 1.

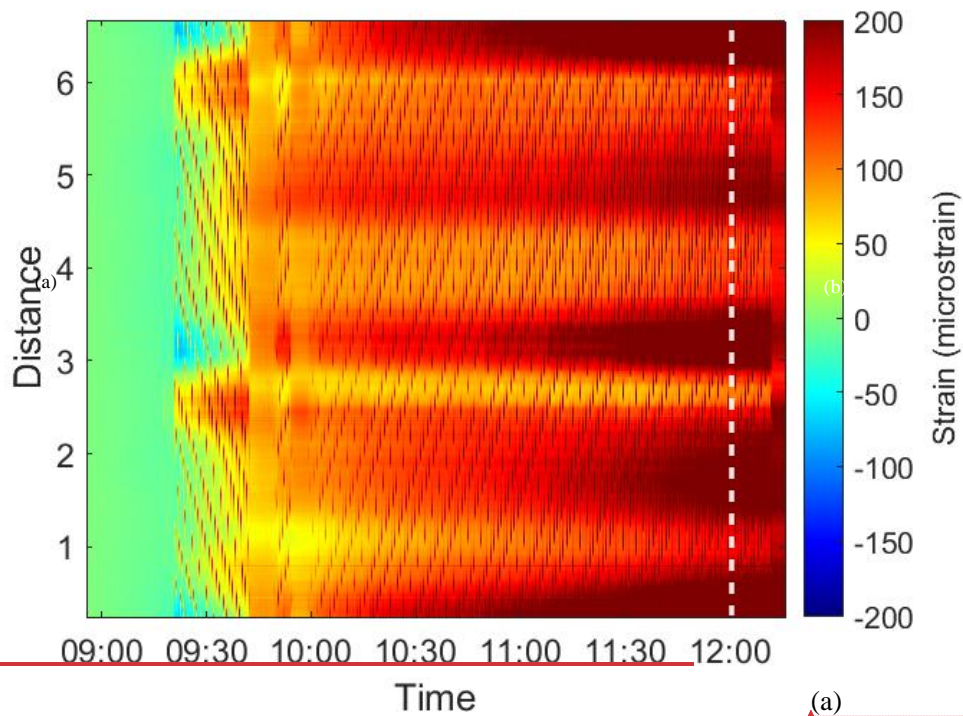
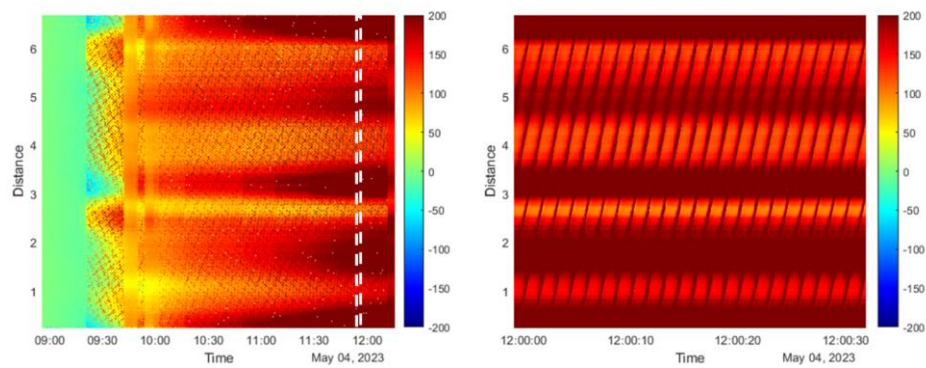
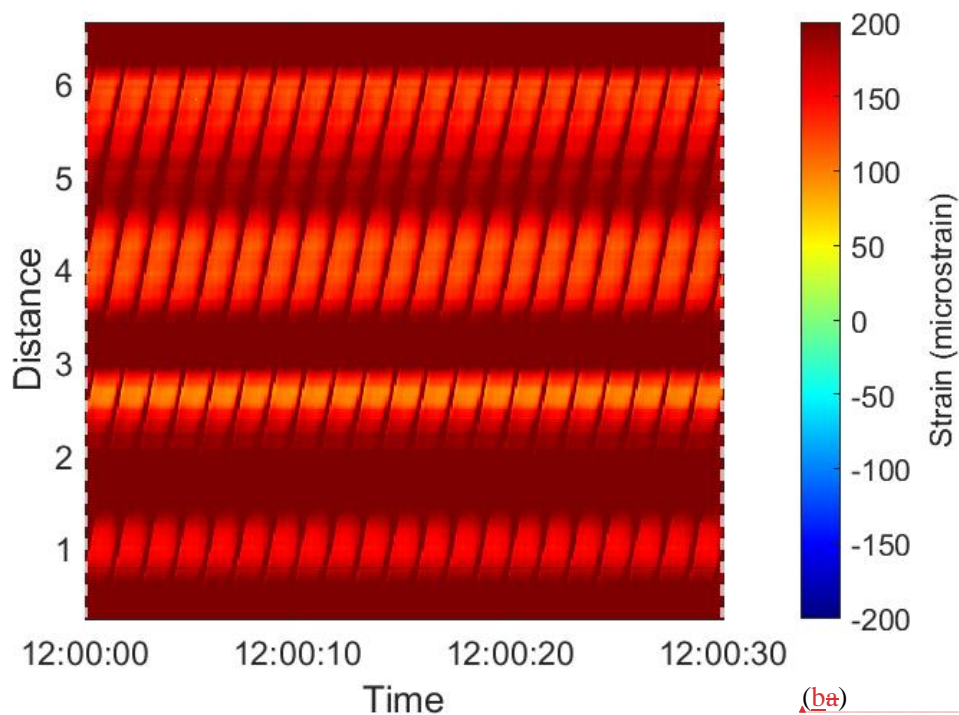
Figure 33. Waterfall representation of the strain profile over time for the circumference of the ring rear. The vertical axis denotes distance in meters, while the color gradient indicates strain in micro-strain. (a) Strain profile throughout the entire test period. (b) A magnified view of the strain profile corresponding to the region outlined by the white dashed square in the left panel.

160 The raw strain data collected during the test are shown in ~~Figure 3~~Figure 3a, where red indicates tensile strain and blue represents compression. The diagonal banding pattern corresponds to gear rotation, with rotation direction changes visible in the shifting patterns between 9:19 to 9:41 (clockwise) and 9:48 to 12:12 (counterclockwise). ~~Figure 3~~Figure 3b provides a detailed view of a 30-second interval outlined by white dashed lines in Fig.3a, revealing the distinct locations of the four planet gears as they rotate along the circumference of the ring gear.

As the test progressed, a shift toward darker red regions indicated increasing strain, which was attributed to rising temperatures from frictional heat generation between the gears. The strain distribution and rotational behavior of the gears could be clearly tracked throughout the test. As the test progressed, a shift toward darker red regions indicated an increase in measured strain. However, since this strain was derived directly from the frequency shift, it still reflected a combination of both temperature and mechanical effects. The darker red horizontal strips were attributed to rising temperatures caused by frictional heat generated between the gears, while the diagonal strips were linked to the mechanical strain from the meshing of the rotational gears. Overall, the strain distribution and rotational behavior of the gears were clearly tracked throughout the test.

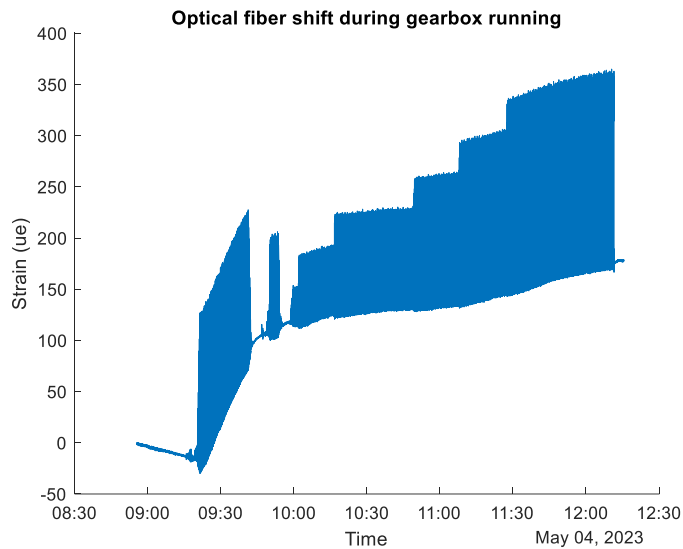
Figure 44 The strain response at a random selected location (4.62m or close to the bottom of the gearbox) during the loading test.

Temperature changes were also shown in the strain data, as shown in Figure 4, which illustrates the response at a single location (bottom of the gearbox in Figure 1 or 4.62 m in Figure 3). Before 9:15 am, the strain exhibited a downward drift of approximately 30 microstrain. This is due to the gearbox having run overnight and it was stopped for this test and the drops indicating a cooling effect of about 3 °C. After 9:15 am, the measured strain, which includes mechanical strain and thermal, drifted by approximately 150 microstrain at 12:15, equivalent to a 15 °C temperature increase, caused by heat generated during operation. The maximum drift rate occurred between 9:19 and 9:41 am, coinciding with the transition from idle to maximum speed.

Because this test focuses on mechanical strains and the thermal effect due to friction was assumed to be a slow effect on the measured data, the slow drift temperature change shall be removed from the overall measured strain. The large drift can be removed by high-pass filter to isolate dynamic strain variations from slower thermal processes. In this research, a 0.01 Hz (100 seconds period) was applied to the measured strain. Although the temperature was not completely removed, due to the small fraction of thermal change generated in 100 seconds, the thermal induced drift became negligible, as shown in Figure 5 and Figure 6, highlights the strain behavior under varying loads.

Although temperature effects were filtered out in this analysis to focus on strain behavior, the system's capability to measure temperature concurrently should not be overlooked. As shown in Fig. 4, DFOS captured a potential 3-degree cooling when the gearbox stopped rotating and 15-degree heating during gearbox operation at the bottom of the gearbox. If localized overheating occurs, such as from internal damage or inadequate lubrication, the system can detect and pinpoint these anomalies, preventing potential thermal runaway and costly damage. This adds an additional dimension to gearbox condition monitoring.

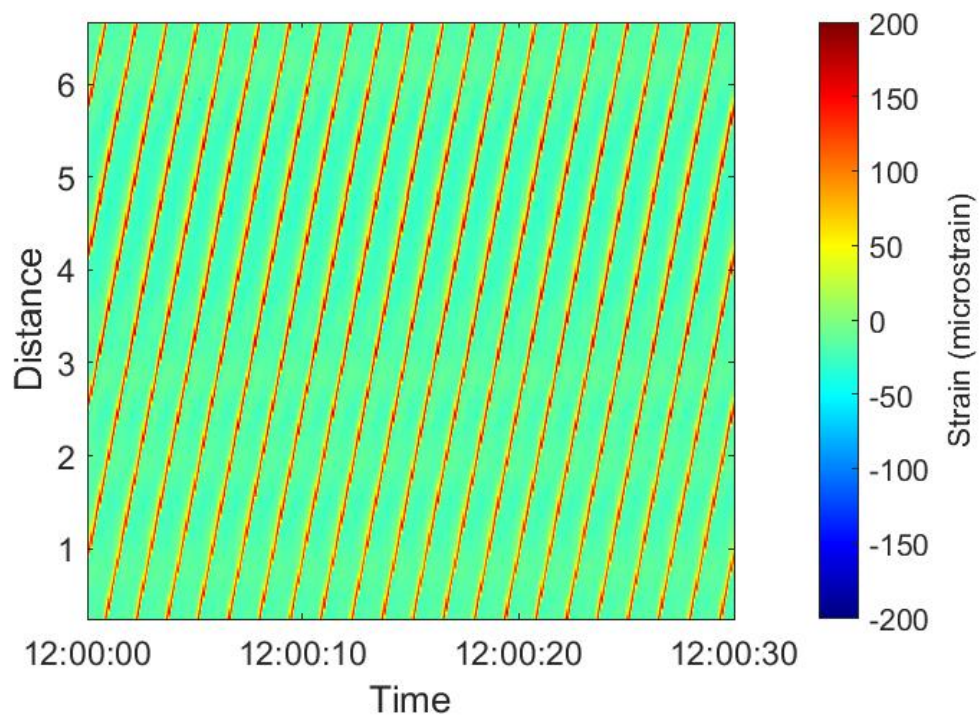
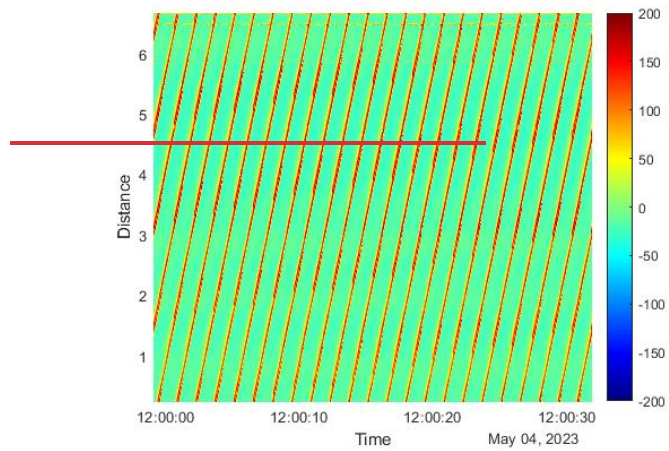
Figure 55. The waterfall of the strain response during the load test after 0.01 Hz high pass filter in period of 30 seconds when the load is at 100% torque, time domain shows strain profile collected with 12.5 Hz.

The strain profile during the maximum load test (Figure 5Figure-5) reveals repeated tensile spikes forming a diagonal pattern, indicating the rotation of the four planet gears. At each timestamp, four red bands (tensile strain) correspond to the locations where planet gears contact the ring gear. These are separated by mild blue bands (compressive strain) where there is no direct gear contact.

After 9:48 am, both tensile and compressive strain intensities increased as the torque rose from 17% to 100%. Each tooth on the ring gear exhibited cyclic strain patterns, reflecting the load distribution during gear engagement. The strain width across approximately five teeth suggests contributions from the helix angle of the gear teeth and partial strain transfer before and after full contact. At the bottom of the gearbox (4.62 m), strain values increased from 33 microstrain at 17% torque to 161 microstrain at 100% torque (Figure 6Figure-6). These measurements demonstrate how DFOS captures detailed strain variations, even at the level of individual gear teeth.

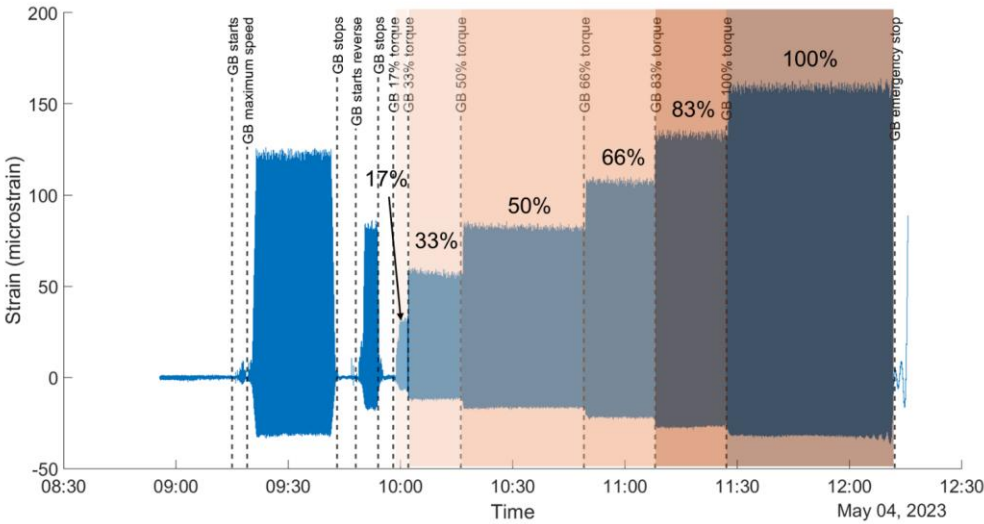
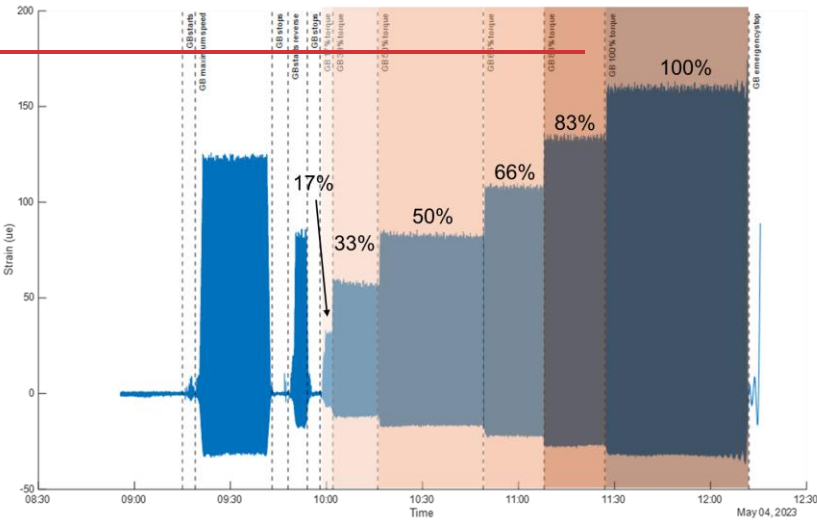
Figure 66 The strain response after 0.01 Hz high pass at location 4.62m (one tooth's strain response). The dash line shows the timing of each loading event listed in table 2. The color background shows the percentage of the rated torque input from 17% to 100%. GB represents gearbox.

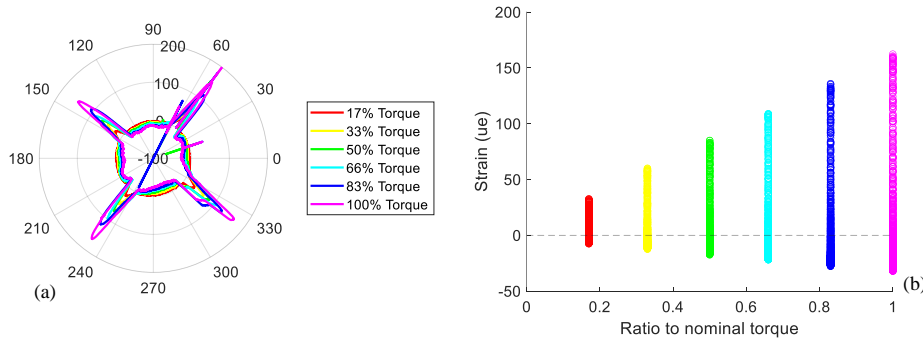
Figure 77 (a) The strain profile in polar axis when different loads are applied to the gearbox and (b) the scatter plot show the clusters of all the collected strain at one location on the ring gears during the load test with different load input.

Examples of strain profiles at various torque levels are shown in Figure 7Figure-7a, plotted on a polar axis to illustrate the gearbox's real-time response. The four prominent strain spikes correspond to the locations of the planet gears, with these spikes rotating as the gears move. This polar axis plot can be generated in real time for each strain profile measurement, clearly displaying the positions of the planet gears and the strain values they produce. The sharp spikes observed at fixed locations (e.g., 18.7° and 63°) exhibit reading errors and constant values, likely due to poor bonding of the optical fiber to the ring gear. A supplemental video illustrating the dynamic rotation of the planet gears and associated strain spikes is in the supplemental documents (Luo and Wu, 2024).

As the gears rotate, six strain profiles corresponding to different torque inputs are presented, with the time frames selected to align with consistent gear-tooth engagement. At higher torque levels, tensile strain increases at points where the planet gears contact the ring gear, while compressive strain intensifies in areas between gear contacts. This behavior is more clearly depicted in Figure 7Figure-7b, which shows strain values recorded at a specific tooth location (4.62 m). The data includes strain measurements as the gear meshes with and disengages from the tooth, highlighting the cyclic strain variations under different torque conditions.

Despite its advantages mentioned above, the current DFOS system also have limitations. Some minor data artifacts were observed, such as sharp spikes at fixed locations (e.g., 18.7° and 63° in Figure 7a). These irregularities are likely caused by micro-bending of the optical fiber during installation or the application of epoxy. Refining installation techniques and applying advanced post-processing methods, such as outlier fitting, could mitigate these issues in future applications.

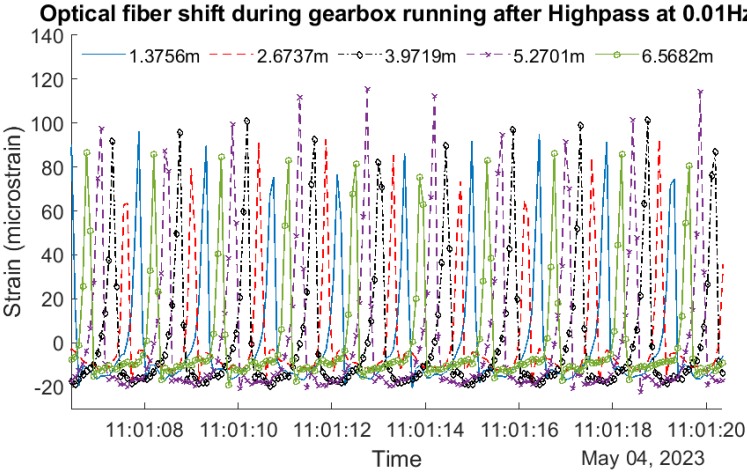
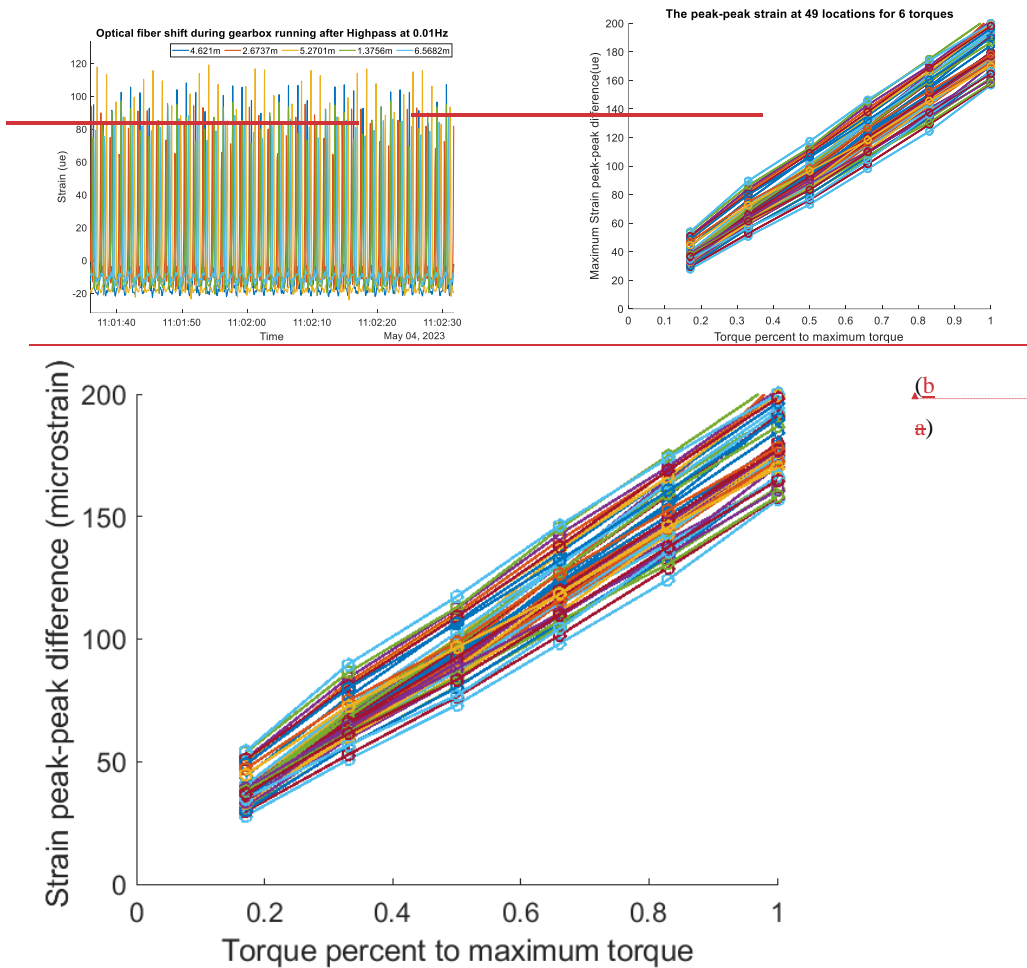
(a)
(b)

Figure 88 (a) An example of collected strain at 5 location locations with time and (b) the peak-peak strain at 49 locations on the ring gear for 6 torque load inputs.

The strain variation at five specific teeth is illustrated in Figure 8Figure-8a. Each distinct spike corresponds to the arrival and departure of a planet gear during its rotation cycle. The time interval between consecutive spikes is measured at 1.44 seconds, indicating a full rotation duration of 5.76 seconds for the first stage. This translates to a rotational speed of 10.42 revolutions per minute (rpm). Additionally, a periodic signal comprising six spikes over 8.64 seconds is observed at all measured locations. This pattern likely reflects periodic fluctuations in the input torque from the back-to-back gearbox system used during testing.

To analyze the relationship between strain and torque, the peak-to-peak strain was calculated for each measurement location. The peak-to-peak strain, defined as the difference between maximum tensile and maximum compressive strain, captures the full range of strain variation at a given tooth. This metric was computed for 49 evenly spaced locations along the ring gear circumference to assess the strain response under varying torque levels. The results revealed a linear relationship between torque and peak-to-peak strain, as illustrated in [Figure 8](#)~~Figure 8b~~. The average linear relationship is shown in Eq. 3. This linear correlation was exceptionally strong, with a high coefficient of determination ($R^2=0.9997$).
