# Wind Turbine Gearbox Operation Monitoring Using High-Resolution Distributed Fiber Optic Sensing

**Abstract.** Efficient gearbox monitoring is vital for improving fault detection, enhancing design, and reducing operation and maintenance (O&M) costs, particularly for offshore wind turbines. This paper introduces an innovative approach using high-resolution Distributed Fiber Optic Sensing (DFOS) based on Optical Frequency Domain Reflectometry (OFDR) to measure gearbox strain in real time. By bonding a single optical fiber around the full circumference of the outer surface of a 2.152 m diameter ring gear of the first planetary stage in a 3.75 MW wind turbine gearbox, we captured millimeter-scale distributed strain profiles of the ring gear from planetary gears passage under different input torque levels. Our results show accurate identification of planet gear locations in real time and rotation speed (10.42 revolutions per minute) and a strong linear correlation between applied torque and measured strain across all monitored locations ( $R^2 = 0.9997$ ), with data collected every 2.6 mm. Strain variations of approximately 200 microstrain were observed on the ring gear exterior from

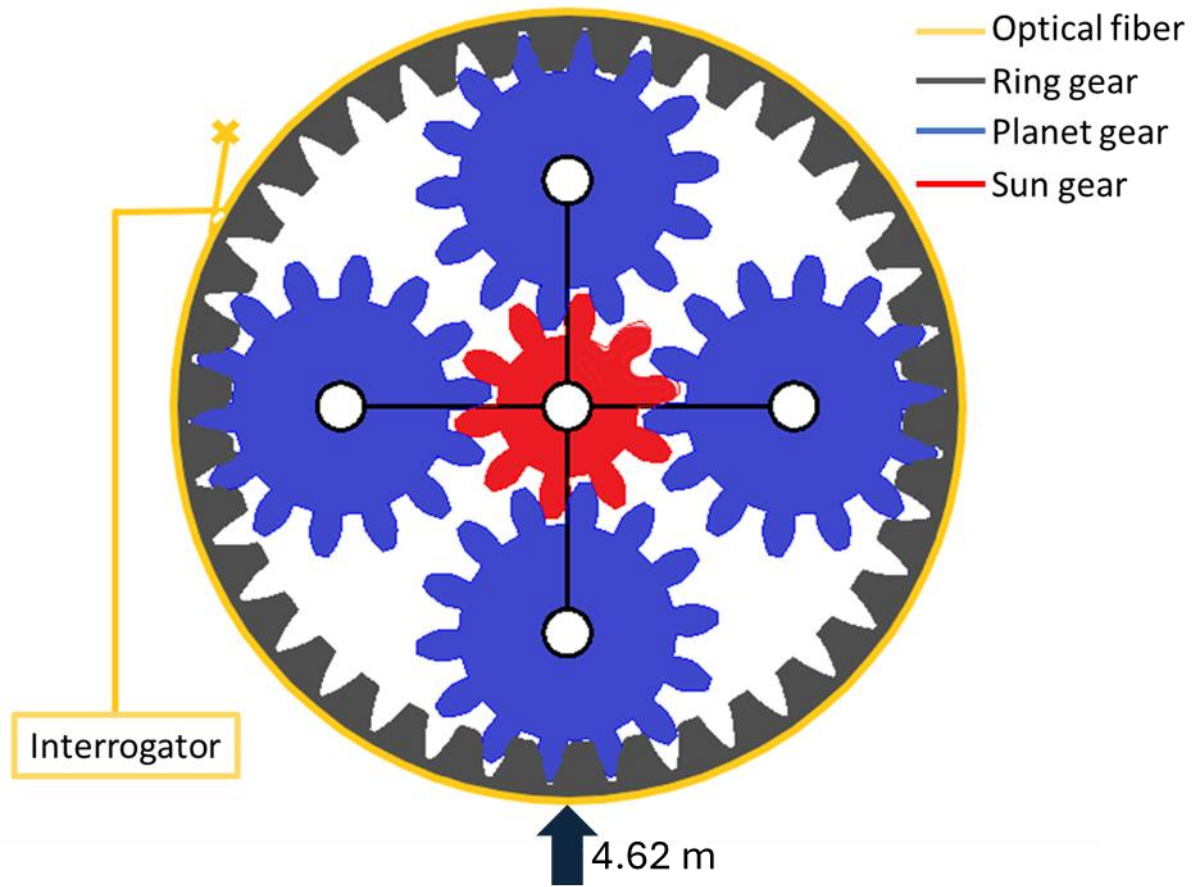
Figure 1 The planetary gear stage and the optical fiber attached to the outer surface of the gearbox. The black arrow indicates the location at the bottom of the gearbox used for strain profile demonstration. The point at 4.62 m refers to the distance from the starting point of the optical fiber attachment on the gearbox.

This study focuses on epicyclic planetary stages with stationary ring gears. In these stages, the input shaft is connected to the planet carrier, which houses planet shafts that rotate with the carrier. The planet gears mesh simultaneously with the stationary ring gear and the central sun gear, increasing velocity between the input carrier and the sun, as shown in Fig. 1. The gear mesh forces between the planets and the ring gear are proportional to the input torque. Due to the relatively thin structure of the ring gear, notable deformations could occur on its outer surface, where an optical fiber is installed for monitoring. By measuring strain on the ring gear, torque and potential abnormalities in gearbox operation can be effectively tracked.

Temperature changes were also shown in the strain data, as shown in Figure 4, which illustrates the response at a single location (bottom of the gearbox in Figure 1 or 4.62 m in Figure 3). Before 9:15 am, the strain exhibited a downward drift of

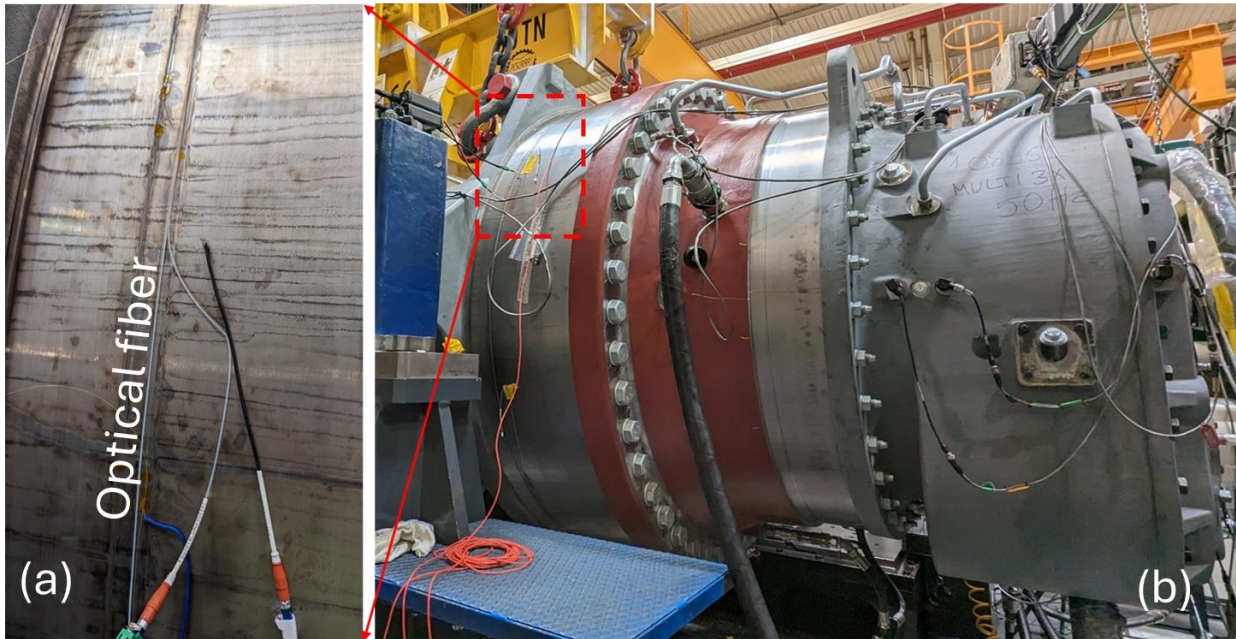
**Figure 2** Photo of the installed optical fibers, one for strain and one for temperature, attached to the outer surface of the gearbox. (a) A close look of the installed optical fibers. (b) The full size of the gearbox.

A 175  $\mu\text{m}$  polyimide-coated single-mode optical fiber was attached to the outer surface of the ring gear in the first planetary stage (Figure 2). The fiber was bonded using Loctite EA 3423 epoxy, providing strong adhesion while remaining removable. This approach allowed the fiber to be detached after testing, as the gearbox was a production model intended for operational deployment. The fiber was connected via an extension cable to the OFDR interrogator, located outside the testing area. The system was used to measure strain and temperature changes during the loading test, with specific setup parameters detailed in Table 1.

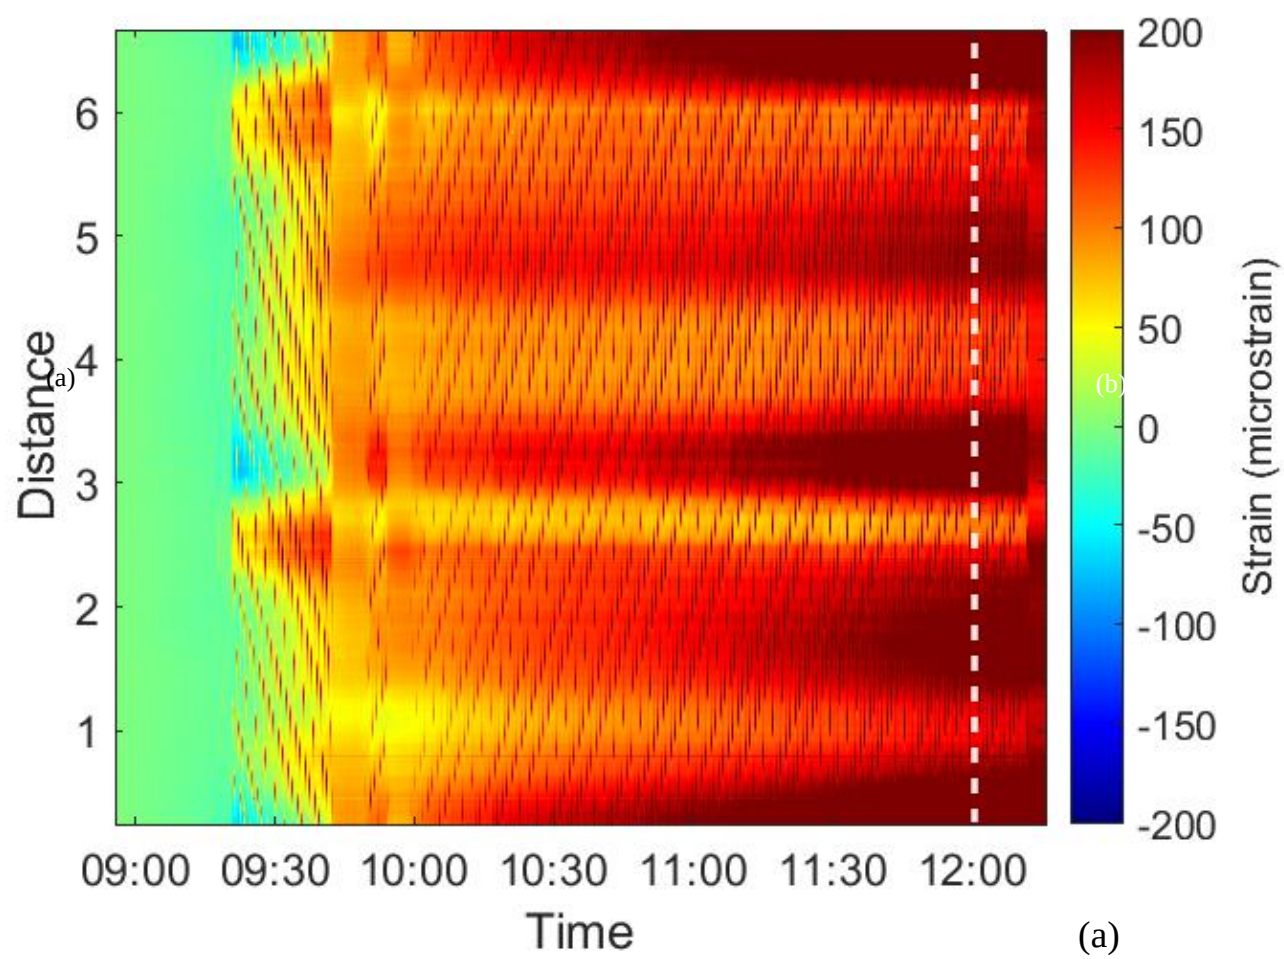
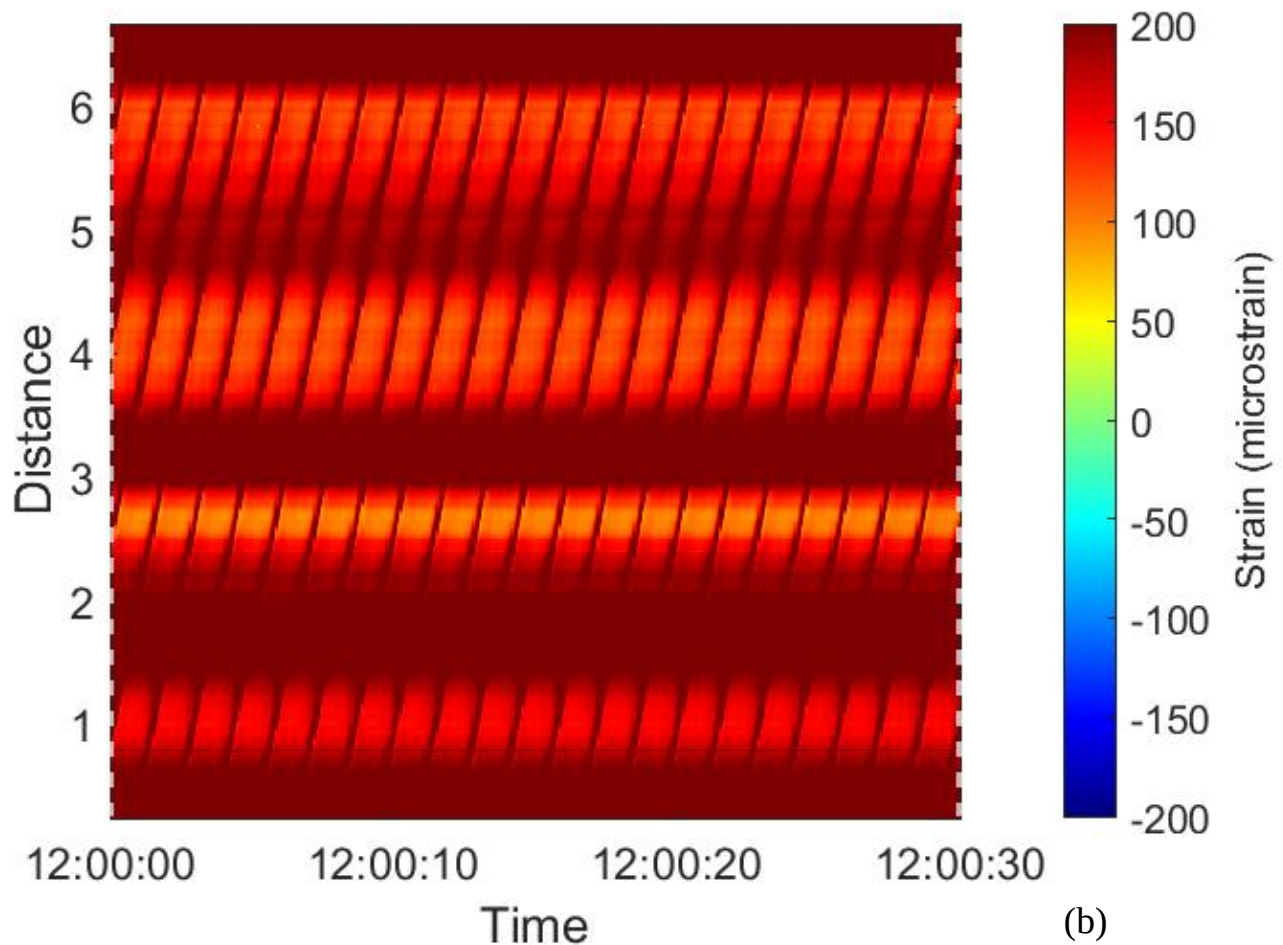
**Figure 3 Waterfall representation of the strain profile over time for the circumference of the ring rear. The vertical axis denotes distance in meters, while the color gradient indicates strain in micro-strain. (a) Strain profile throughout the entire test period. (b) A magnified view of the strain profile corresponding to the region outlined by the white dashed square in the left panel.**

The raw strain data collected during the test are shown in Figure 3a, where red indicates tensile strain and blue represents compression. The diagonal banding pattern corresponds to gear rotation, with rotation direction changes visible in the shifting patterns between 9:19 to 9:41 (clockwise) and 9:48 to 12:12 (counterclockwise). Figure 3b provides a detailed view of a 30-second interval outlined by white dashed lines in Fig.3a, revealing the distinct locations of the four planet gears as they rotate along the circumference of the ring gear.

As the test progressed, a shift toward darker red regions indicated an increase in measured strain. However, since this strain was derived directly from the frequency shift, it still reflected a combination of both temperature and mechanical effects. The darker red horizontal strips were attributed to rising temperatures caused by frictional heat generated between the gears, while the diagonal strips were linked to the mechanical strain from the meshing of the rotational gears. Overall, the strain distribution and rotational behavior of the gears were clearly tracked throughout the test.

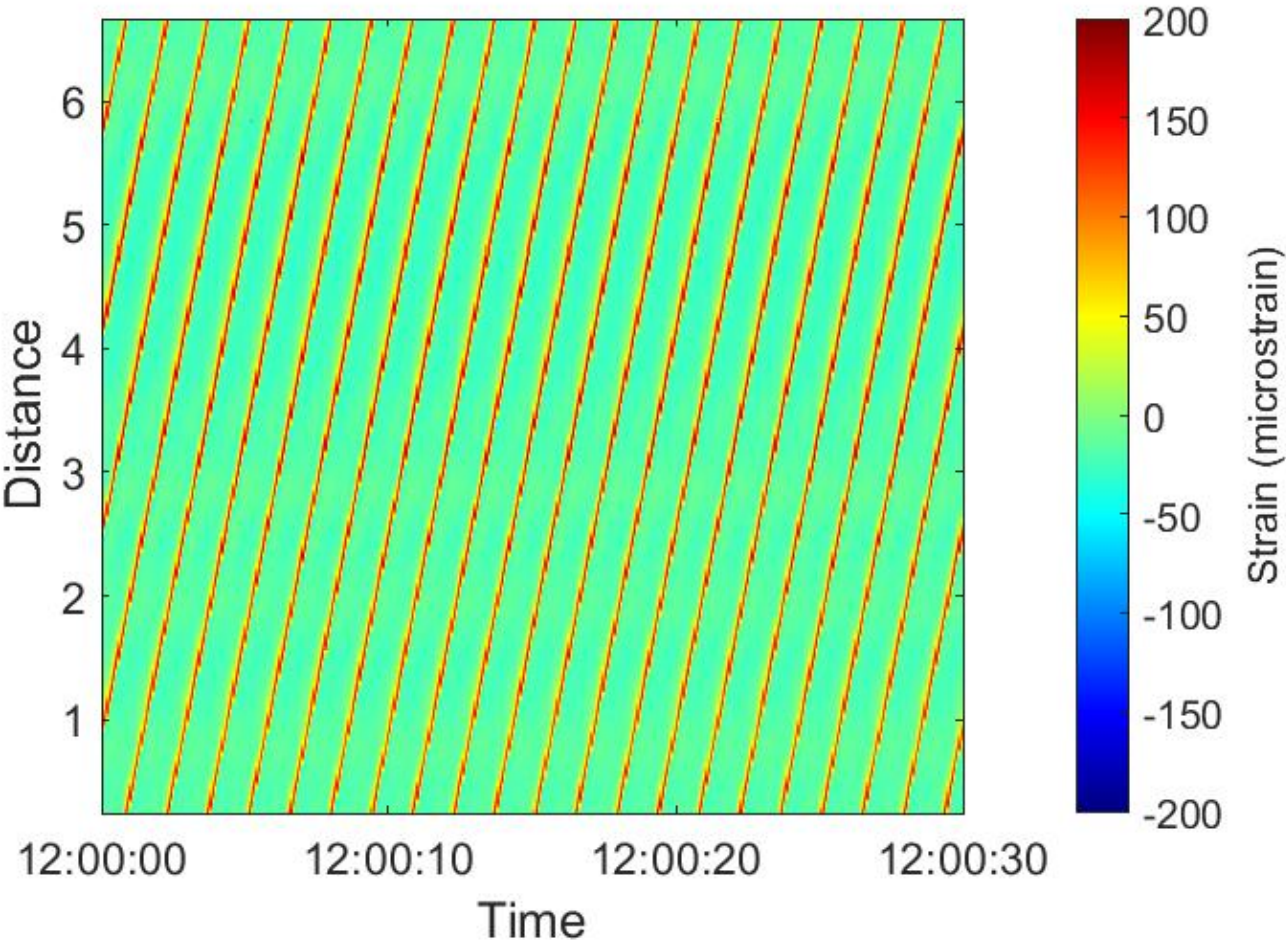
**Figure 5** The waterfall of the strain response during the load test after 0.01 Hz high pass filter in period of 30 seconds when the load is at 100% torque, time domain shows strain profile collected with 12.5 Hz.

190 The strain profile during the maximum load test (Figure 5) reveals repeated tensile spikes forming a diagonal pattern, indicating the rotation of the four planet gears. At each timestamp, four red bands (tensile strain) correspond to the locations

where planet gears contact the ring gear. These are separated by mild blue bands (compressive strain) where there is no direct gear contact.

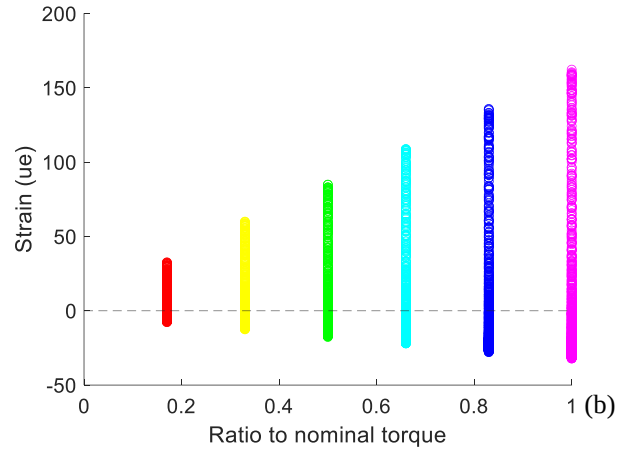
**Figure 7 (a) The strain profile in polar axis when different loads are applied to the gearbox and (b) the scatter plot show the clusters of all the collected strain at one location on the ring gears during the load test with different load input.**

Examples of strain profiles at various torque levels are shown in Figure 7a, plotted on a polar axis to illustrate the gearbox's real-time response. The four prominent strain spikes correspond to the locations of the planet gears, with these spikes rotating as the gears move. This polar axis plot can be generated in real time for each strain profile measurement, clearly displaying the positions of the planet gears and the strain values they produce. The sharp spikes observed at fixed locations (e.g., 18.7° and 63°) exhibit reading errors and constant values, likely due to poor bonding of the optical fiber to the ring gear. A supplemental video illustrating the dynamic rotation of the planet gears and associated strain spikes is in the supplemental documents (Luo and Wu, 2024).

As the gears rotate, six strain profiles corresponding to different torque inputs are presented, with the time frames selected to align with consistent gear-tooth engagement. At higher torque levels, tensile strain increases at points where the planet gears contact the ring gear, while compressive strain intensifies in areas between gear contacts. This behavior is more clearly depicted in Figure 7b, which shows strain values recorded at a specific tooth location (4.62 m). The data includes strain measurements as the gear meshes with and disengages from the tooth, highlighting the cyclic strain variations under different torque conditions.

Despite its advantages mentioned above, the current DFOS system also have limitations. Some minor data artifacts were observed, such as sharp spikes at fixed locations (e.g., 18.7° and 63° in Figure 7a). These irregularities are likely caused by micro-bending of the optical fiber during installation or the application of epoxy. Refining installation techniques and applying advanced post-processing methods, such as outlier fitting, could mitigate these issues in future applications.
