Wind Turbine Gearbox Operation Monitoring Using High-Resolution Distributed Fiber Optic Sensing

Abstract. Efficient gearbox monitoring is vital for improving fault detection, enhancing design, and reducing operation and maintenance (O&M) costs, particularly for offshore wind turbines. This paper introduces an innovative approach using high-resolution Distributed Fiber Optic Sensing (DFOS) based on Optical Frequency Domain Reflectometry (OFDR) to measure gearbox strain in real time. By bonding a single optical fiber around the full circumference of the outer surface of a 2.152 m diameter ring gear of the first planetary stage in a 3.75 MW wind turbine gearbox, we measured circumferential strain from planetary gear passage every 2.6 mm around the ring gear under different input torque levels. Our results show accurate identification of planet gear locations in real time and rotation speed (10.42 revolutions per minute), with a strong linear correlation ($R^2 = 0.9997$) between applied torque and measured strain across all 2,500 measured locations. Strain variations of approximately 200 microstrain were observed on the ring gear exterior from each (planet passage or planet-ring gear

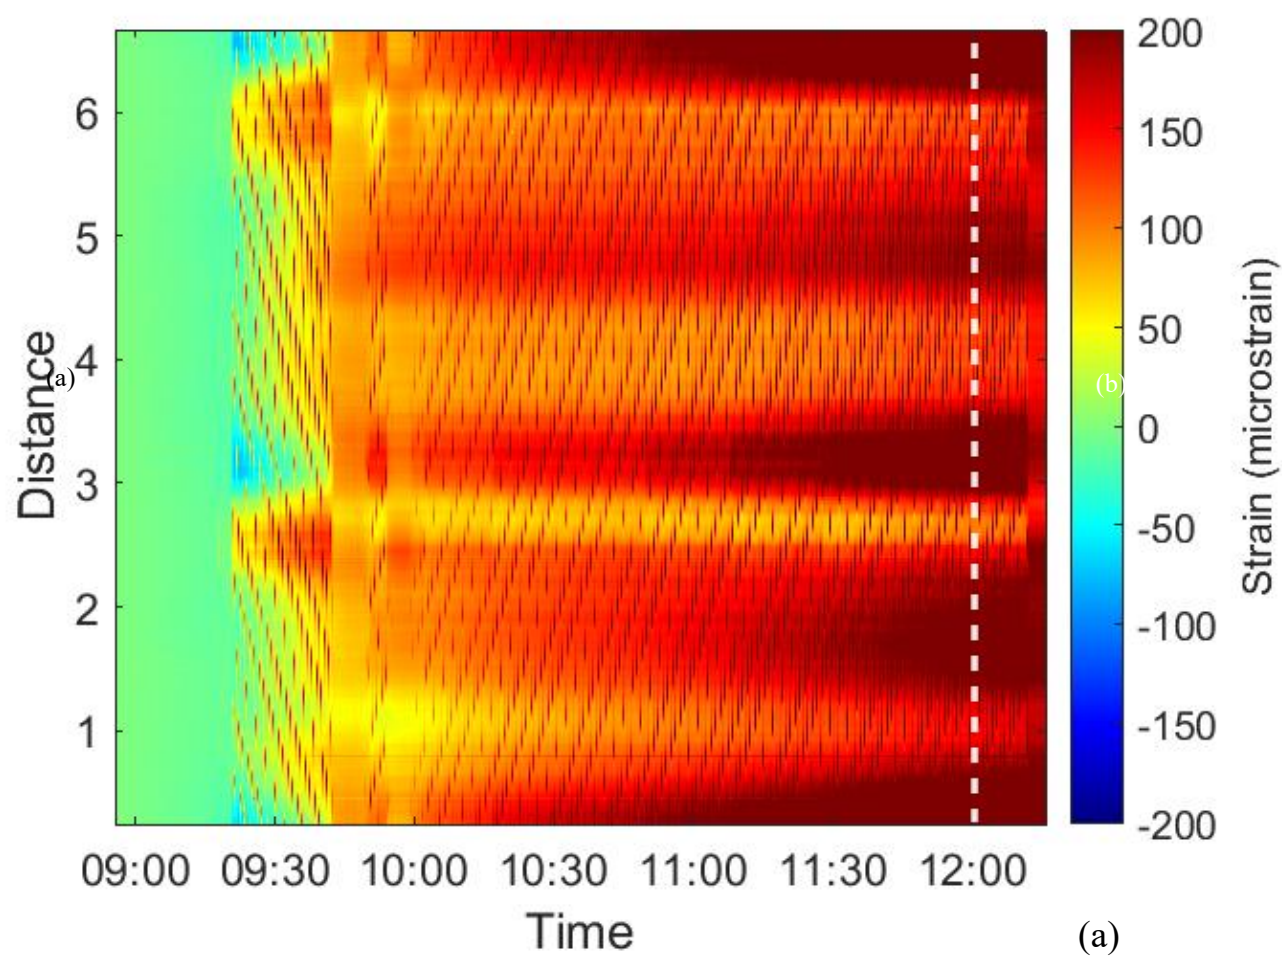
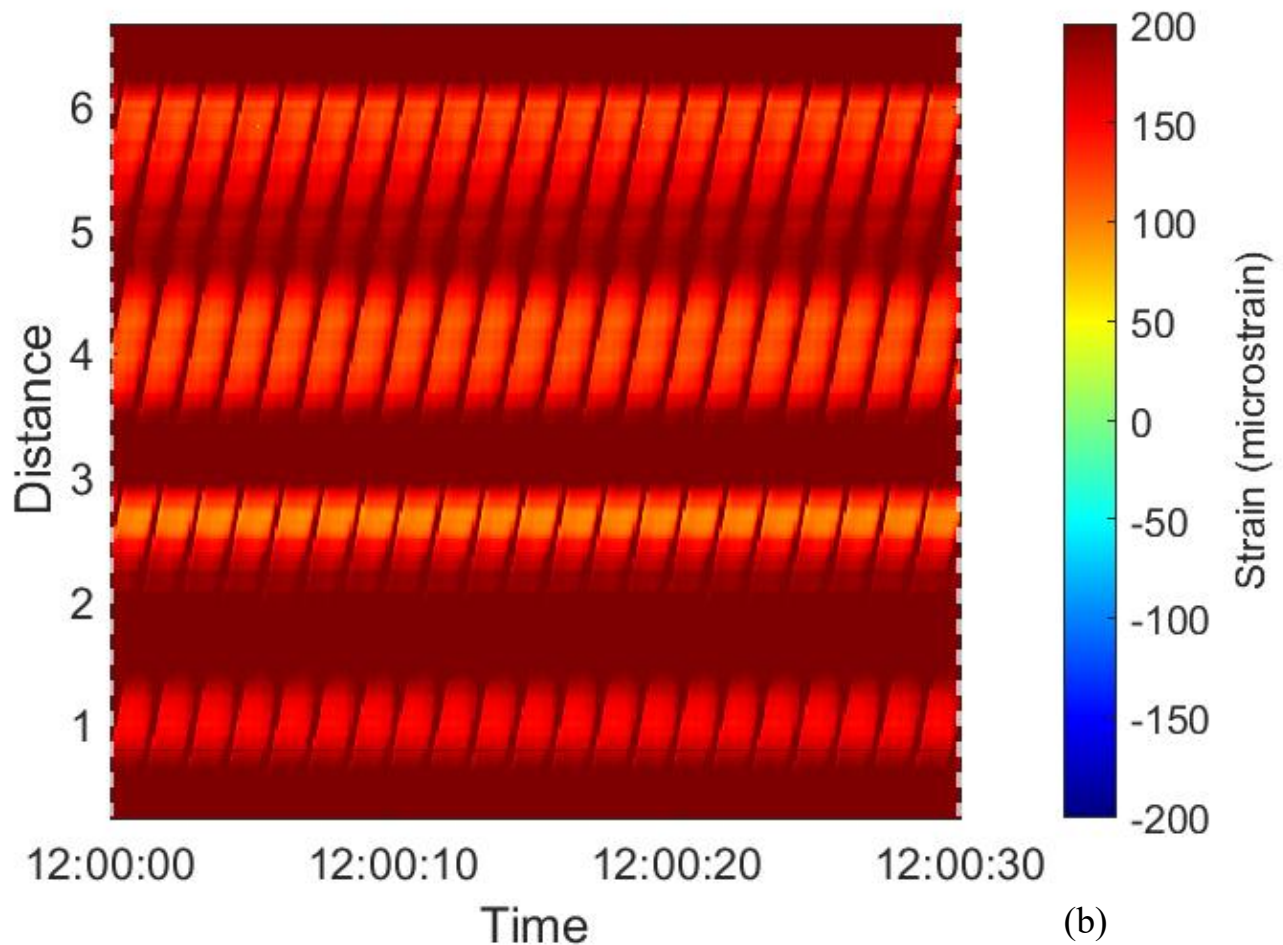
Figure 3 Waterfall representation of the strain profile over time for the circumference of the ring rear. The vertical axis denotes distance in meters, while the color gradient indicates strain in micro-strain. (a) Strain profile throughout the entire test period. (b) A magnified view of the strain profile corresponding to the region outlined by the white dashed square in the left panel.

The raw strain data collected during the test are shown in Figure 3a, where red indicates tensile strain and blue represents compression. The diagonal banding pattern corresponds to gear rotation, with rotation direction changes visible in the shifting patterns between 9:19 to 9:41 (clockwise) and 9:48 to 12:12 (counterclockwise). Figure 3b provides a detailed view of a 30-second interval outlined by white dashed lines in Fig.3a, revealing the distinct locations of the four planet gears as they rotate along the circumference of the ring gear.

As the test progressed, a shift toward darker red regions indicated an increase in measured strain. However, since this strain was derived directly from the frequency shift, it still reflected a combination of both temperature and mechanical effects. The darker red horizontal strips were attributed to rising temperatures caused by frictional heat generated by shearing the gear teeth when gears rotate, while the diagonal strips were linked to the mechanical strain from the meshing of the rotational gears. Overall, the strain distribution and rotational behavior of the gears were clearly tracked throughout the test.

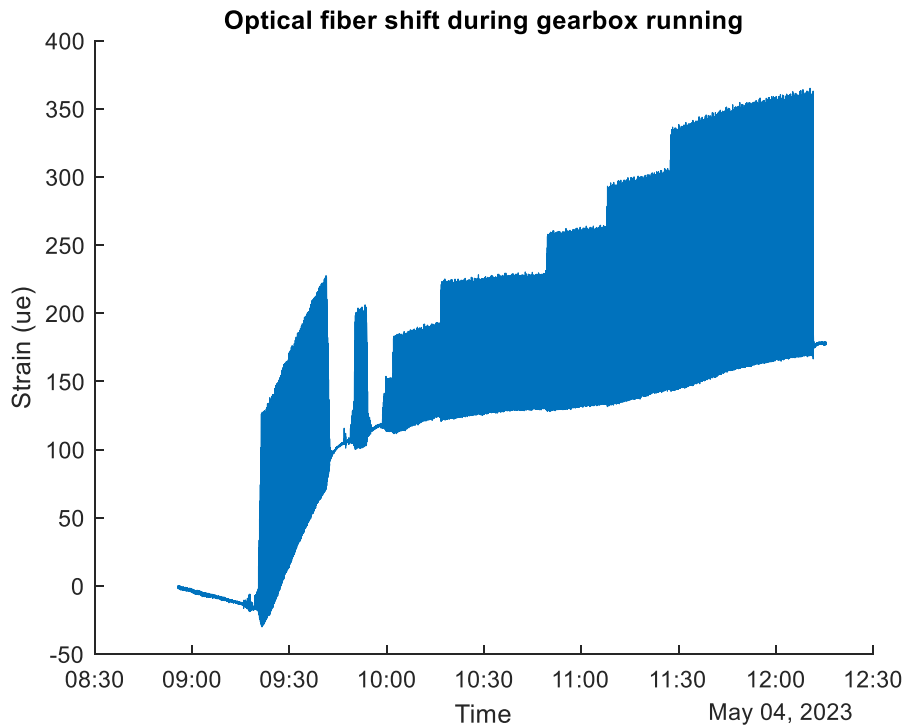
Figure 4 The strain response at 4.62m or close to the bottom of the gearbox during the loading test.

Temperature changes were also shown in the strain data, as shown in Figure 4, which illustrates the response at a single location (bottom of the gearbox in Figure 1 or 4.62 m in Figure 3). Before 9:15 am, the strain exhibited a downward drift of

175 approximately 30 microstrain. This is due to the gearbox having run overnight and it was stopped for this test and the drops indicating a cooling effect of about 3 °C. After 9:15 am, the measured strain, which includes mechanical strain and thermal, drifted by approximately 150 microstrain at 12:15, equivalent to a 15 °C temperature increase, caused by heat generated during operation. The maximum drift rate occurred between 9:19 and 9:41 am, coinciding with the transition from idle to maximum speed.

Although temperature effects were filtered out in this analysis to focus on strain behavior, the system's capability to measure temperature concurrently should not be overlooked. As shown in Fig. 4, DFOS captured a potential 3-degree cooling when the gearbox stopped rotating and 15-degree heating during gearbox operation at the bottom of the gearbox. If localized
300 overheating occurs, such as from internal damage or inadequate lubrication, the system can detect and pinpoint these anomalies, preventing potential thermal runaway and costly damage. This adds an additional dimension to gearbox condition monitoring.

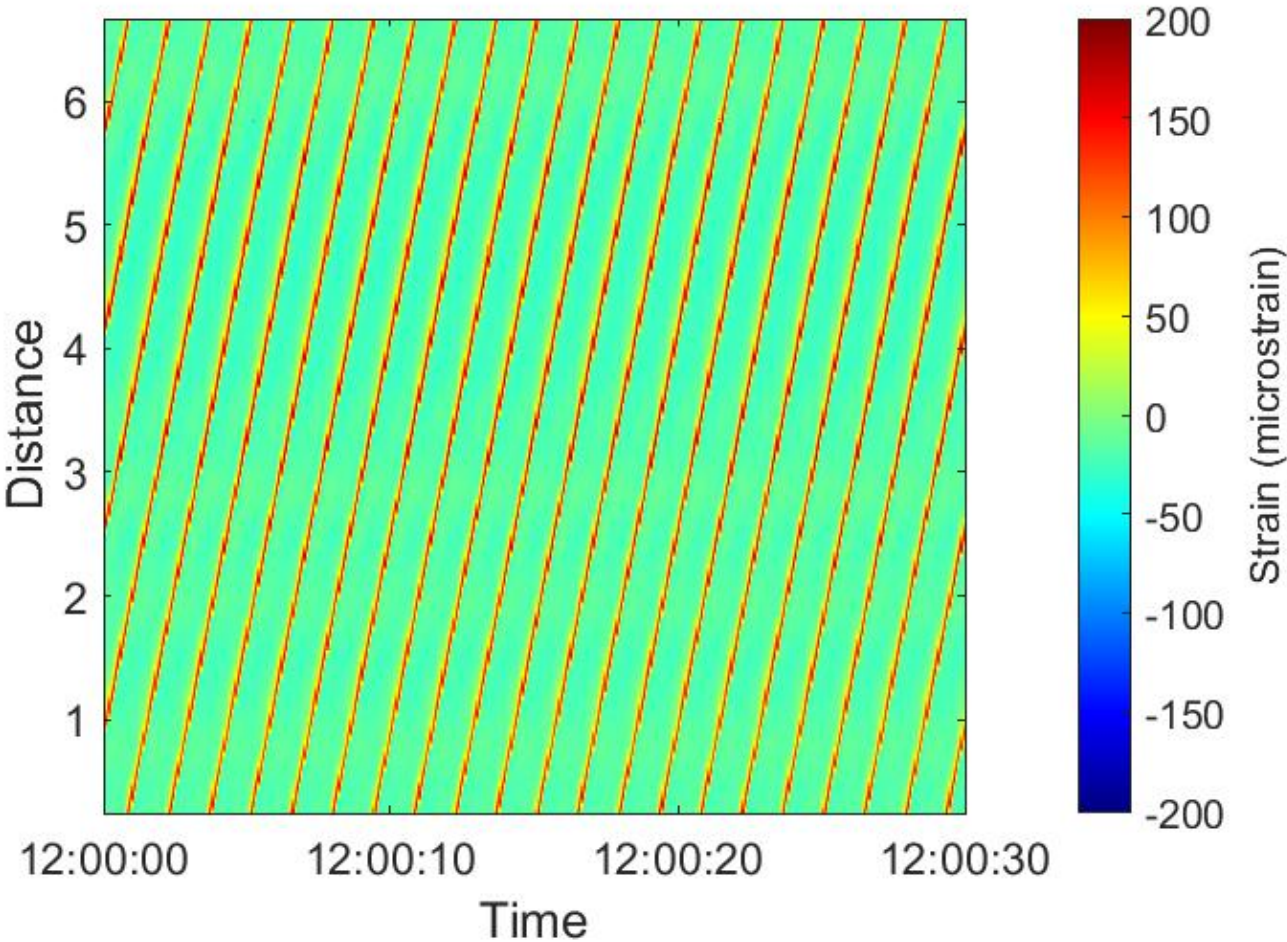
Figure 5 The waterfall of the strain response during the load test after 0.01 Hz high pass filter in period of 30 seconds when the load is at 100% torque, time domain shows strain profile collected with 12.5 Hz.

190 The strain profile during the maximum load test (Figure 5) reveals repeated tensile spikes forming a diagonal pattern, indicating the rotation of the four planet gears. At each timestamp, four red bands (tensile strain) correspond to the locations

where planet gears contact the ring gear. These are separated by mild blue bands (compressive strain) where there is no direct gear contact.

After 9:48 am, both tensile and compressive strain intensities increased as the torque rose from 17% to 100%. Each tooth on the ring gear exhibited cyclic strain patterns, reflecting the load distribution during gear engagement. The strain width across approximately five teeth suggests contributions from the helix angle of the gear teeth and partial strain transfer before and after full contact. At the bottom of the gearbox (4.62 m), strain values increased from 33 microstrain at 17% torque to 161 microstrain at 100% torque (Figure 6). These measurements demonstrate how DFOS captures detailed strain variations, even at the level of individual gear teeth.

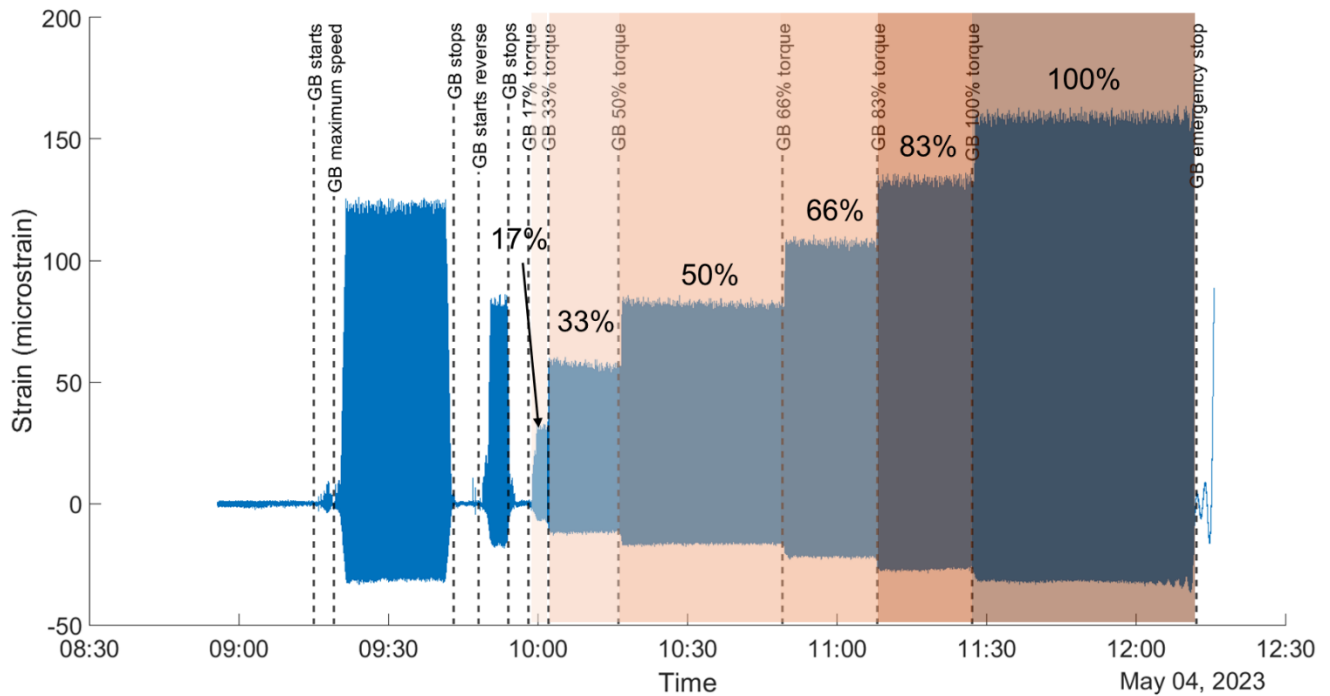
205 **Figure 6** The strain response after 0.01 Hz high pass at location 4.62m (one tooth's strain response). The dash line shows the timing of each loading event listed in table 2. The color background shows the percentage of the rated torque input from 17% to 100%, GB represents gearbox.

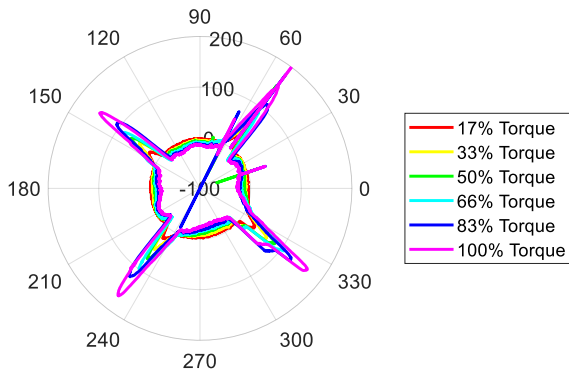
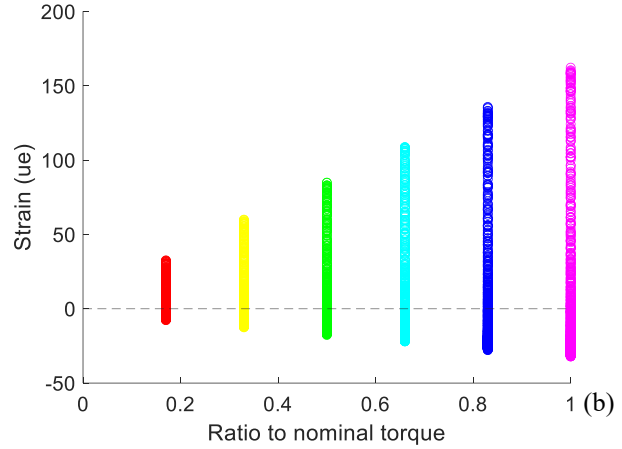
Figure 7 (a) The strain profile in polar axis when different loads are applied to the gearbox and (b) the scatter plot show the clusters of all the collected strain at one location on the ring gears during the load test with different load input.

Examples of strain profiles at various torque levels are shown in Figure 7a, plotted on a polar axis to illustrate the gearbox's real-time response. The four prominent strain spikes correspond to the locations of the planet gears, with these spikes rotating as the gears move. This polar axis plot can be generated in real time for each strain profile measurement, clearly displaying the positions of the planet gears and the strain values they produce. The sharp spikes observed at fixed locations (e.g., 18.7° and 63°) exhibit reading errors and constant values, likely due to poor bonding of the optical fiber to the ring gear. A supplemental video illustrating the dynamic rotation of the planet gears and associated strain spikes is in the supplemental documents (Luo and Wu, 2024).

215 As the gears rotate, six strain profiles corresponding to different torque inputs are presented, with the time frames selected to align with consistent gear-tooth engagement. At higher torque levels, tensile strain increases at points where the planet gears contact the ring gear, while compressive strain intensifies in areas between gear contacts. This behavior is more clearly depicted in Figure 7b, which shows strain values recorded at a specific tooth location (4.62 m). The data includes strain measurements as the gear meshes with and disengages from the tooth, highlighting the cyclic strain variations under different torque conditions.

Despite its advantages mentioned above, the current DFOS system also has limitations. Some minor data artifacts were observed, such as sharp spikes at fixed locations (e.g., 18.7° and 63° in Figure 7a). These irregularities are likely caused by
295 micro-bending of the optical fiber during installation or the application of epoxy. Refining installation techniques and applying advanced post-processing methods, such as outlier fitting, could mitigate these issues in future applications.

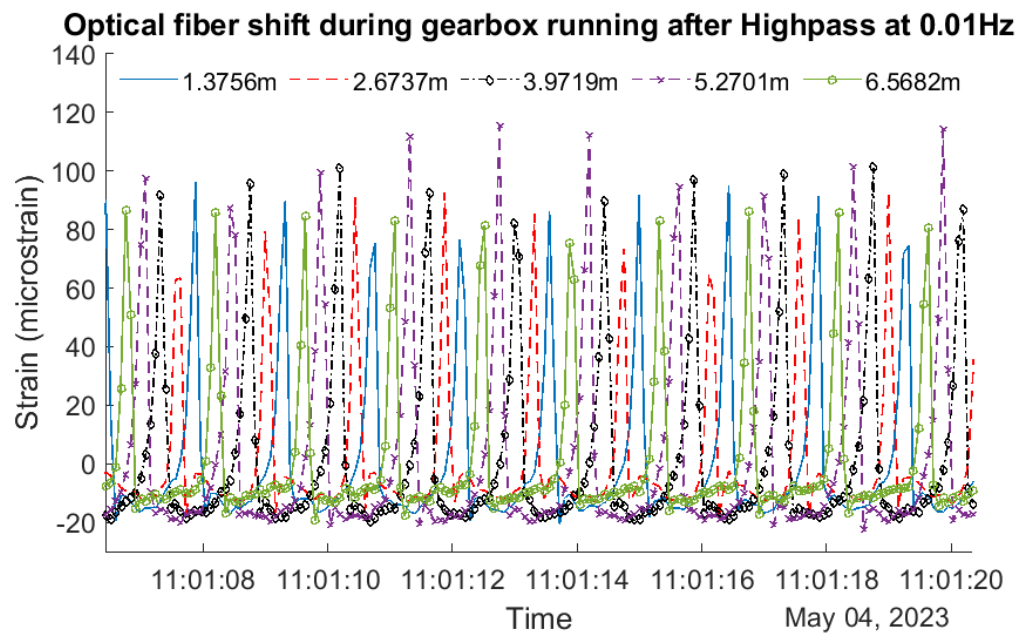
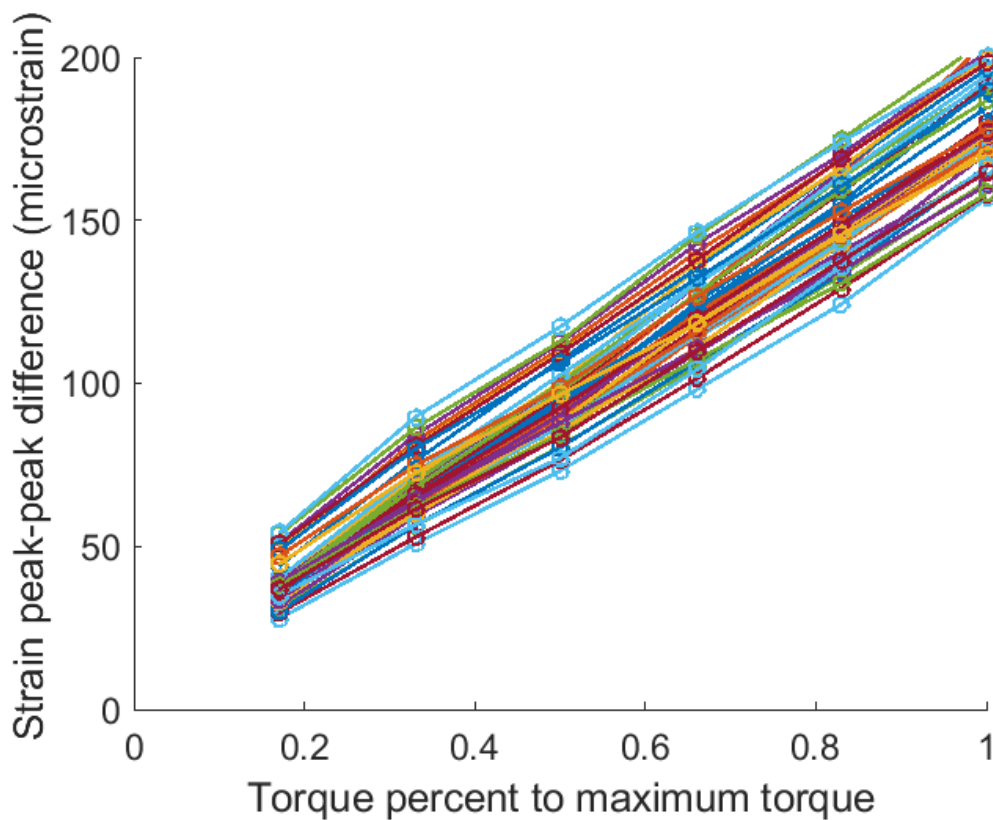
245 Figure 8 (a) An example of collected strain at 5 locations with time and (b) the peak-peak strain at 49 locations on the ring gear for 6 torque load inputs.

The strain variation at five specific teeth is illustrated in Figure 8a. Each distinct spike corresponds to the arrival and departure of a planet gear during its rotation cycle. The time interval between consecutive spikes is measured at 1.44 seconds, indicating a full rotation duration of 5.76 seconds for the first stage. This translates to a rotational speed of 10.42 revolutions per minute (rpm). Additionally, a periodic signal comprising six spikes over 8.64 seconds is observed at all measured locations. This pattern likely reflects periodic fluctuations in the input torque from the back-to-back gearbox system used during testing.

To analyze the relationship between strain and torque, the peak-to-peak strain was calculated for each measurement location. The peak-to-peak strain, defined as the difference between maximum tensile and maximum compressive strain, captures the full range of strain variation at a given tooth. This metric was computed for 49 evenly spaced locations along the ring gear circumference to assess the strain response under varying torque levels. The results revealed a linear relationship between torque and peak-to-peak strain, as illustrated in Figure 8b. The average linear relationship is shown in Eq. 3. This linear correlation was exceptionally strong, with a high coefficient of determination ($R^2=0.9997$).
